Arborist Report

Inventory and Assessment of Trees Associated to Development at
15052 Buena Vista Avenue, White Rock

August 4, 2021

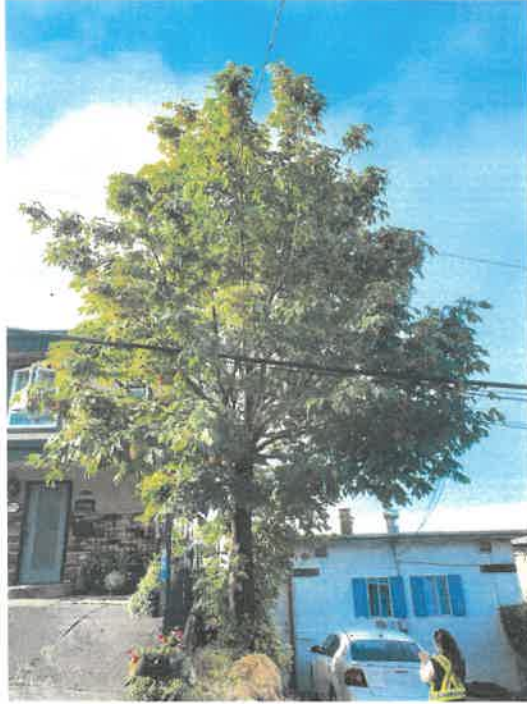
Image 1: Tree ci1

tag ci1	species <i>Acer macrophyllum</i> Bigleaf Maple	dbh 41 cm	description Decurrent, natural form. Growing in a concrete retaining wall. Kretzschmaria deusta at the base. Tree sweeps north. Crown is growing into power lines to the west. Sun scorch in the crown. Its TPZ is 2.46m	action Retain Install barrier 2.46m from tree
-------------------	---	---------------------	---	--

- Tree barriers shown on the “Tree Plan for Construction” are to be installed and kept in place during the entire duration of construction.
