# Arboricultural Inventory and Report

Site Location:  
1363 Johnston Road  
White Rock, BC

To be submitted with Tree Retention and Removal Plan  
dated January 19<sup>th</sup>, 2021

Date: 2021/01/19  
Updated: 2022/06/02

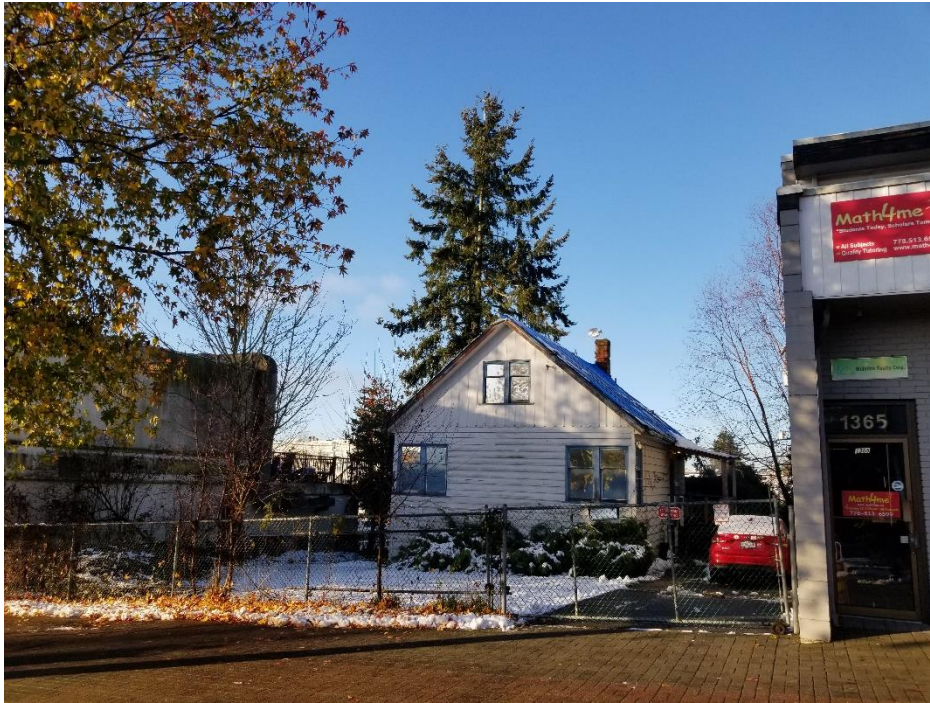
Photo 1. Trees City01 (left), #8814 (center), and #8813 (left) , Front of property viewed from Johnston Road.

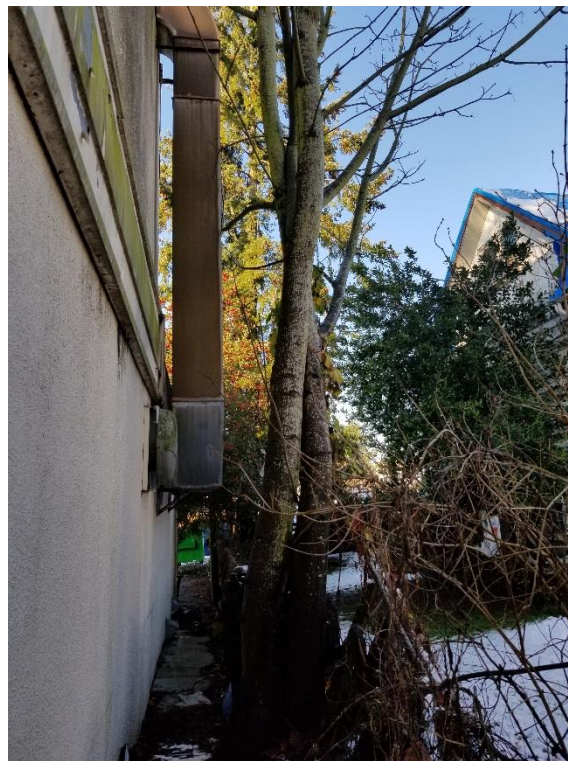
Photo 2. Tree #8814, Showing location on property line.

- 8813: Is recommended for removal to accommodate the proposed building.
- 8812: Approval from owner of 1365 Johnston Road required before removal.
- 8814: Approval from owner of 1355 Johnston Road required before removal.

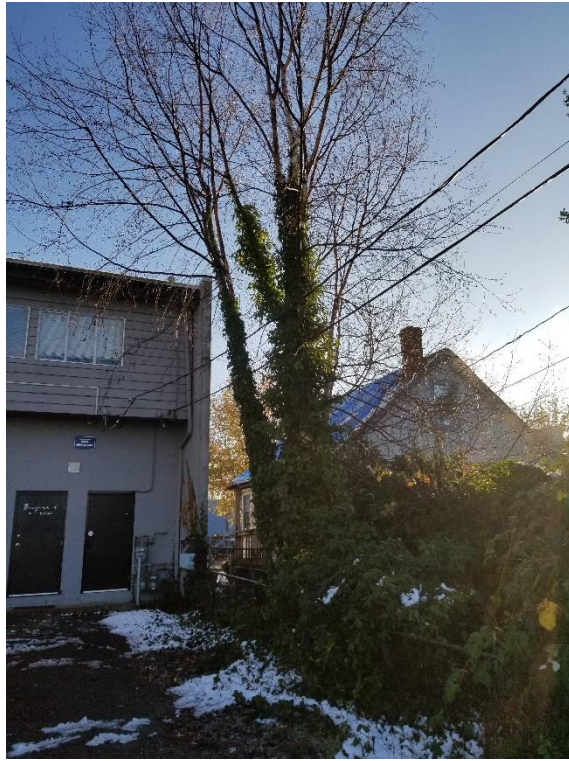
Photo 3. Tree #8812, West facing view from Winter Lane.

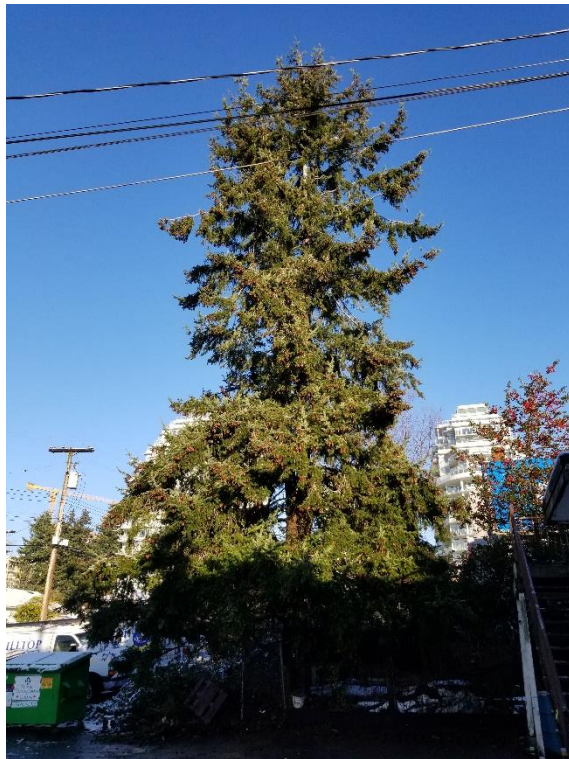
Photo 4. Tree #8813, North facing view.
