**Tree Evaluation Report for:
14205 – Malabar Avenue
White Rock, BC**

**Mike Fadum and Associates Ltd.
#105, 8277-129 Street
Surrey, BC
Phone 778-593-0300
Fax 778-593-0302**

Date: January 5, 2023

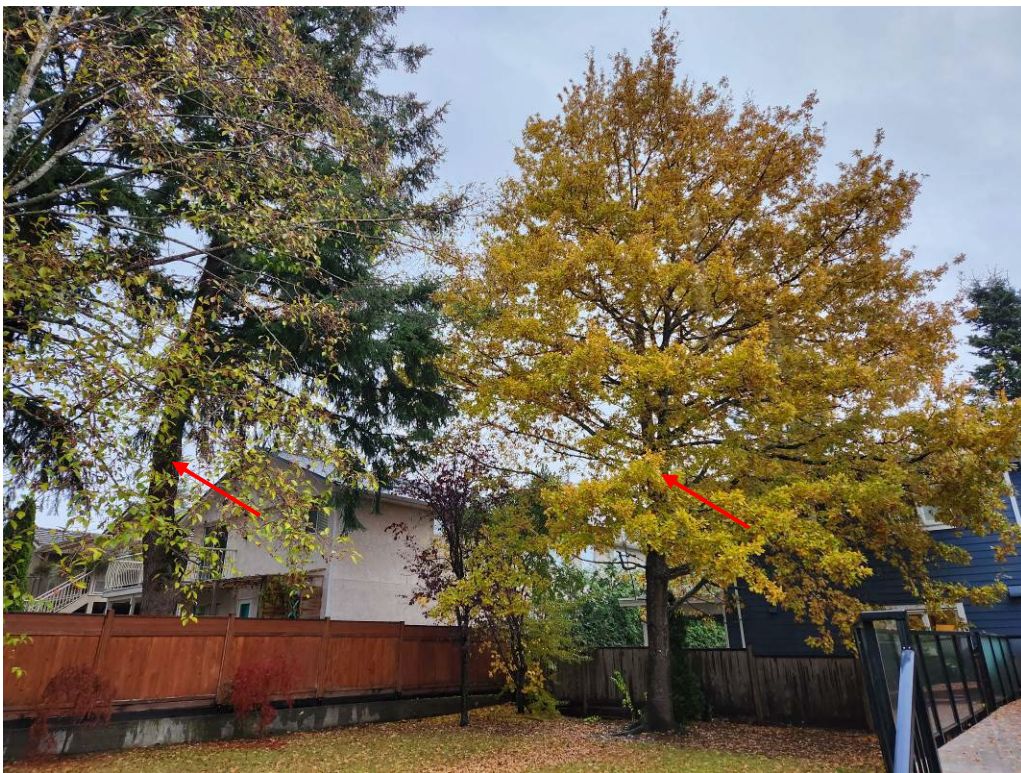
Figure 2. OS1 and 3971 from left to right.

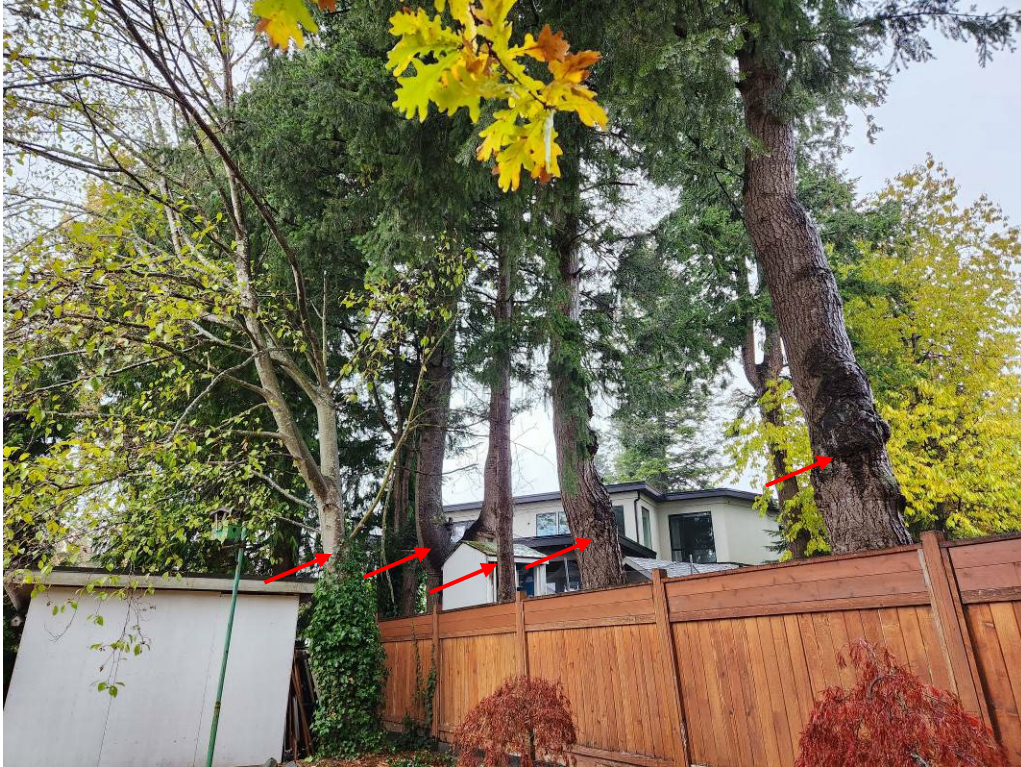
OS2	Douglas-Fir (<i>Pseudotsuga menziesii</i>)	~55	5.7	70	M, MG	Retaining wall on subject property likely limiting root growth to the south. Reaction wood at ~4.0m. Likely previously topped.	4.5	Retain
OS3	Douglas-Fir (<i>Pseudotsuga menziesii</i>)	~25	3.0	70	M, M	Suppressed. Retaining wall on subject property likely limiting root growth to the south. Not surveyed at time of assessment, location approximate.	2.5	Retain
OS4	Western Hemlock (<i>Tsuga heterophylla</i>)	~70	5.0	75	M, MG	Co-dominance forms at ~3.0m. Foliage appears healthy.	5.0	Retain
OS5	Douglas-Fir (<i>Pseudotsuga menziesii</i>)	~25	4.5	30	MP, M	Past topping cuts. Suppressed. Not surveyed at time of assessment, location approximate.	4.0	Retain

Figure 3. 3998, OS4, OS3, OS2 and OS1 from left to right,

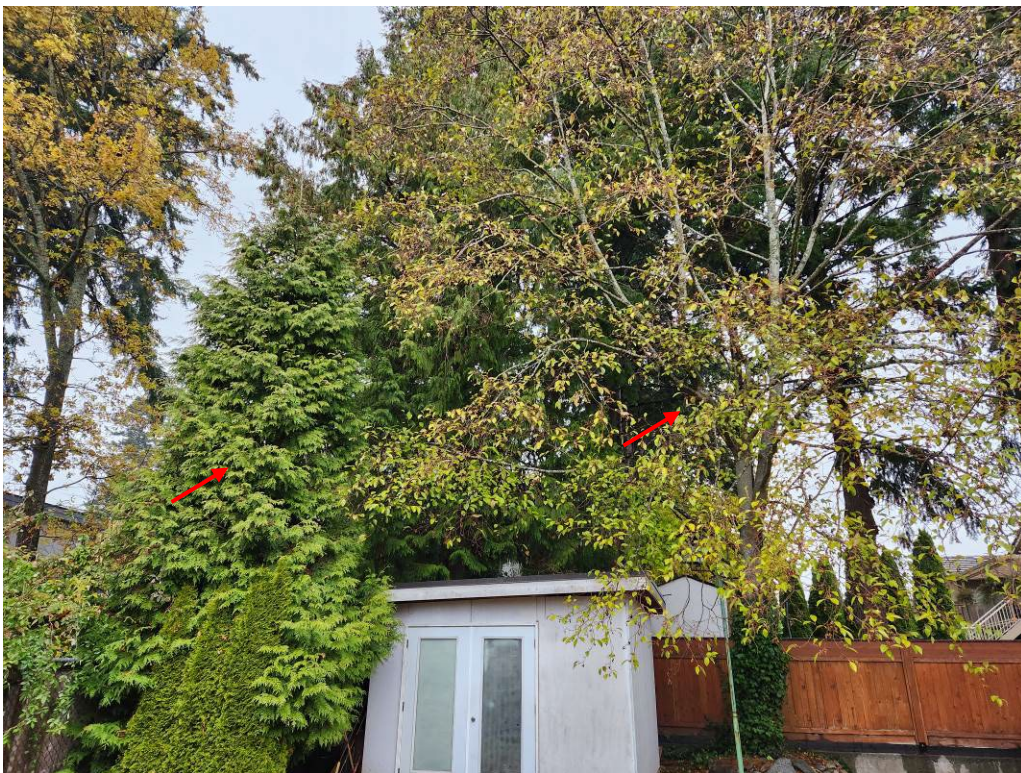
Figure 4. 3969 and 3998 from left to right.

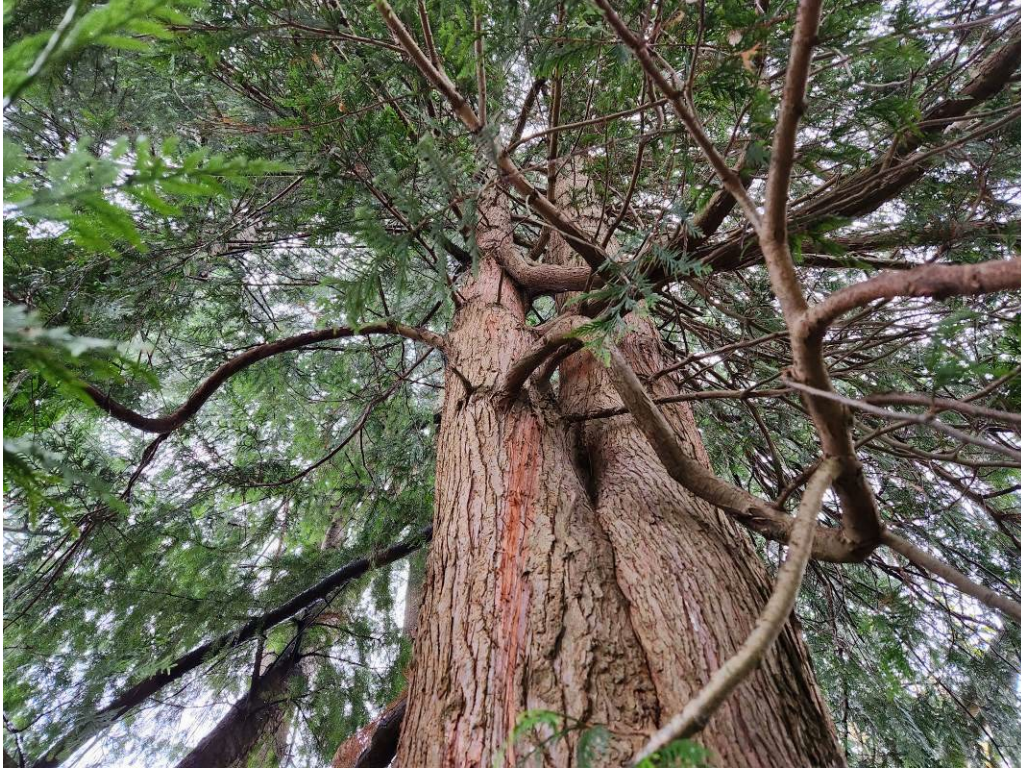
Tree #	Type	DBH (cm)	Dripline (m)	LCR (%)	Condition (Structure, Health)	Comments	TPZ (m)	Recommendation
35	Western Redcedar (<i>Thuja plicata</i>)	58	4.5	98	M, G	Co-dominance forms at ~2.0m with inclusion – likely limb locked. Healthy foliage. Not surveyed at time of assessment, location approximate.	4.5	Retain
3969	Excelsa Redcedar (<i>Thuja plicata</i> 'Excelsa')	25	2.0	98	G, G	Healthy foliage. Not surveyed at time of assessment, location approximate.	2.0	Retain
3971	English Oak (<i>Quercus robur</i>)	54	7.4	NA	MG, G	Slightly phototropic.	6.0	Remove Expected to be significantly impacted by future house excavation. Canopy expected to conflict with future house.
3998	Red Alder (<i>Alnus rubra</i>)	45	8.7	NA	M, M	Highly phototropic. Exaggerated DBH due to heavy ivy infestation.	6.0	Retain
OS1	Douglas-Fir (<i>Pseudotsuga menziesii</i>)	~65	7.2	70	M, MG	Retaining wall on subject property likely limiting root growth to the south. Reaction wood at ~4.0m. Likely previously topped.	6.0	Retain

Figure 5. Canopy of tree 35

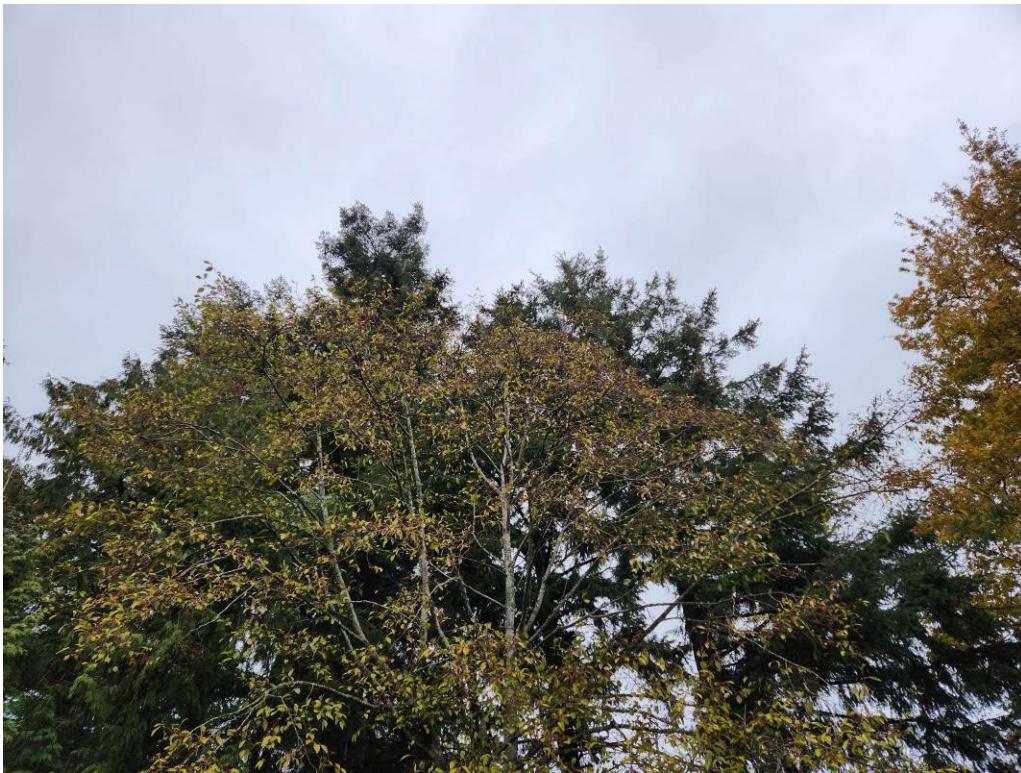
Figure 6. Canopies of trees to the north appear relatively healthy.

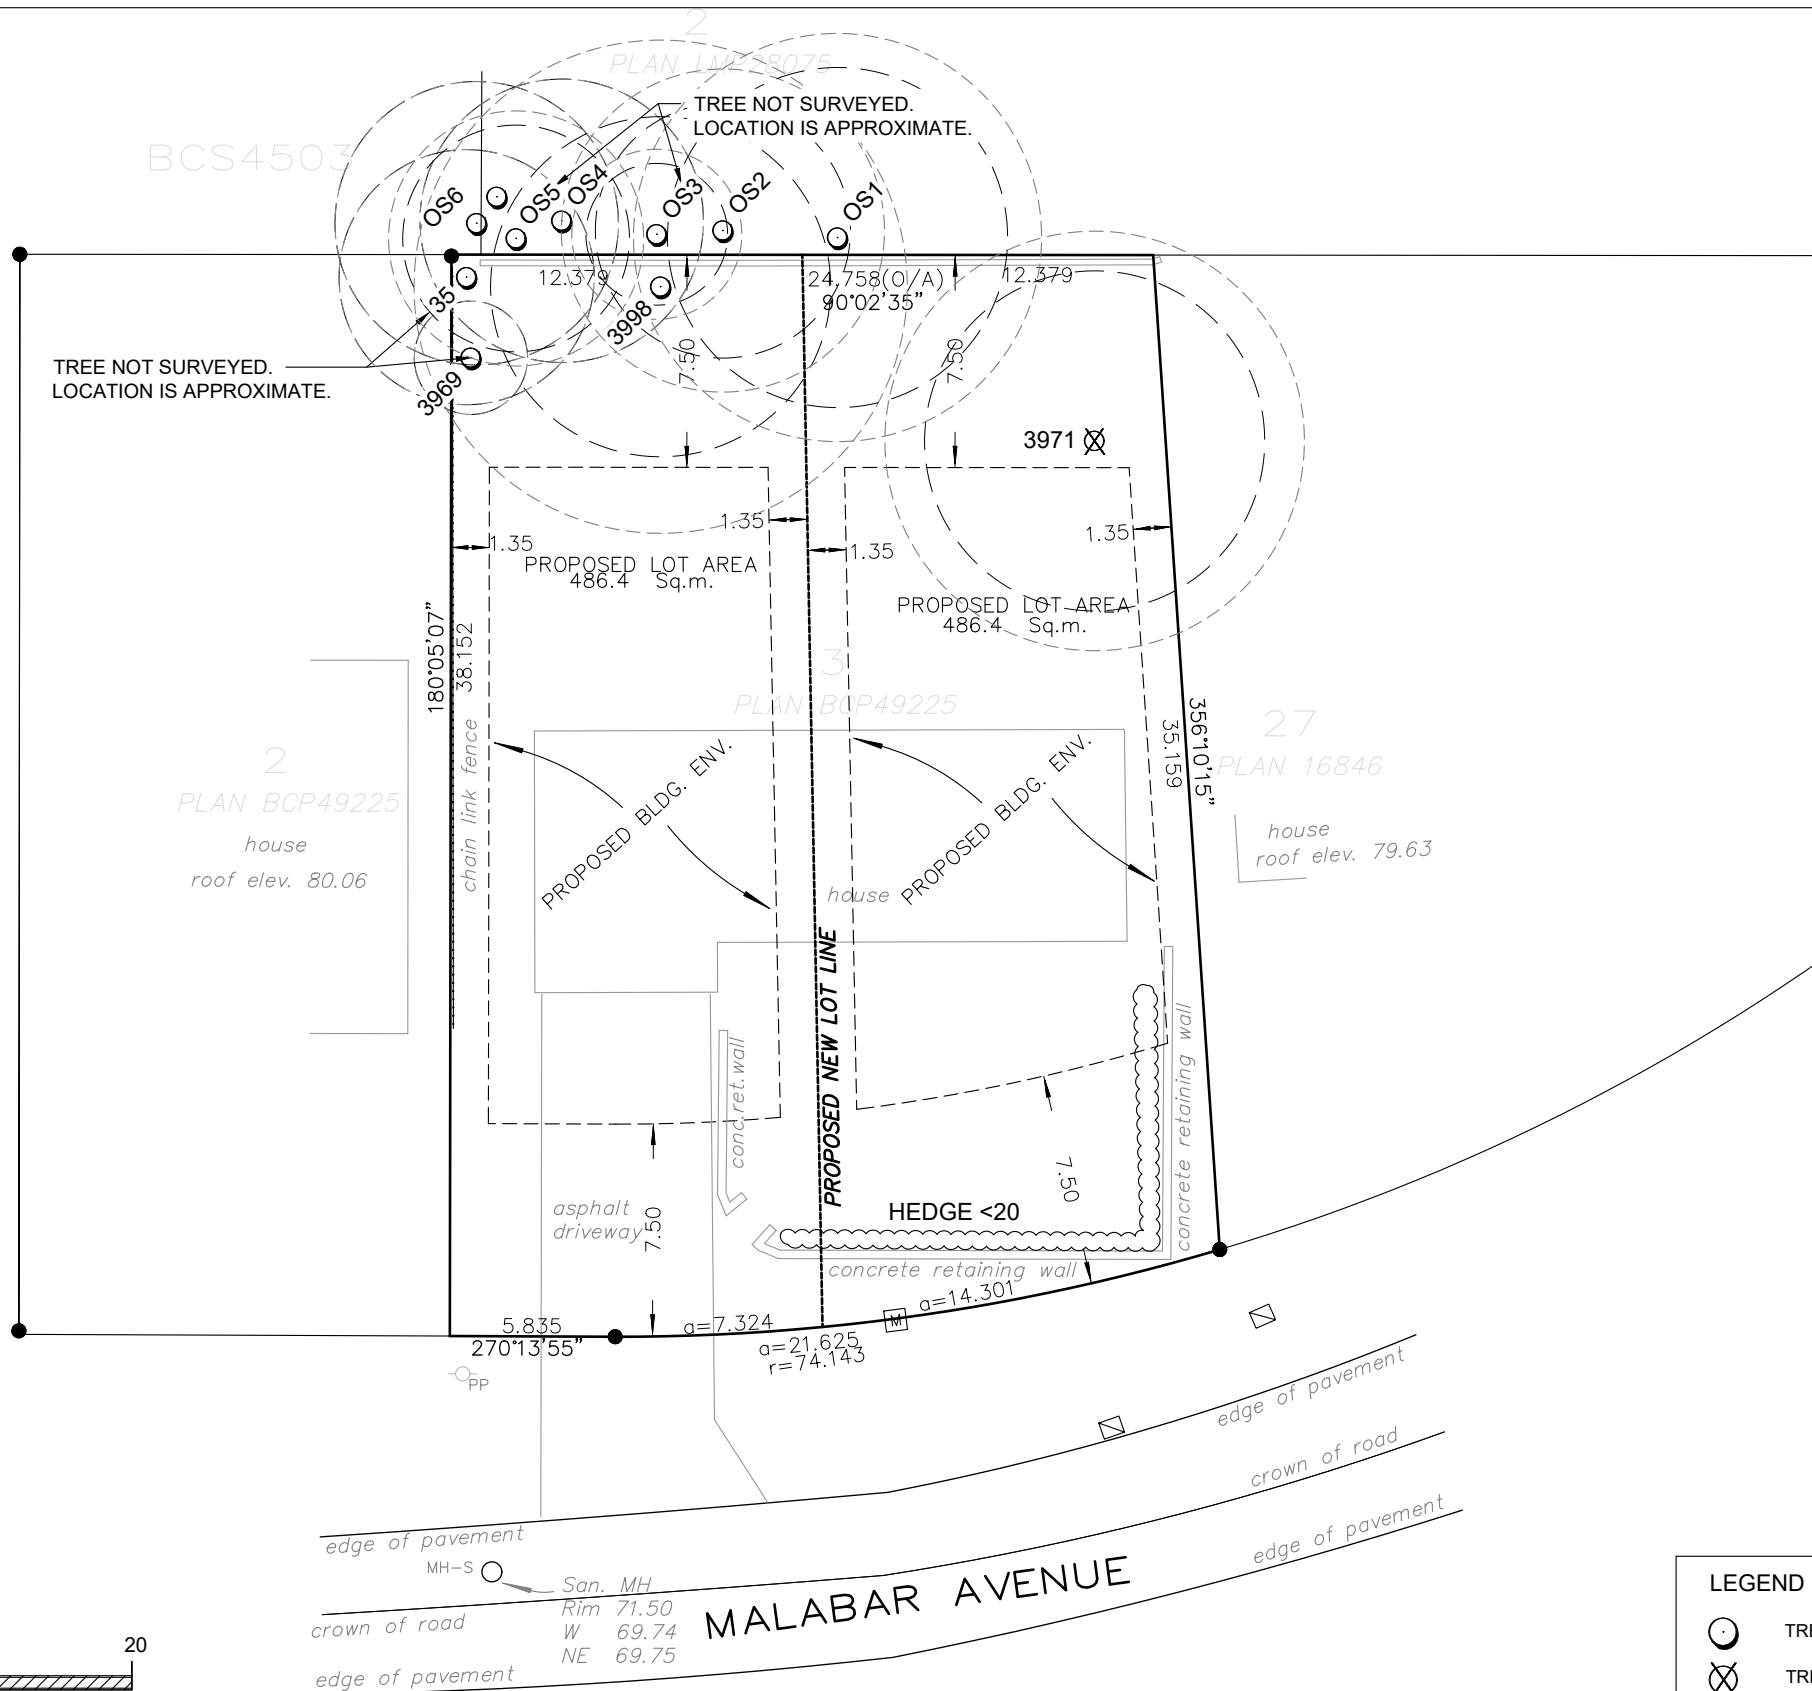
SHEET TITLE
T1 - TREE REMOVAL AND PRESERVATION PLAN

TREE NOT SURVEYED.
LOCATION IS APPROXIMATE.
