TECHNICAL MEMO

Oxford Street Assessment

2021-06-25

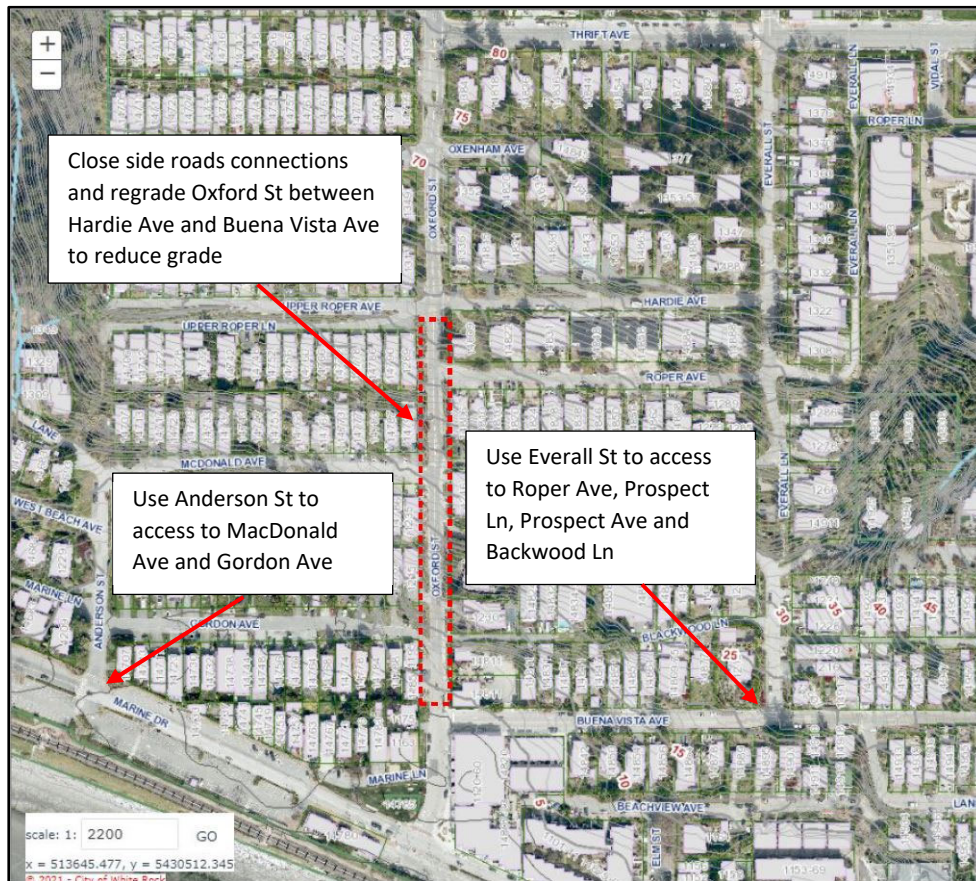
Figure 1-Regrading Oxford Street

There are noticeable humps along Oxford Street between Oxenham Avenue to Buena Vista Avenue. These humps resulted mostly by creating a flat landing area for the intersections connecting side roads. The grades can be ameliorated between Hardie Avenue and Buena Vista Avenue by removing these humps. Adding to this removal, the grades can be effectively improved by further excavation supported with retaining walls. To enable this improvement, as shown in the following Figure 1, this option requires closing a few side roads to Oxford Street, including Roper Avenue, MacDonald Avenue, Prospect Lane, Prospect Avenue, and Gordon Avenue. These side roads can be accessed either by Anderson Street from Marin Drive or by Everall Street from Buena Vista Avenue.

The major challenge of this option is the driveway regrading and driveway tie-ins. It may not be possible to regrade the road and maintain driveway access to a number of properties at the same time. Emergency access for fire, police, and ambulance may also be affected. A further study is required to determine the feasibility.

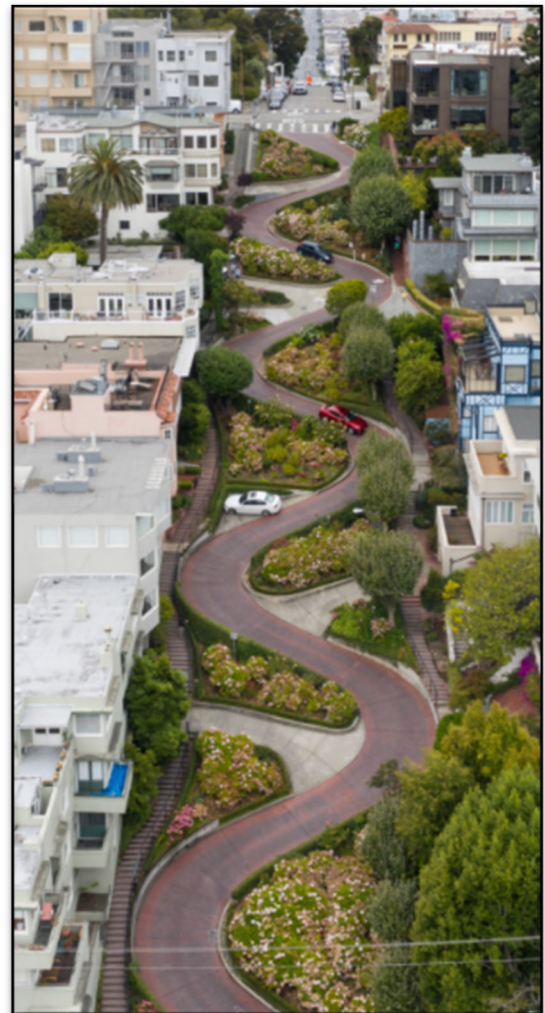
Figure 2-Meandering Scenic Drive (San Francisco Lombard Street from en.wikipedia.org)

This option converts Oxford Street into a one-way street for the southbound traffic only. The conversion will narrow Oxford Street down to one travel lane, and the one-lane Oxford Street will meander within the 20 m wide road ROW to stretch the length of the street and accordingly reduce the grade. The closed northbound lane can be used to upgrade the sidewalk amenities such as adding a treed boulevard with street furniture and viewpoints for ocean view. This option could create a scenic drive of Oxford Street as exemplified in Figure 2.

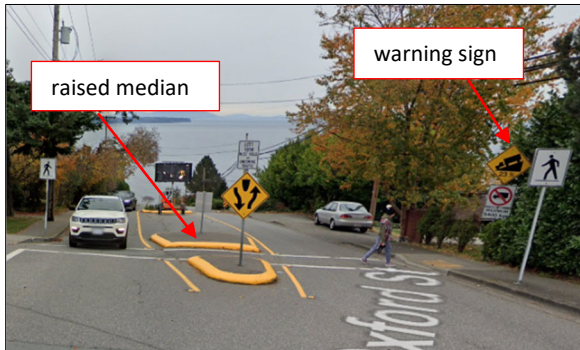
Figure 1-1 Raised median & warning sign

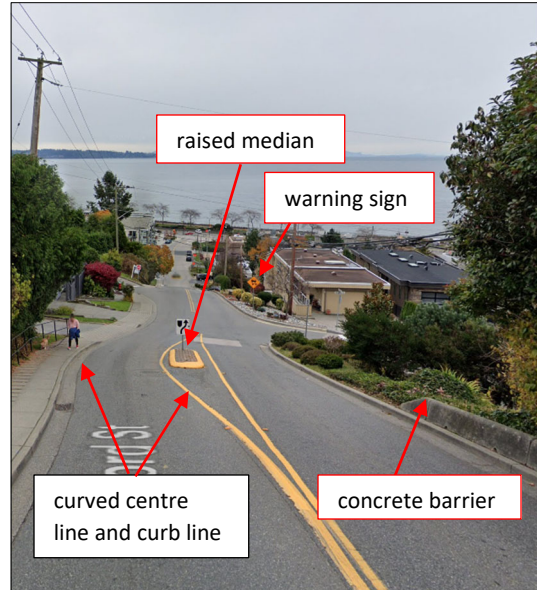
Figure 1-4 Raised median & warning sign

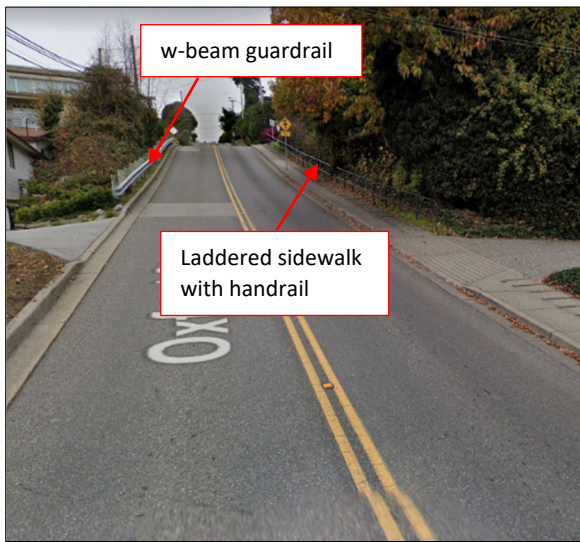
Figure 1-2 W-beam guardrail & laddered sidewalk c/w handrail

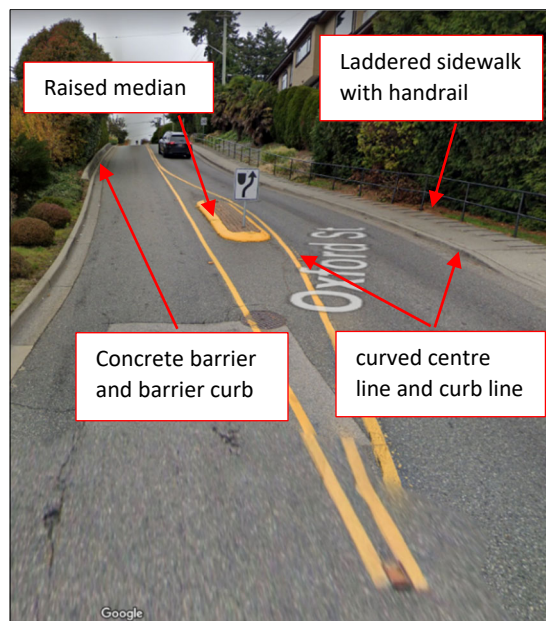
Figure 1-5 Concrete barrier & curved curb line

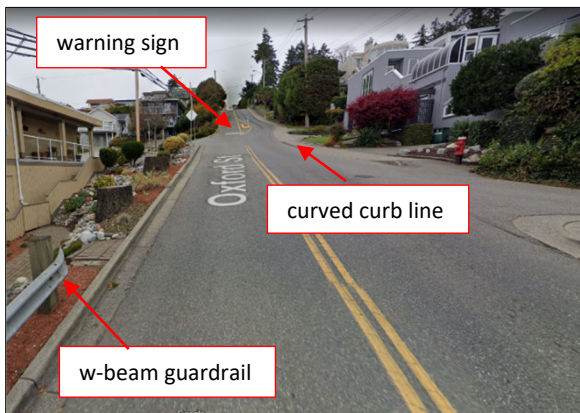
Figure 1-3 W-beam guardrail and curved curb line
