## **ARBORIST REPORT**

**WATERSTOCK\_Beachway 2**

**15704 – 15770 NORTH BLUFF ROAD, WHITE ROCK, BC**

**September 21st, 2020**

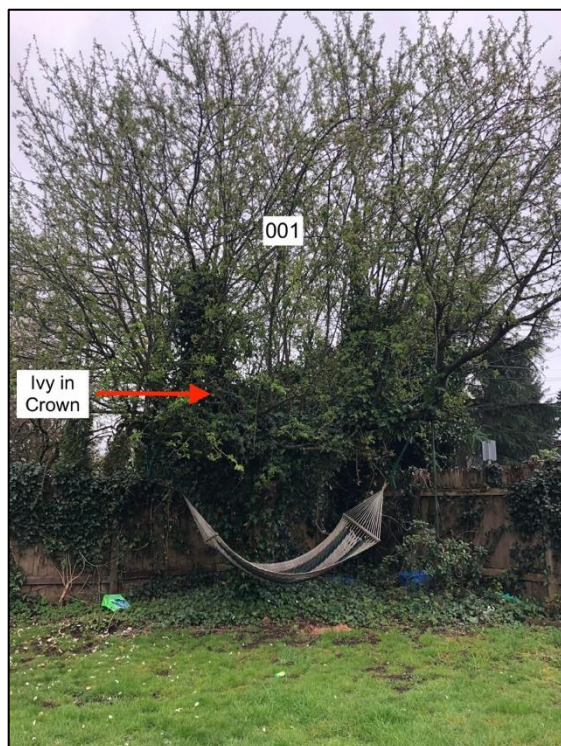
| Tree # | Tag # | Common Name<br><i>Botanical Name</i> | DBH (m.) | C-Rad (m.) | LCR (%) | Comments | Retain / Remove |
|---|---|---|---|---|---|---|---|
| 001 | 2125 | Apple<br><i>Malus</i> spp. | 0.40 | 4.0 | 80 | CROWN – Ivy growing up 80% of stem. Hammock in crown.<br>FIGURE 2<br>WITHIN PROPOSED UNDERGROUND PARKING ENTRANCE | REMOVE |

Fig. 2 – Tree 001 with ivy growing throughout crown.

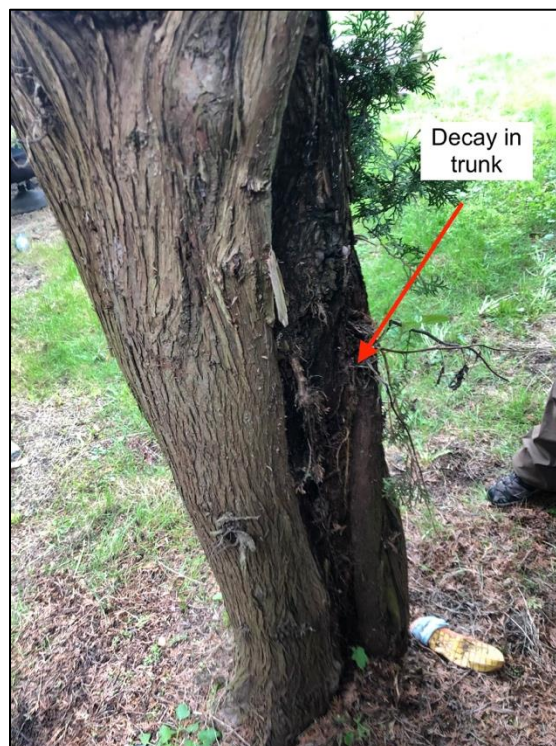
| Tree # | Tag # | Common Name<br><i>Botanical Name</i> | DBH (m.) | C-Rad (m.) | LCR (%) | Comments | Retain / Remove |
|---|---|---|---|---|---|---|---|
| 005 | 0959 | Cypress<br><i>Chamaecyparis</i> spp. | 0.30 | 1.0 | 80 | TRUNK – Codominant at 1 meter. Decay column from base to 1 meter on west side.<br>FIGURE 3<br>WITHIN PROPOSED BUILDING ENVELOPE | REMOVE |

Fig. 3 – Tree 005 with decay from base to 1 meter.

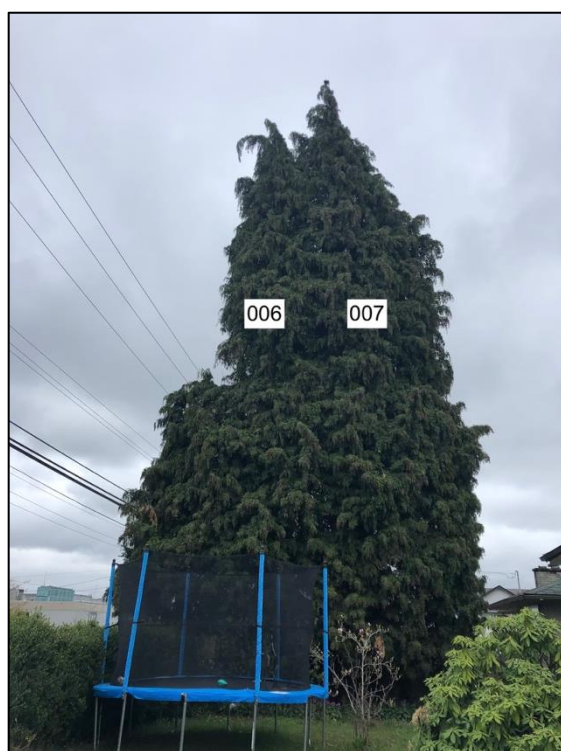
| Tree # | Tag # | Common Name<br><i>Botanical Name</i> | DBH (m.) | C-Rad (m.) | LCR (%) | Comments | Retain / Remove |
|---|---|---|---|---|---|---|---|
| 006 | 3913 | Lawson cypress<br><i>Chamaecyparis lawsonia</i> | 0.40<br>0.40 | 3.5 | 100 | TRUNK – Ivy growing up base. Codominant stems at base.<br>CROWN – Excessive coning. Some flagging present.<br>FIGURE 4<br>WITHIN PROPOSED BUILDING ENVELOPE | REMOVE |
| 007 | 3912 | Lawson cypress<br><i>Chamaecyparis lawsonia</i> | 0.50<br>0.35 | 3.5 | 100 | TRUNK – Ivy growing up base. Codominant stems at base.<br>CROWN – Excessive coning. Some flagging present.<br>FIGURE 4<br>WITHIN PROPOSED BUILDING ENVELOPE | REMOVE |

Fig. 4 – View of Trees 006 and 007.

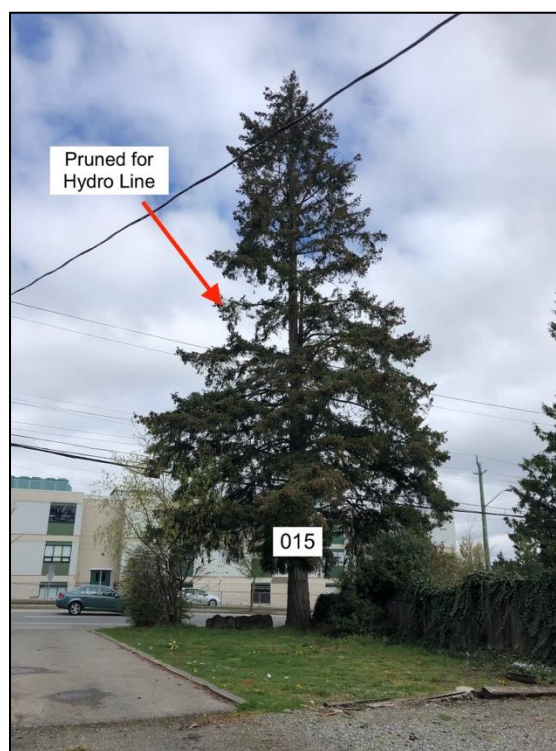
| Tree # | Tag # | Common Name<br><i>Botanical Name</i> | DBH (m.) | C-Rad (m.) | LCR (%) | Comments | Retain / Remove |
|---|---|---|---|---|---|---|---|
| 015 | 2502 | Douglas-fir<br><i>Pseudotsuga menziesii</i> | 0.85 | 7.5 | 90 | Declining<br>CROWN – Excessive coning. Pruned on north side for Hydro clearance.<br>FIGURE 5<br><b>WITHIN PROPOSED EXCAVATION ZONE FOR BUILDING AND UNDERGROUND PARKING</b> | REMOVE |

Fig. 5 – Tree 015 with pruning on north side.

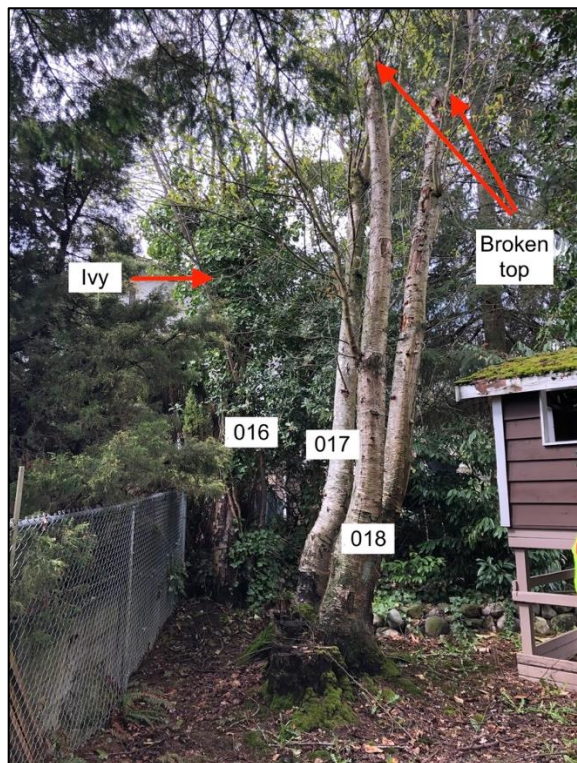
| Tree # | Tag # | Common Name<br><i>Botanical Name</i> | DBH<br>(m.) | C-Rad<br>(m.) | LCR<br>(%) | Comments | Retain /<br>Remove |
|---|---|---|---|---|---|---|---|
| 016 | 2506 | Paper birch<br><i>Betula papyrifera</i> | 0.36 | 4.0 | 40 | Declining<br>TRUNK – Holly growing up 60% of stem.<br>FIGURE 6 | REMOVE |
| 017 | 2505 | Paper birch<br><i>Betula papyrifera</i> | 0.31 | 4.0 | 40 | TRUNK – Conks present. Lean north. Past stems trimmed at base on south side.<br>CROWN – Broken top. Likely decay column in broken top from Bronze Birch Borer.<br>FIGURE 6<br>RETAIN WITH TREE PROTECTION FENCING<br>SUITABLE FOR RETENTION | RETAIN |
| 018 | 2504 | Paper birch<br><i>Betula papyrifera</i> | 0.30<br>0.30 | 4.0 | 50 | TRUNK – Conks present. Lean north. Past stems trimmed at base on south side. Codominant stems at base.<br>CROWN – Broken top. Likely decay column in broken top from Bronze Birch Borer.<br>FIGURE 6<br>RETAIN WITH TREE PROTECTION FENCING<br>SUITABLE FOR RETENTION | RETAIN |

**Fig. 6** – Trees 016, 017, and 018 in poor condition.

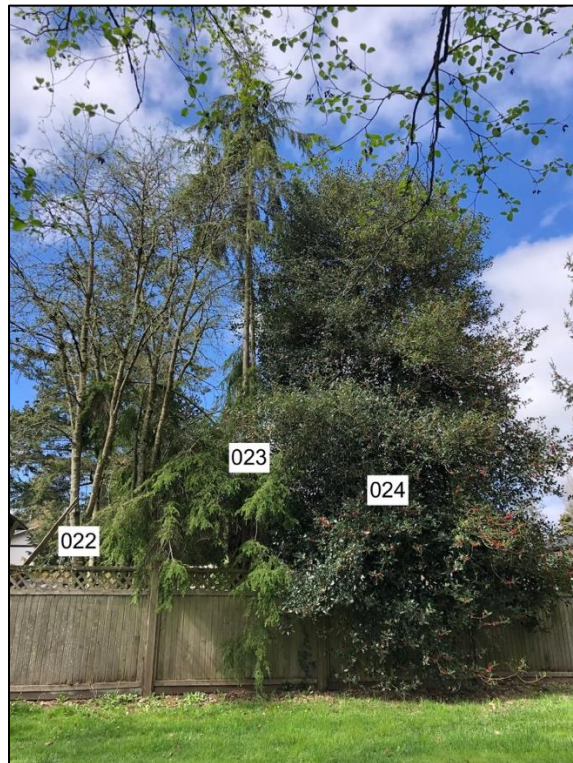
| Tree # | Tag # | Common Name<br><i>Botanical Name</i> | DBH<br>(m.) | C-Rad<br>(m.) | LCR<br>(%) | Comments | Retain /<br>Remove |
|---|---|---|---|---|---|---|---|
| 022 | 0957 | Western hemlock<br><i>Tsuga heterophylla</i> | 0.10<br>–<br>0.20 | 3.0 | 50 | TRUNK – Four codominant stems at base.<br>FIGURE 7<br>WITHIN PROPOSED EXCAVATION ZONE FOR BUILDING AND<br>UNDERGROUND PARKING | REMOVE |
| 023 | 0956 | Douglas-fir<br><i>Pseudotsuga<br/>menziesii</i> | 0.15<br>0.15 | 3.0 | 40 | CROWN – No foliage in lower crown.<br>FIGURE 7<br>WITHIN PROPOSED EXCAVATION ZONE FOR BUILDING AND<br>UNDERGROUND PARKING | REMOVE |

| Tree # | Tag # | Common Name<br><i>Botanical Name</i> | DBH (m.) | C-Rad (m.) | LCR (%) | Comments | Retain / Remove |
|---|---|---|---|---|---|---|---|
| 024 | 0955 | English holly<br><i>Ilex aquifolium</i> | - | - | - | INVASIVE SPECIES – NOT PROTECTED UNDER BYLAW<br>FIGURE 7 | REMOVE |

**Fig. 7** – West view of Tree 022, 023, and 024.

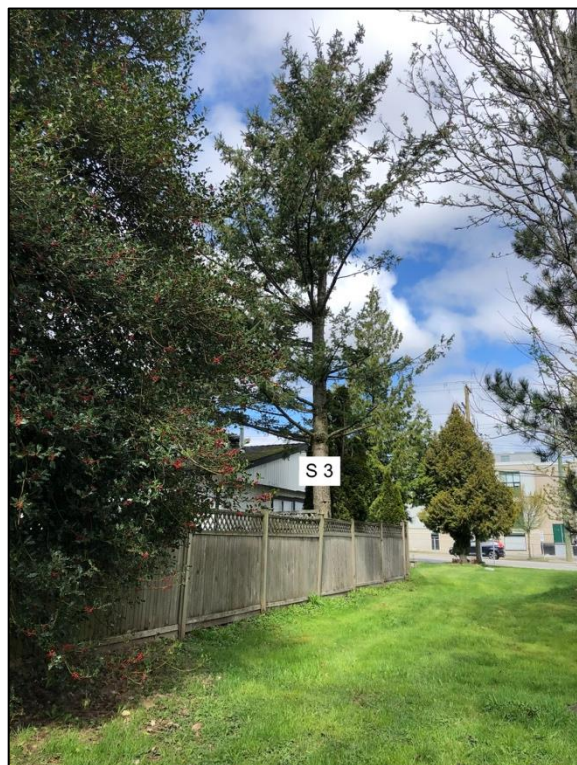
| Tree # | Tag # | Common Name<br><i>Botanical Name</i> | DBH (m.) | C-Rad (m.) | LCR (%) | Comments | Retain / Remove |
|---|---|---|---|---|---|---|---|
| S 3 | 0954 | Douglas-fir<br><i>Pseudotsuga menziesii</i> | 0.40 | 4.5 | 90 | LOCATION – Adjacent to fence.<br>CROWN – Pruned on east side. Sparse foliage.<br>FIGURE 8<br><b>STRADDLING TREE REQUIRES CITY PERMISISON TO REMOVE<br/>– REPLACEMENTS HANDLED CASH IN LIEU<br/>WITHIN PROPOSED EXCAVATION ZONE FOR BUILDING AND<br/>UNDERGROUND PARKING</b> | REMOVE |

**Fig. 8** – Tree S 3 with crown weighted to west side.

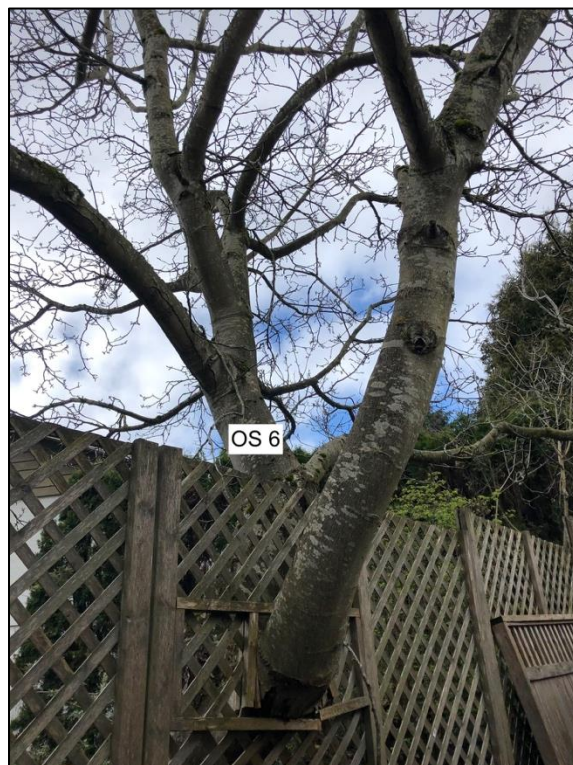
| Tree # | Tag # | Common Name<br><i>Botanical Name</i> | DBH (m.) | C-Rad (m.) | LCR (%) | Comments | Retain / Remove |
|---|---|---|---|---|---|---|---|
| OS 6 | - | English walnut<br><i>Juglas regia</i> | 0.45<br>0.35 | 5.0 | 80 | TRUNK – Codominant stems at 1 meter. North stem growing through fence onto onsite property.<br>FIGURE 9<br><b>RETAIN WITH TREE PROTECTION FENCING<br/>SUITABLE FOR RETENTION</b> | RETAIN |

**Fig. 9** – Tree OS 6 growing through fence.
