**Arborist Report for Development  
1091 Stayte Road  
White Rock, BC V4B 4Y8**

***April 28, 2022 Updated***

Submitted to:  
**City of White Rock  
Planning & Development Services Department**

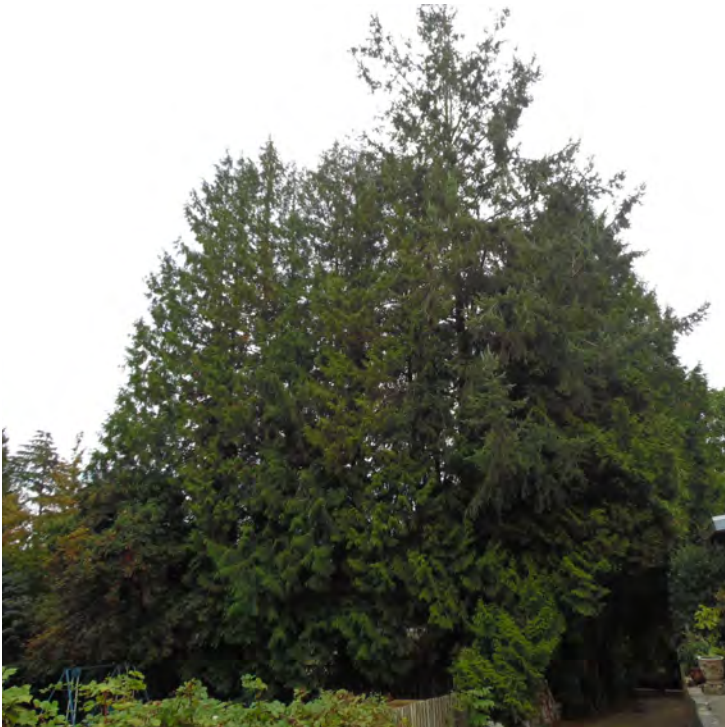
Trees #669 - #674 share canopies.

Photo 5  
Trees #666 - #674, from right to left.  
All trees share a crown.

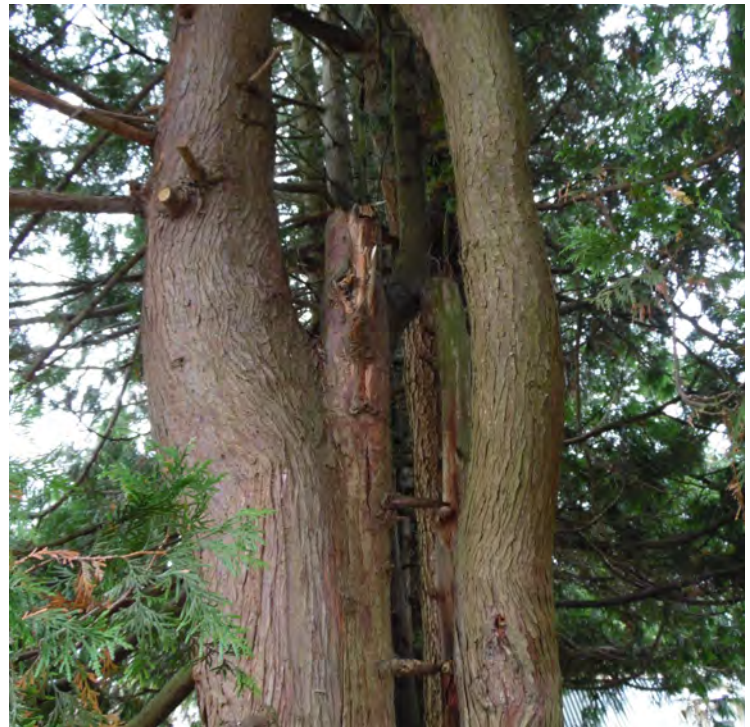
City trees #666 - #668 are in poor health due to decay found on the main stems.

Photo 6  
Tree #666, photo showing pruning cut dieback on the main stems. Good reaction growth has developed.

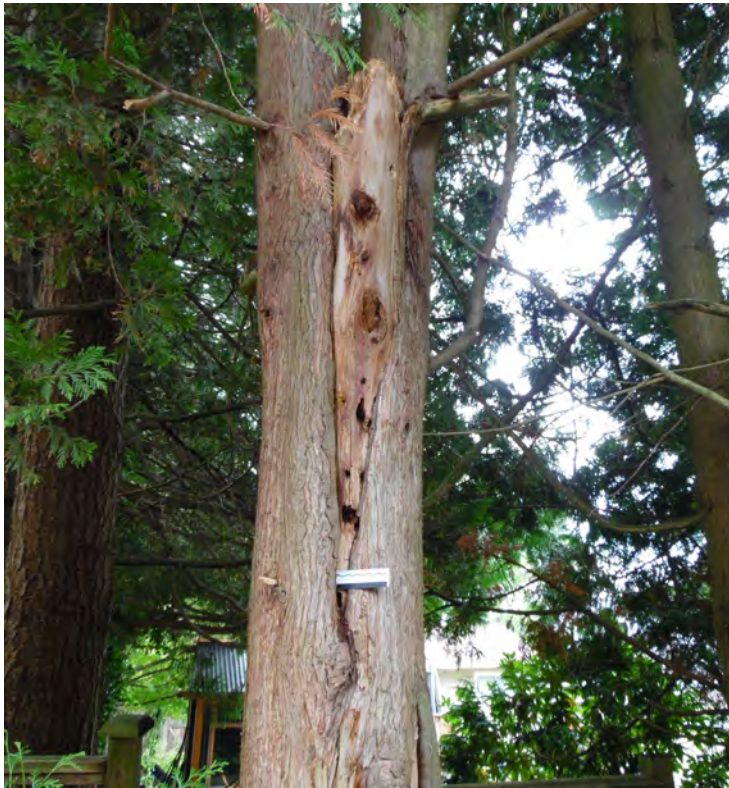
Photo 7

Tree #667, photo showing pruning cut dieback on the main stem. Minimal reaction growth has developed.

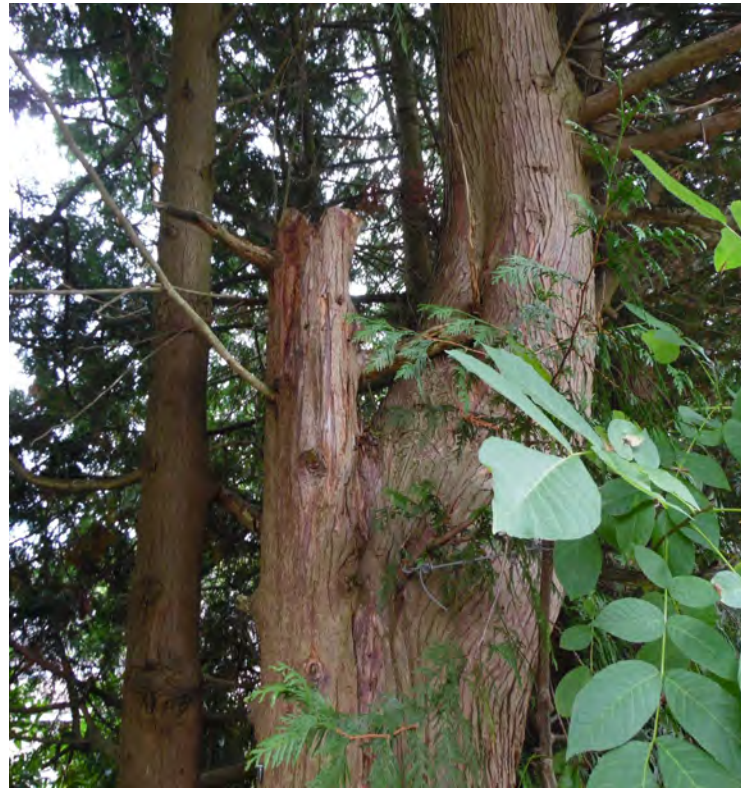
Photo 8

Tree #668, photo showing pruning cut dieback on the main stem. Good reaction growth has developed.

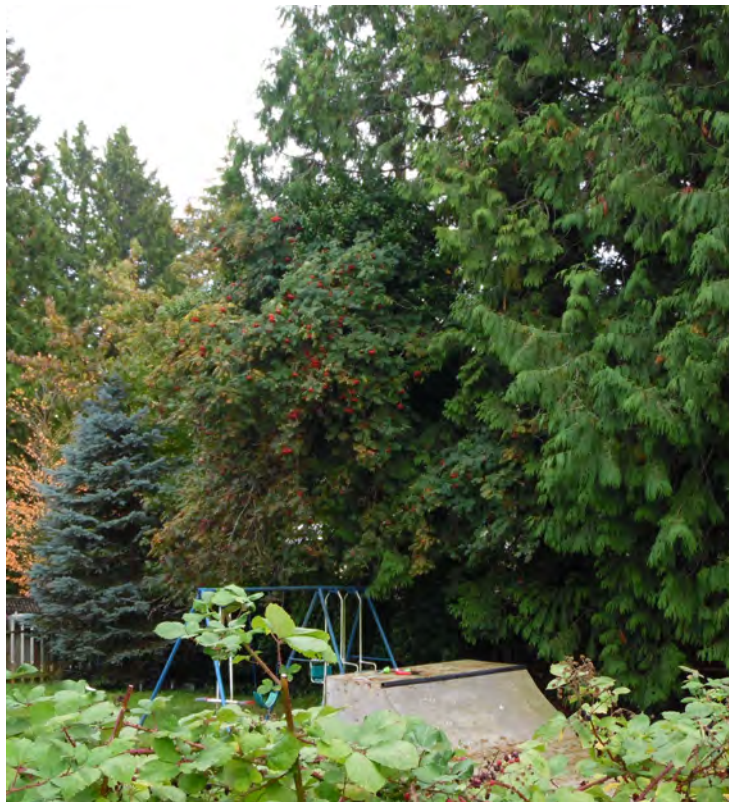
Photo 9

Tree #674 will have 60% encroachment from the new house excavation zone and is therefore recommended for removal due to conflicts with construction.

Tree #674 in center with red berries.

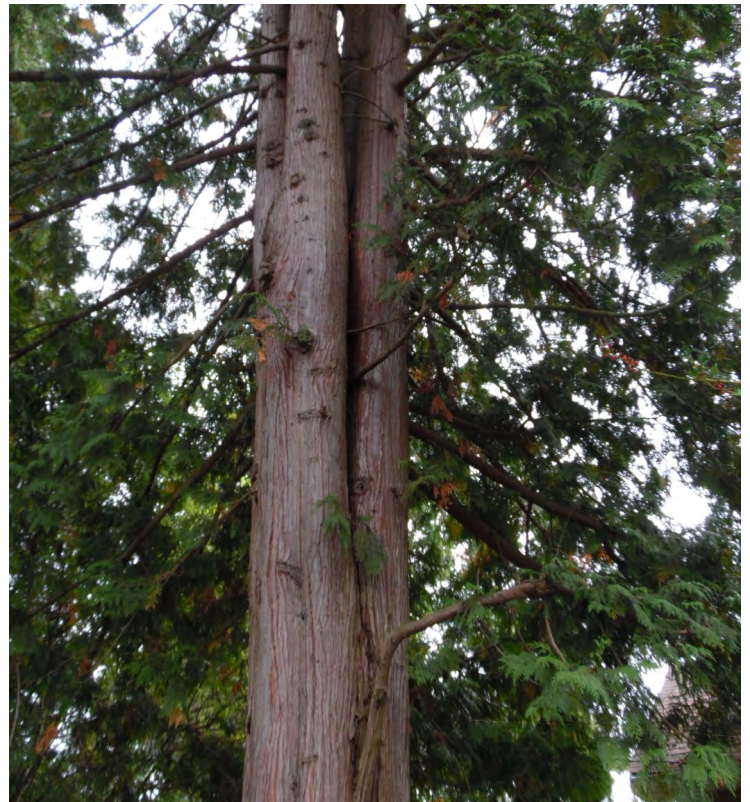
Photo 10

Offsite tree #671, 672, 673 and 675 will have 20%, 20%, 3% and 27% encroachment from the new house excavation zones. Arborist supervision is recommended during excavation and construction. A reduction in the excavation zone from 1.5m to 1m has been implemented for this side of the house.

Tree #675, photo showing co-dominant stems at 3m and 5m.

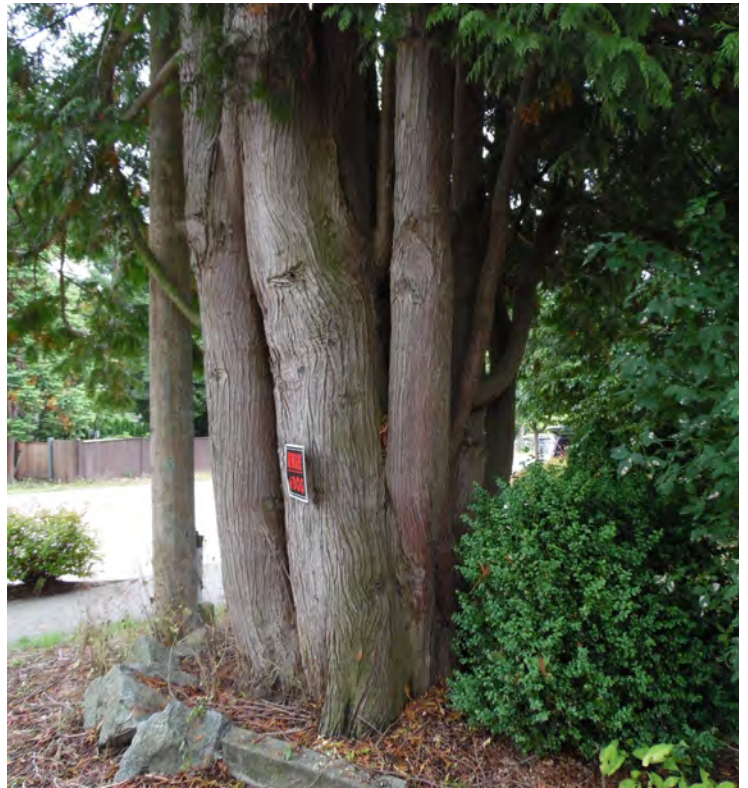
Offsite/City shared tree #677 will have 32% encroachment from the new house excavation zone. A concrete walkway, gate and fence are proposed in its TPZ. Arborist supervision is recommended during excavation and construction. A reduction in the excavation zone from 1.5m to 1m has been implemented.

Photo 12  
Photo showing the co-dominant base of tree #677.

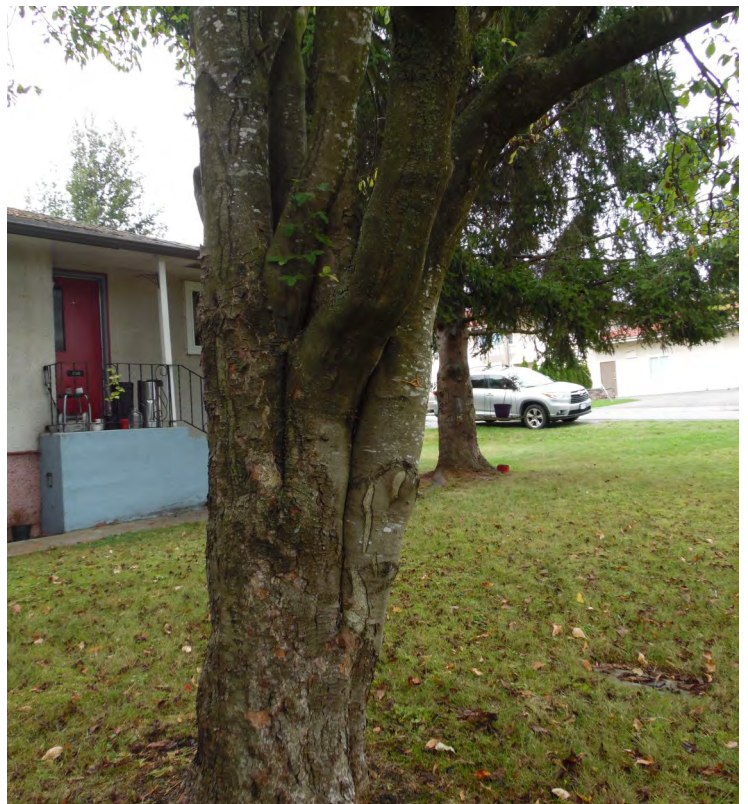
Tree #678 will have 3% encroachment from the new house excavation zone. A concrete walkway, gate and fence are proposed in its TPZ. Arborist supervision is recommended during excavation and construction. A reduction in the excavation zone from 1.5m to 1m has been implemented.

Photo 14  
Photo showing the base of tree #678.  
Tree #681 in background.

**NEW April 26, 2022** – The pathway has been aligned with the east side entry doorway. The pathway located inside the tree protection zone of tree #678 shall be above grade using paving stones, slab-on grade concrete, Grasscrete or gravel. The pathway shall be a suitable distance away from the basal flare of the tree, as determined by the project Arborist at time of preparation/installation. No digging shall be done inside the tree protection zone. Arborist supervision during the preparation and installation of the pathway is recommended.

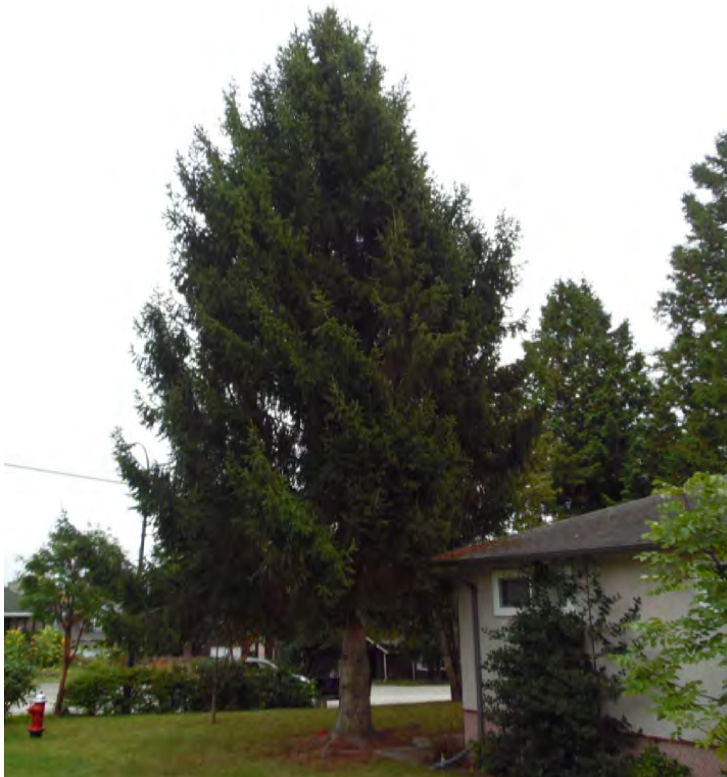
Tree #681 will have 100% encroachment from the new house excavation zone and is therefore recommended for removal due to conflicts with construction.

Photo 15  
Tree #681

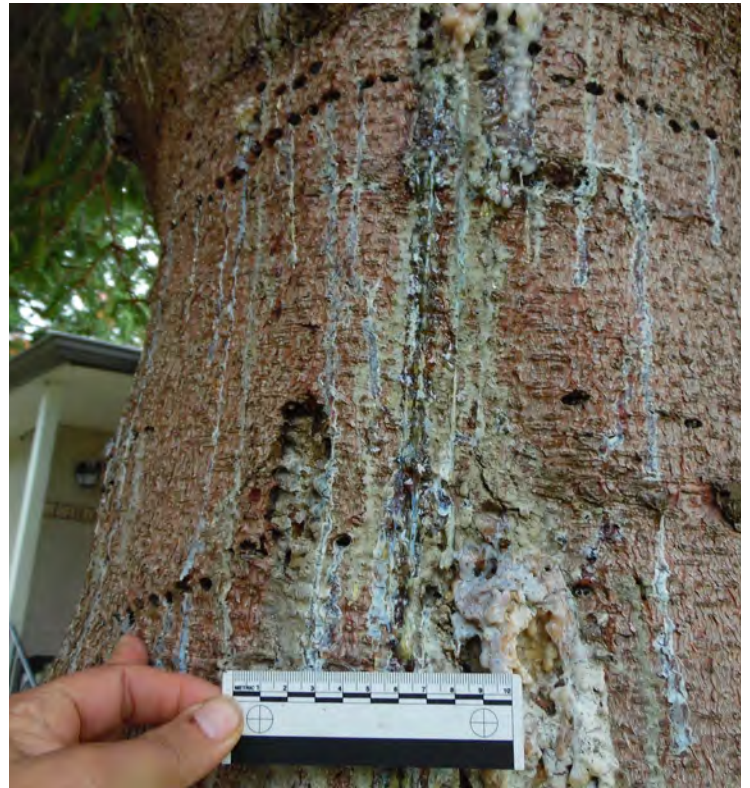
679 City	Paperbark maple	<i>Acer griseum</i>	.1, .11	4.5	60	<5	Good	Good		<b>Retain and Monitor</b>	5.58
680 City	Paperbark maple	<i>Acer griseum</i>	.13	4.5	65	<5	Good	Good		<b>Retain and Monitor</b>	5.4
681	Spruce	<i>Picea engelmannii</i>	.54	15	90	5	Good	Fair	Moderate Sapsucker damage and related resinosis	<b>Remove due to conflicts with construction.</b>	3.24

Photo 16  
Sapsucker damage on tree #681.

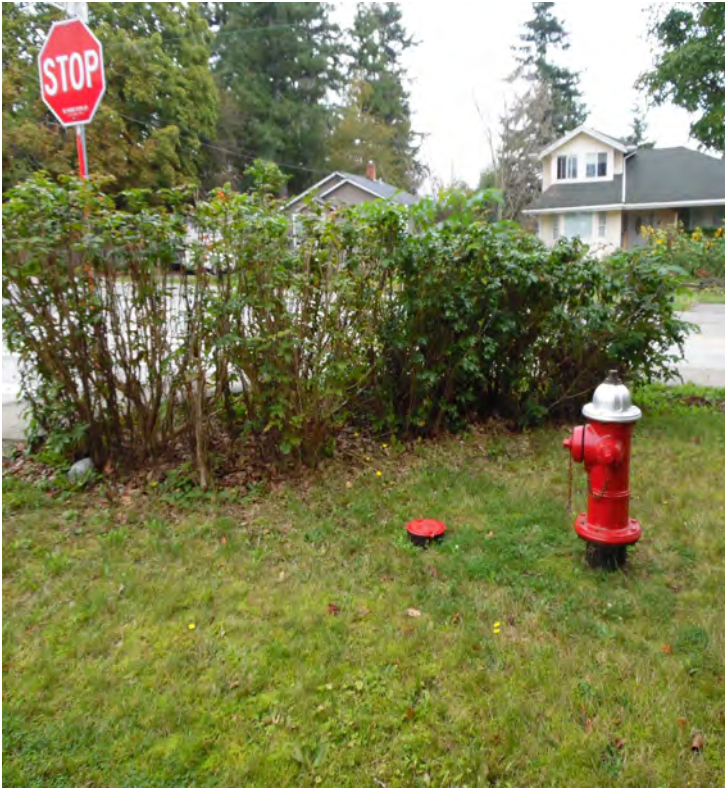
Photo 19

Hedge #2 on city property. Volunteer trees have started growing in the hedge.
