PROJECT: VIDAL STREET DEVELOPMENT

SITE ADDRESS: 14937 Thrift Ave & 1441/1443-45/1465 Vidal Street, White Rock, BC

VDZ PROJECT # DP2018-59

Original Report November 5, 2018
Revision 1 May 8, 2019
Revision 2 September 23, 2020 – A.L.
Revision 3 July 11, 2022 – D.G.R. - Updated Survey.

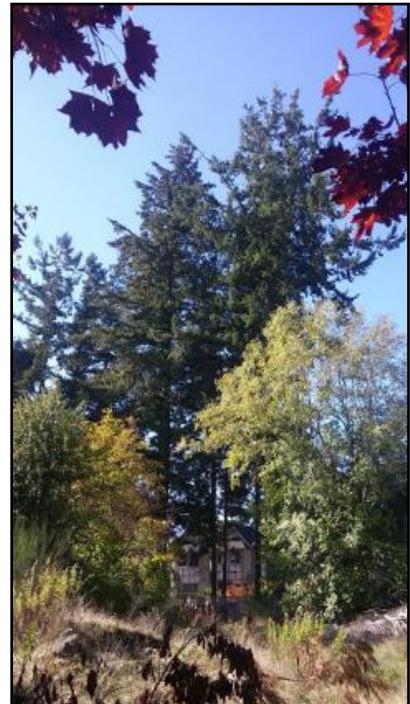
- Tree 06 noticeable decay on single stem of the multi-stemmed tree.
- OS 02-OS 08, dripline extends to/over subject property line. Root radar used to assess root systems. Will need an arborist present to monitor excavation on the property line, and during installation of the proposed retaining wall / landscape features.

Fig. 5 – View of Trees OS2 – OS8

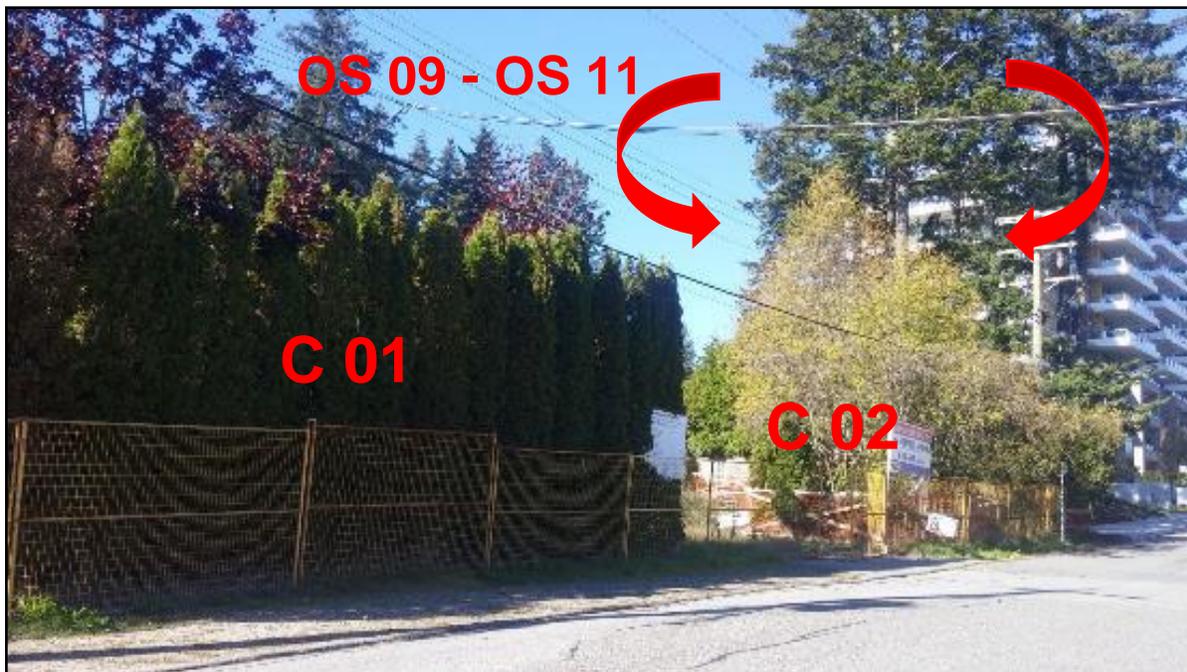
As there are off-site trees with driplines that extend into the subject property, there may be interconnected root systems within the grouping (OS9-OS11) which likely extend onto the property. BC Plant Health Care Root Radar results determined the roots of tree 06 has poor structure and multiple trunks with decay. In addition, OS2-OS6 have feeder or structural roots which grow towards the property. Any work done within the critical root zone will need to be monitored by the arborist. Any retention wall should be maintained to avoid root disruption and destabilization.

Fig. 7 – View facing north/northwest. OS 9 – OS 11 make up part of the edge of a larger grouping of conifers.

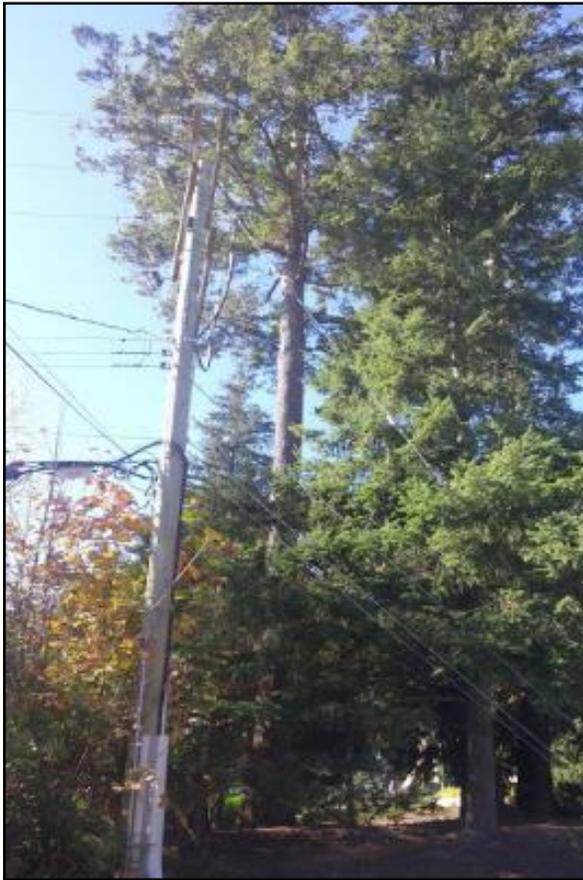
Fig. 8 – Alternate view of Trees OS 9 – OS 11

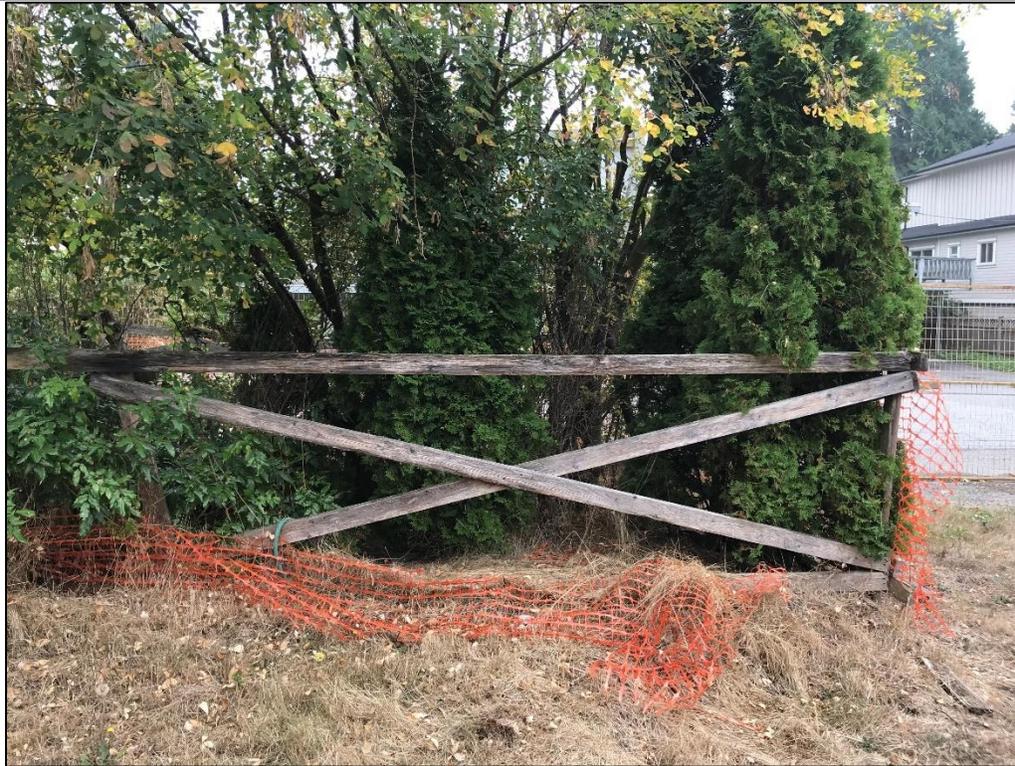
Fig. 9 – View facing east on 1465 Vidal st, tree protection fencing damaged. Needs repair.

- Tree 05 suffered a failed limb prior to September 15th, 2020 visit.
- Tree protection fencing requires repairs and placing for all protected trees prior to any land clearing activities.

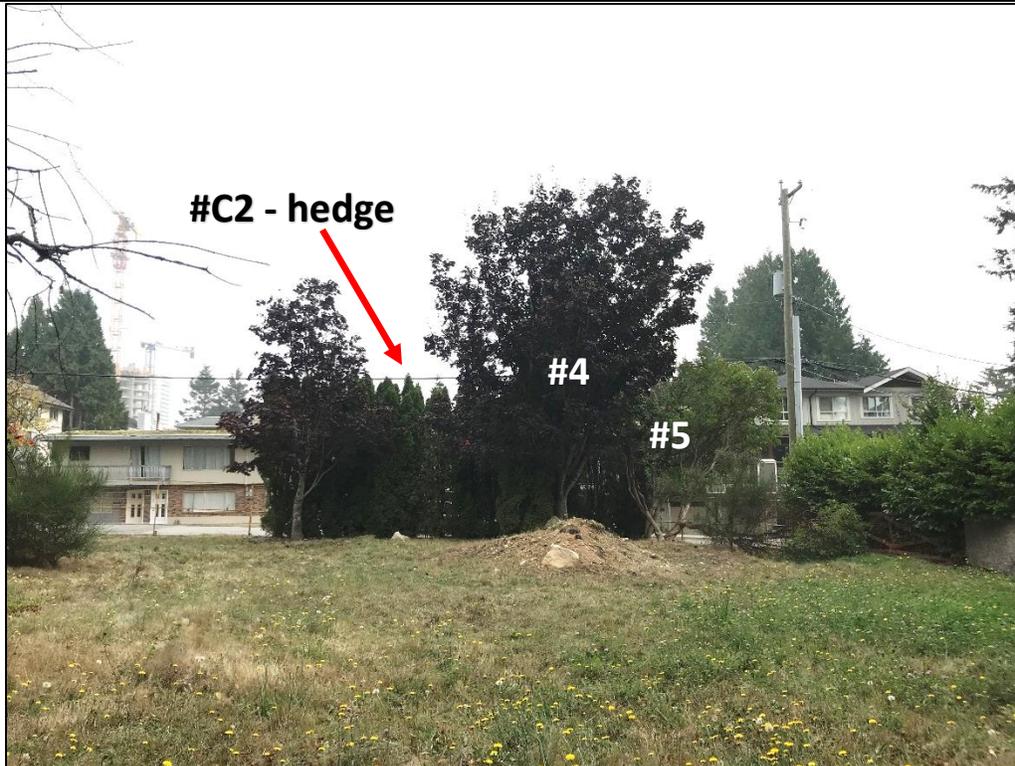
Fig. 10 – View facing east. Southeast corner of 1445 Vidal st. C2 hedge, #4 norway maple, and #5 lilac.

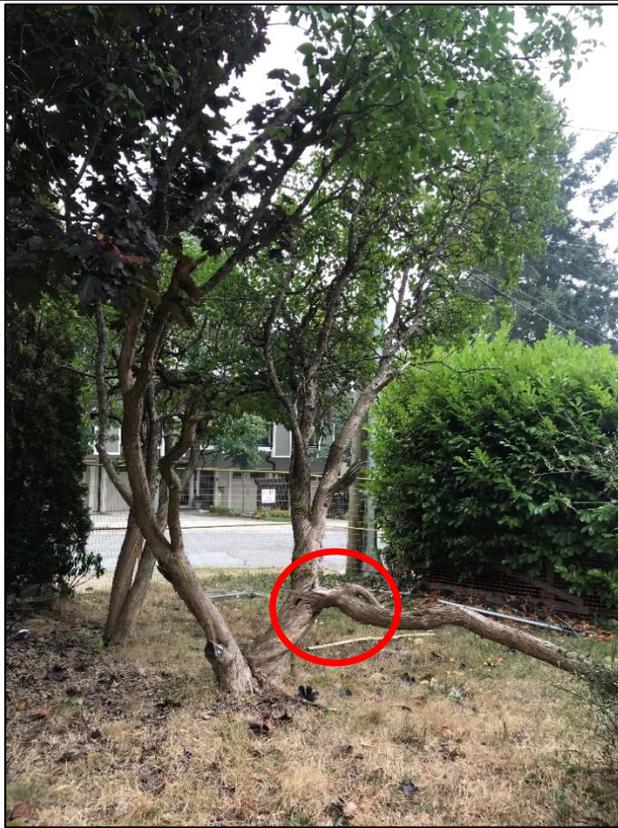
Fig. 13 – Tree #5, failed limb.

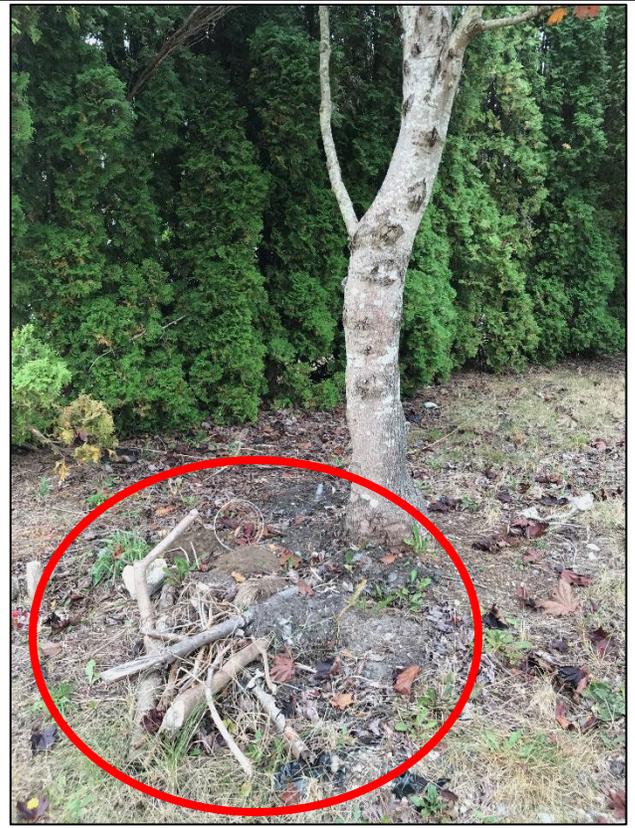
Fig. 14 – Pruning of tree branches along east property line, 1465, 1443-45.
