Arborist Report

Inventory and Assessment of Trees Associated to Construction at
15495 Oxenham Avenue, White Rock

December 9, 2022

Russ Vankoughnett
ISA Certified Arborist and Tree Risk Assessor PN 8330A

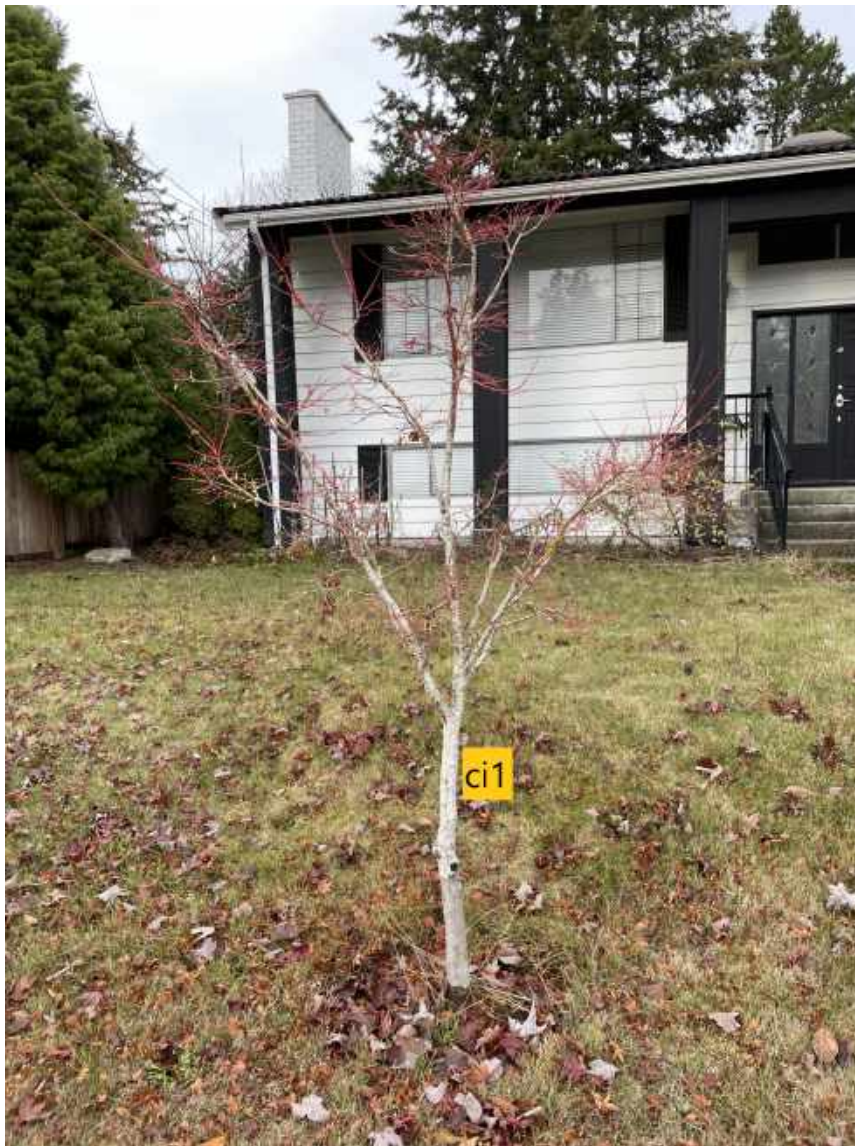
Image 1: **ci1** (Coral bark maple)

ID#	Common Name	Botanical Name	DBH (cm)	Condition & Comments	Action	TPZ (m)
ci1	Japanese maple	<i>Acer palmatum</i>	5 caliper	Observation November 27/2018 An immature specimen in good condition. ~2m tall. Can be relocated if necessary. Observation November 25/2022 No change. A small ornamental tree planted by a resident on the property line shared with City. The tree is immature such that it can easily be replanted in another location or replaced (with no loss in canopy) with a new, more appropriate boulevard tree. The location is in conflict with the proposed driveway.	remove	1.5m
ci 2354	Japanese maple	<i>Acer palmatum</i>	30	Observation November 27/2018 Natural form, good condition, does not enter subject property Observation November 25/2022 No change	Retain Install barrier at the property line.	1.8m
ci 2448	Shore pine	<i>Pinus contorta</i>	56	Observation November 27/2018 Multi stem at base, pruning for hydro clearance has left it with a shrub like form, crown is a bit sparse Observation November 25/2022 Observe there have been a few limbs removed. Not significantly changed.	Retain Install barrier at 3.36m from the tree.	3.36m

- Plans conflict with tree ci1 and a small hedge on City property.
- Plan shows the building is to be 2m from tree 806- Excavation will critically impact the tree.
- Trees 803 and 805 which were observed in 2018 have died.

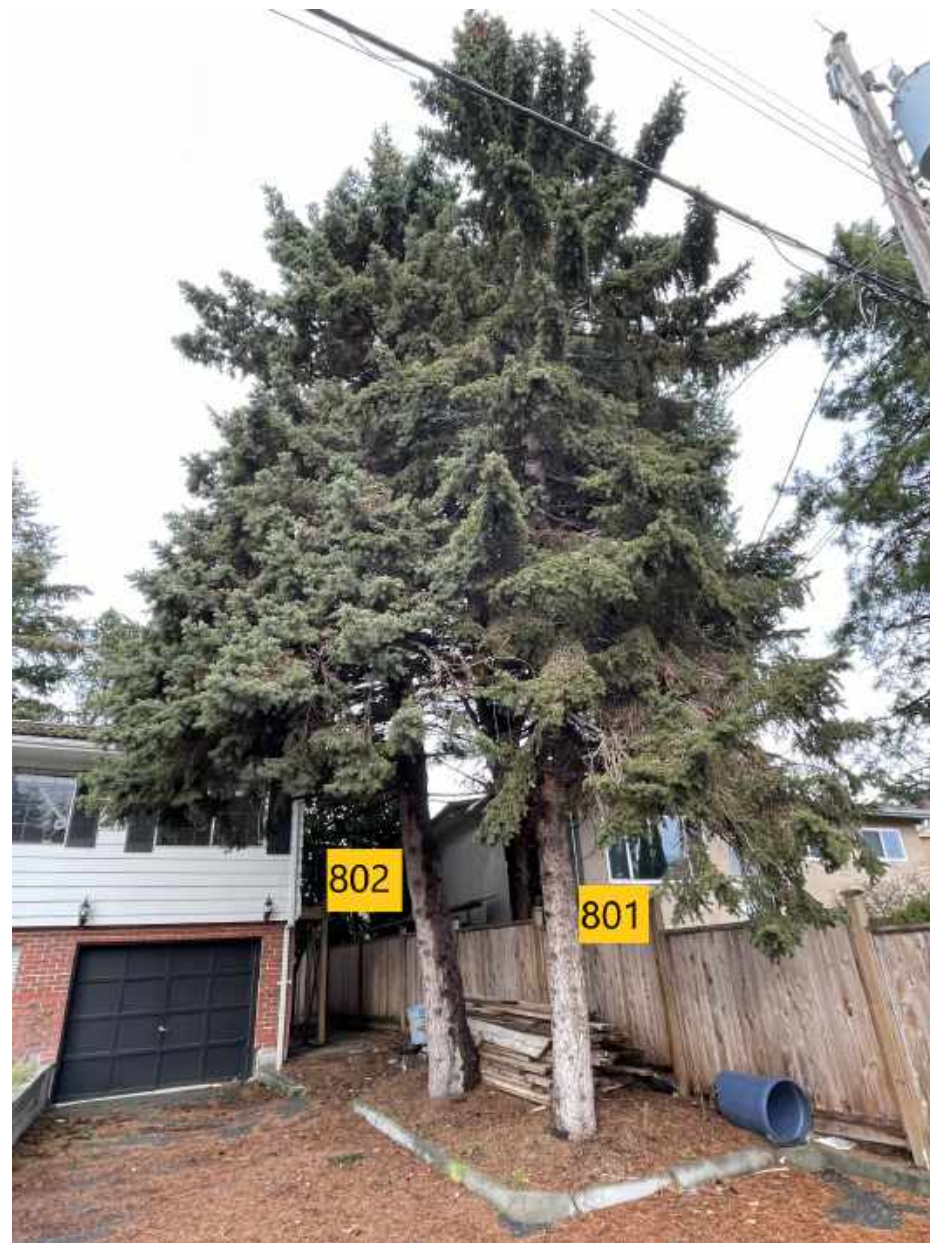
Image 4: trees **#801 & #802**

801	Norway spruce	<i>Picea abies</i>	32	Observation November 27/2018 Single stem with a phototropic lean and unbalanced crown to the south, previously topped with regenerated leaders. Overall form is natural, crown health is moderate.	Retain Landscaping to performed by hand	1.92

Observation November 25/2022 Lower dead branches, topped at about 15 feet with regenerated dogleg leaders, growing about .5m away from the existing driveway and within a concrete garden bed. The plan shows unit pavers installed along the PL share with neighbor.	under arborist supervision.	
802	Norway spruce	<i>Picea abies</i>	44	Observation November 27/2018 Single stem with a phototropic lean and unbalanced crown to the west, previously topped with regenerated leaders. Overall form is natural, crown health is good. Observation November 25/2022 Lower dead branches, topped at about 15 feet with regenerated dogleg leaders, growing about .5m away from the driveway and within a concrete garden bed The plan shows unit pavers installed along the PL share with neighbor.	Retain Landscaping to performed by hand under arborist supervision.	2.64
803	Monkey puzzle tree	<i>Araucaria araucana</i>	31	Observation November 27/2018 100% Ivy infested, lower 60% of crown is dead. Ivy has caused tree to decline beyond expectation of recovery. Observation November 25/2022 Tree has died and been removed.	No action	1.86

- 1)- The existing pool is 3m from tree 806. The proposed building is 2m from 806. Excavation would be at least 0.8m from os6. Removal is recommended at this distance.
- 2)- The arborist report is updated to show the retention of trees 801 and 802. Landscaping performed in the zone is to be done with use of hand tool and under arborist supervision.

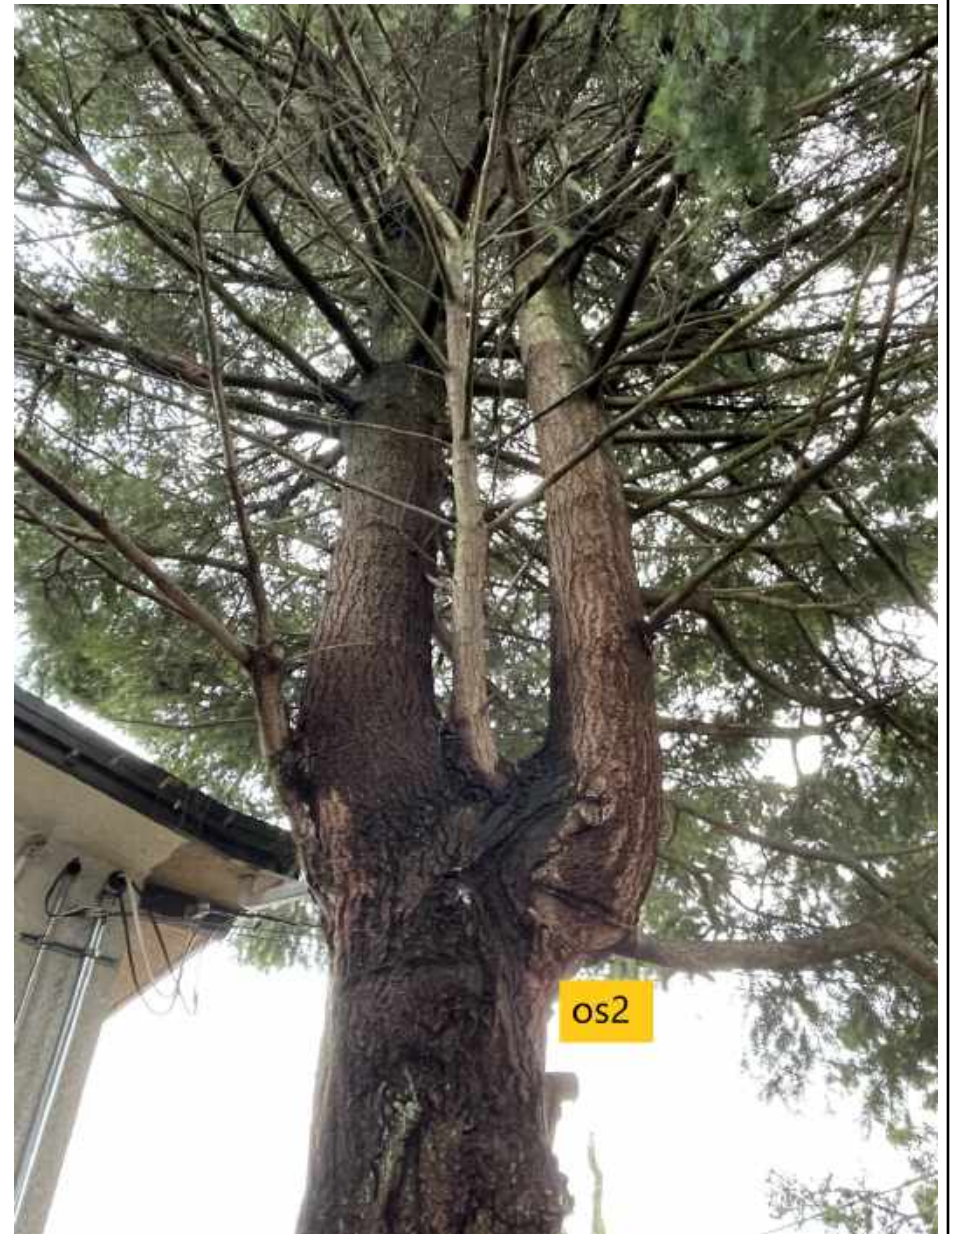
Image 6: **os2** topped with very large regenerated dogleg leaders

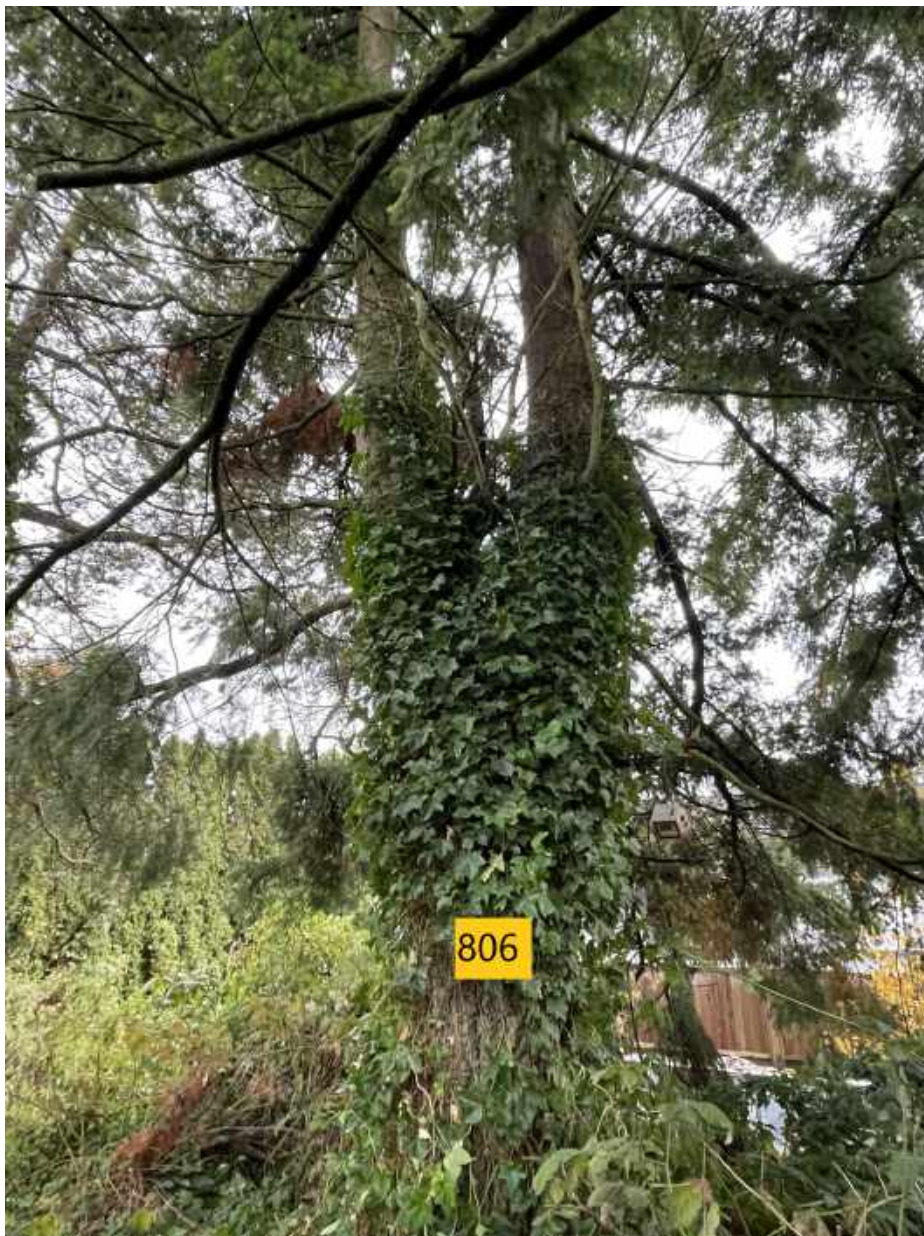
Image 7: tree **#806**

806	Douglas fir	<i>Pseudotsuga menziesii</i>	80	<p>Observation November 27/2018 Dual stem at 8' with included bark, natural form crown.</p> <p>Observation November 25/2022 Ivy infested on the lower 15 feet, long reaching lower (9-10m) branches on the south side. -- The location of the existing pool is 3.1m from the tree. City arborist has communicated that retention of the tree is desired. --A solution whereby the excavation does not encroach to within 3.1m from the tree will optimally enable retention.</p> <p>Based on the existing proposal tree is 2m from the house hence the excavation will be at least 80cm from the tree. Too close to retain.</p>	Remove	4.8
807	Douglas fir	<i>Pseudotsuga menziesii</i>	71	<p>Observation November 27/2018 Dual stem at 10' with included bark, natural form crown, a bit unbalanced to the south, Ivy growing up trunk.</p> <p>Observation November 25/2022 Ivy infested on the lower 15 feet.</p> <p>The location of the tree is 3.6m from the proposed house. Excavation will be about 2.2m from the tree.</p>	<p>Retain</p> <p>Install barrier 4.26m.</p> <p>Arborist to supervise the excavation.</p>	4.26

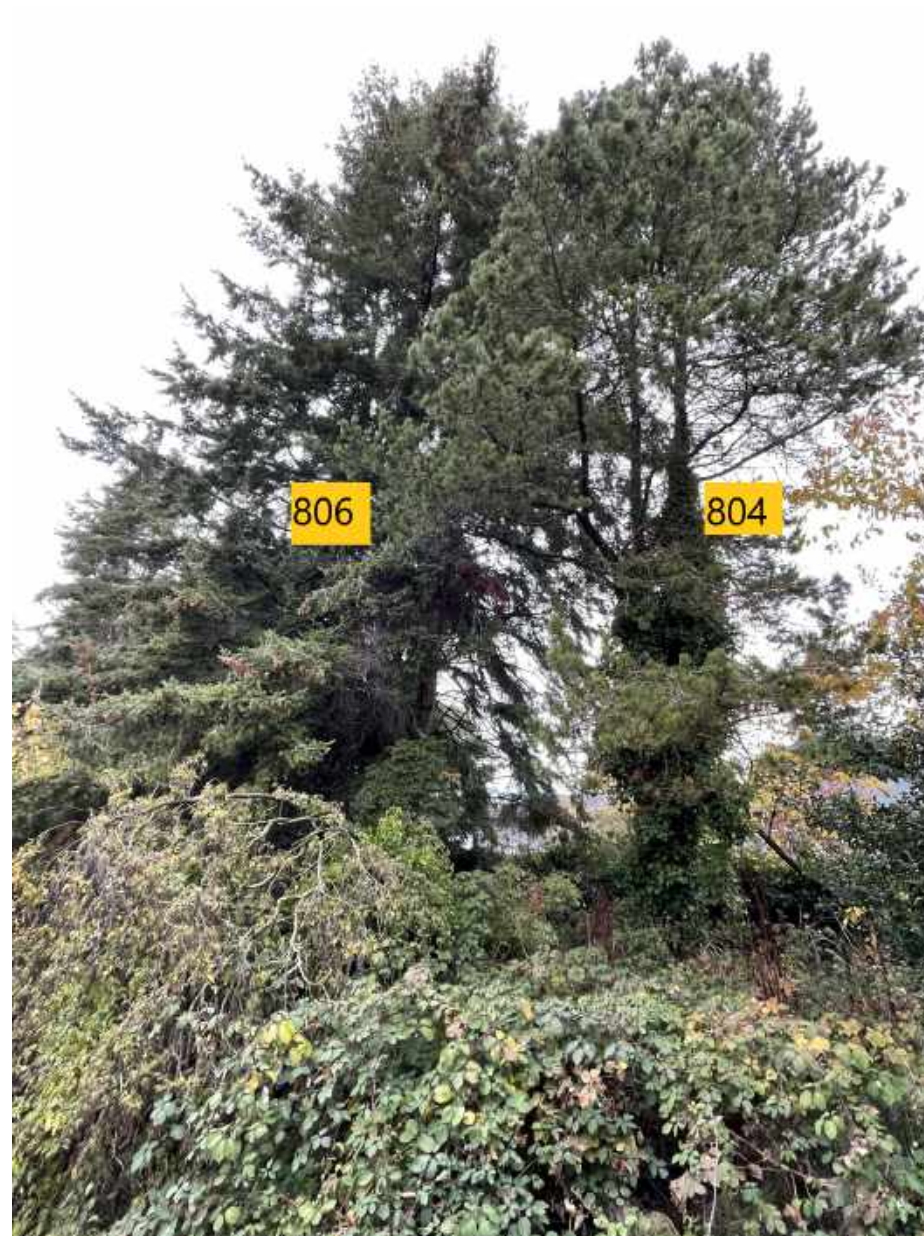
Image 8: trees **#806 & #804**

804	Shore pine	<i>Pinus contorta</i>	59	Observation November 27/2018 Previously topped at 10' with regenerated leaders, Ivy up lower 40% of tree, many dead branches in crown, shaded out on west side but overall form is natural. Lower half of crown is sparse. Observation November 25/2022 Ivy infested on the lower 25 feet.	Retain Install barrier 3.54m from tree. Arborist to supervise the removal of the ivy from the trunk.	3.54
805	Goldenchain tree	<i>Laburnum anagyroides</i>	46	Observation November 27/2018 Phototropic lean to south, ivy infested, crown weeps into the pool. Observation November 25/2022 Tree has failed	No action	2.76

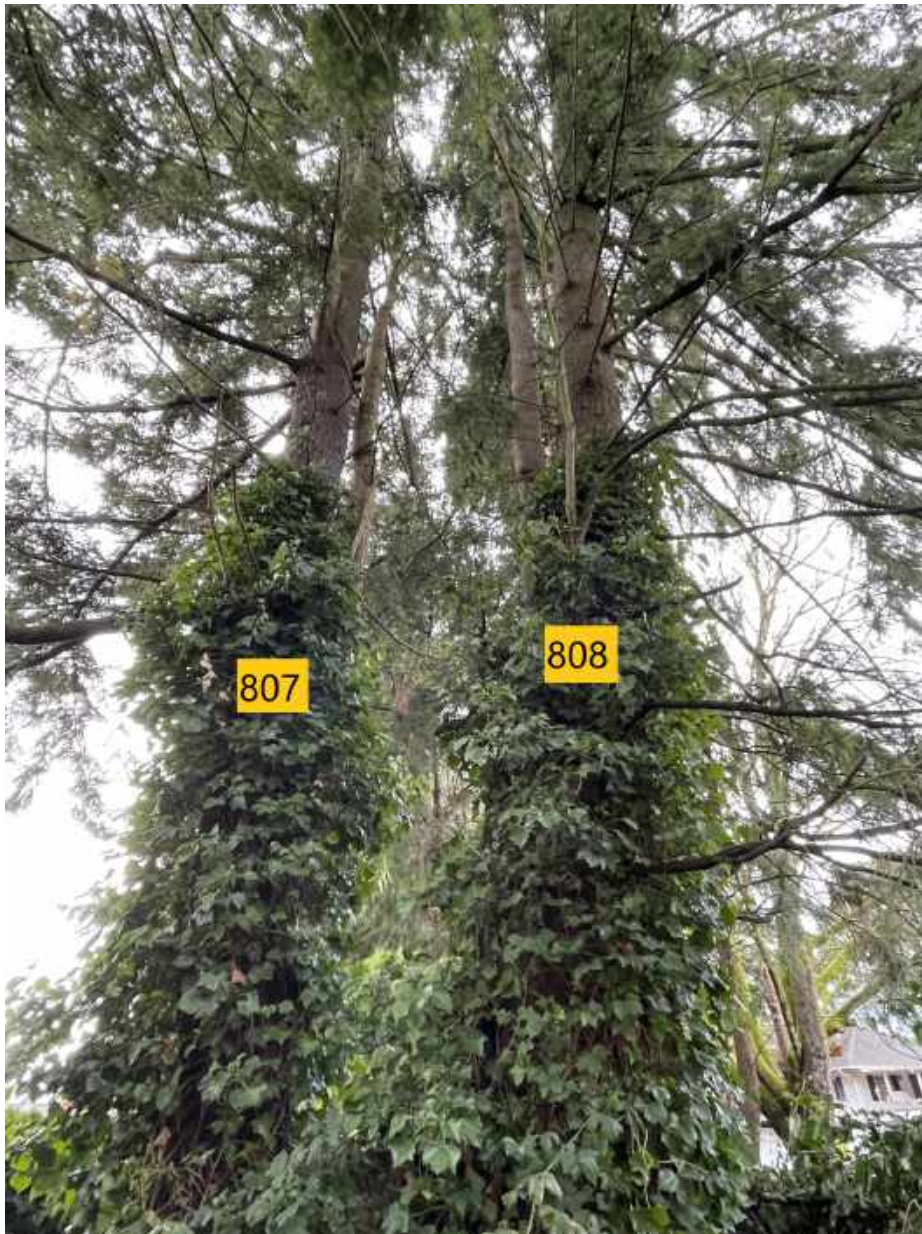
Image 9: tree **#807 & #808**

808	Douglas fir	<i>Pseudotsuga menziesii</i>	90	<p>Observation November 27/2018 Dual stem at 6' with included bark, phototropic lean and unbalanced crown to the north, overall natural form crown.</p> <p>Observation November 25/2022 Ivy infested on the lower 15 feet.</p> <p>The location of the tree is 4.8m from the proposed house. Excavation will be about 3.4m from the tree.</p>	<p>Retain</p> <p>Install barrier 5.4m.</p> <p>Arborist to supervise the excavation.</p>	5.4
os1	Weeping cypress	<i>Chamaecyparis nootkatensis</i> 'Pendula'	22	<p>Observation November 27/2018 Immature, does not enter subject property</p> <p>Observation November 25/2022 Natural form, good condition.</p>	<p>Retain</p> <p>Install barrier 1.5m from tree.</p>	1.5
os2	Douglas fir	<i>Pseudotsuga menziesii</i>	90	<p>Observation November 27/2018 Previously topped at 10' with large regenerated leaders, attachments are poor with branches fused to the compression wood. One large</p>	<p>Retain</p> <p>Arborist to supervise</p>	5.4

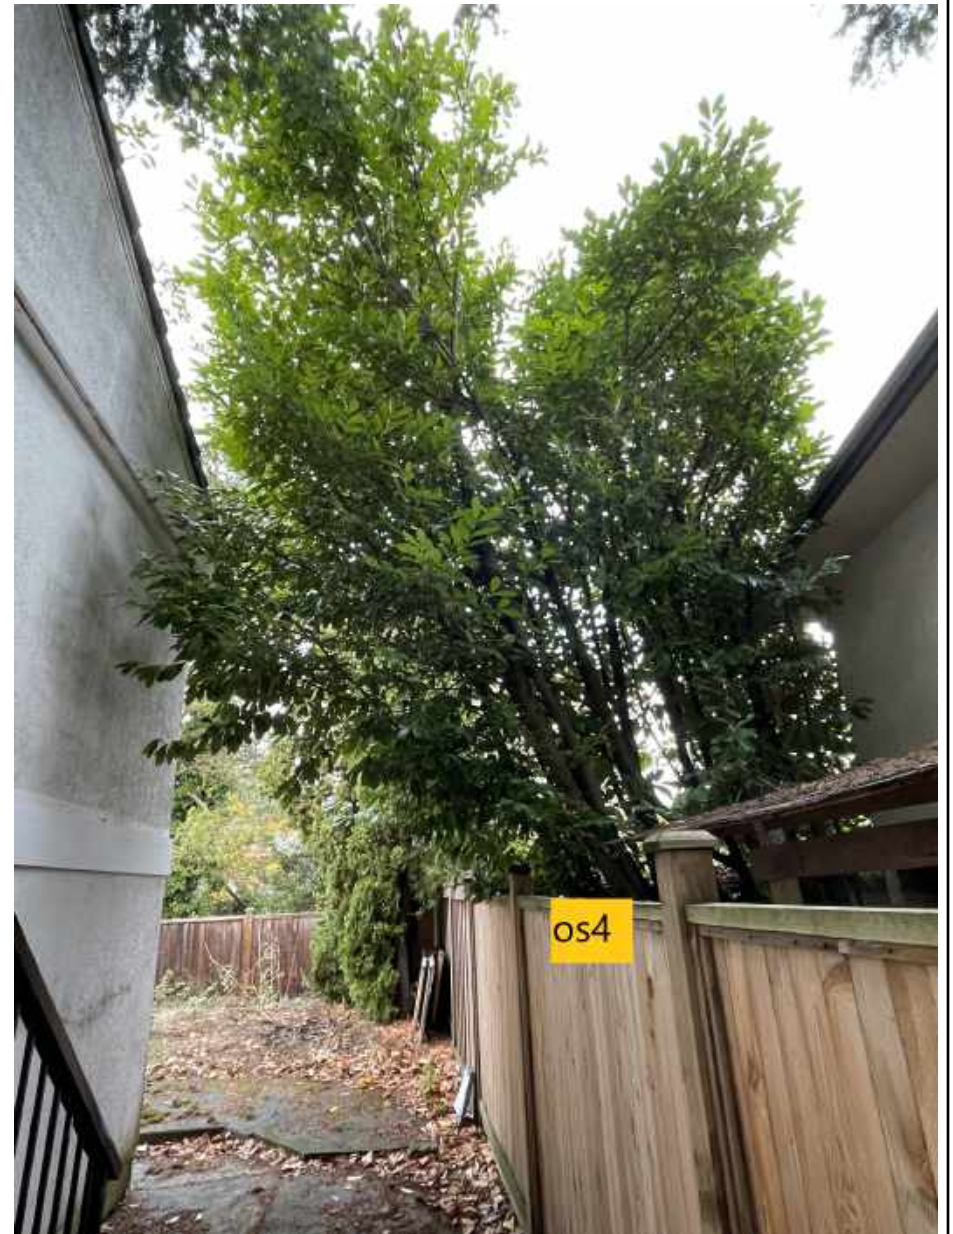
Image 10: tree **os4**

<p>leader has been removed. Crown is large, bushy and dense. May require higher level assessment.</p> <p>Observation November 25/2022</p> <p>No change. NOTE: Dual leaders are topped again at about 25 feet with regenerated leaders.</p> <p>The house (covered entry/porch) is within the edge of the TPZ. Landscape features are shown within the TPZ.</p>	<p>the excavation.</p> <p>Landscaping to performed by hand under arborist supervision.</p>	
os3	English laurel	<i>Prunus laurocerasus</i>	39	<p>Observation November 27/2018</p> <p>Very tall and narrow, squeezed in between two houses.</p> <p>Observation November 25/2022</p> <p>Has been removed.</p>	No action required.	2.34
os4	English laurel	<i>Prunus laurocerasus</i>	14+12 +10= 36	<p>Observation November 27/2018</p> <p>Very tall and narrow, squeezed in between two houses.</p> <p>Observation November 25/2022</p> <p>Many stemmed at base, leaning into subject property almost against the existing house.</p>	<p>Retain</p> <p>Trim the laurel back to the property line.</p>	2.16

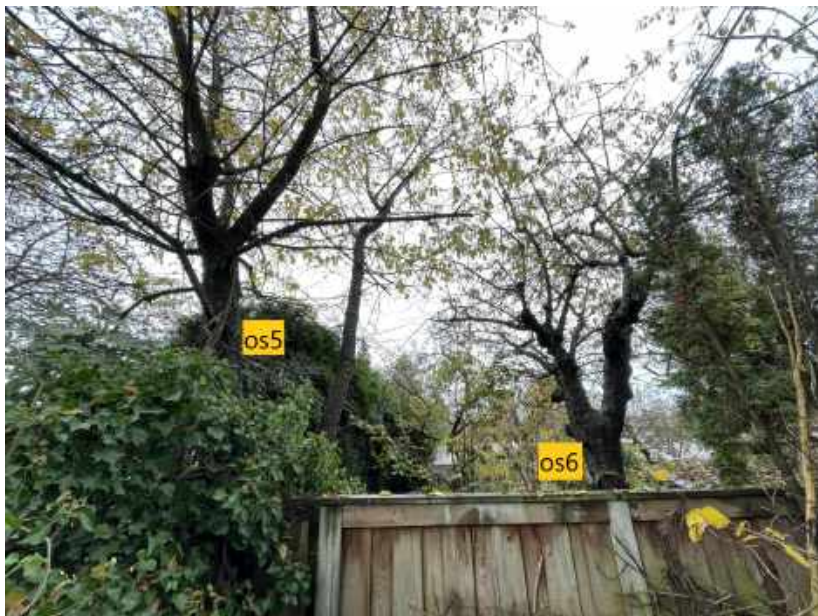
Image 11: **os5 & os6**

os5	Cherry	<i>Prunus avium</i>	32+16 =48	<p>Observation November 27/2018</p> <p>large unkempt crown.</p> <p>Observation November 25/2022</p> <p>Dual-stemmed at base.</p>	<p>Retain</p> <p>Install barrier 2.88m from tree.</p>	2.88
os6	Cherry	<i>Prunus avium</i>	44	<p>Observation November 25/2022</p> <p>Dualed stemmed at about 1.5m, sparse canopy, harshly pruned.</p>	<p>Retain</p> <p>Install barrier 2.64m from tree.</p>	2.64
os7	Cherry	<i>Prunus avium</i>	28+26 +18= 72	<p>Observation November 25/2022</p> <p>Base not visible, structure and cut out roof surround tree at fence level, three stems harshly topped with regenerated branching.</p>	<p>Retain</p> <p>Install barrier 4.32m from the tree.</p>	4.32

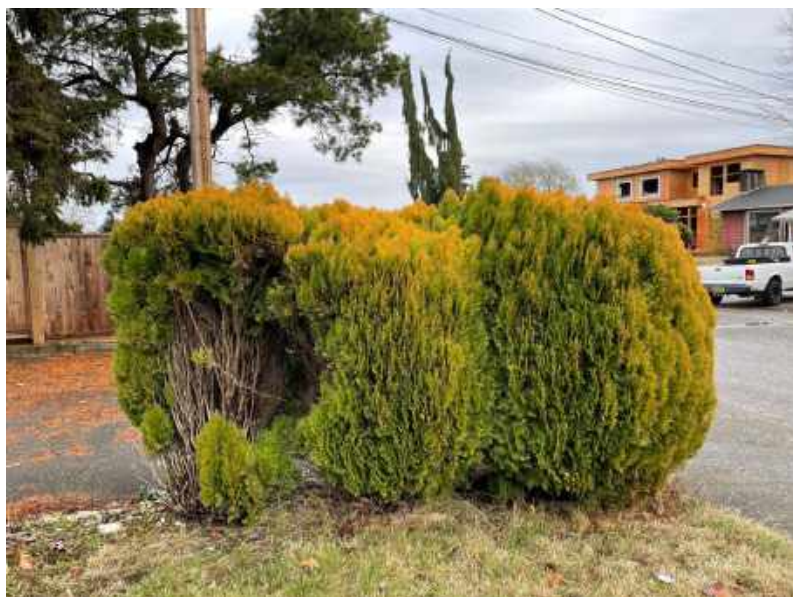
1. There 3 trees (ci2448, ci1 and ci2354) on City land all to be preserved with tree barriers and securities.
2. There also appears to be a hedge of sorts that is not picked up on the arborist report. It is on City property and should not be removed without permission from the City. The ‘hedge’ can be removed with the requirement of one city tree cash in lieu.

- 1)- Ci1 is located in conflict with the proposed driveway. Ci2448 and ci2354 are shown as retained with tree barriers.
- 2)- The hedge located on City property sits in conflict with the proposed driveway. Hedge is shown on Image 13, Page 14 in the arborist report.

Image 13: short (3 shrubs) city hedge along driveway.
