## Arboricultural Assessment Report

Project File No.: 18-028

Project Name: Mixed Use / Residential  
1570/1580 Maple Street, 15654/15664/15674  
North Bluff Road and 1593 Lee Street  
White Rock, BC.

**Re: Arboricultural Services at 1570/1580 Maple St., 15654/15664/15674 North Bluff Rd. & 1593 Lee St., White Rock, BC.**

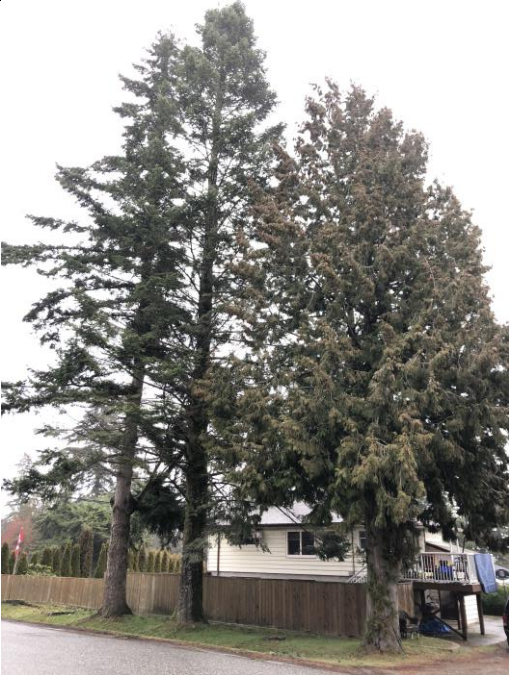
<p>Photo 1: Tree #7123 (left), 4383 (middle), 4382 (right)</p>	<p>Photo 2: Tree #7123, Douglas-fir, poor lower branch structure</p>

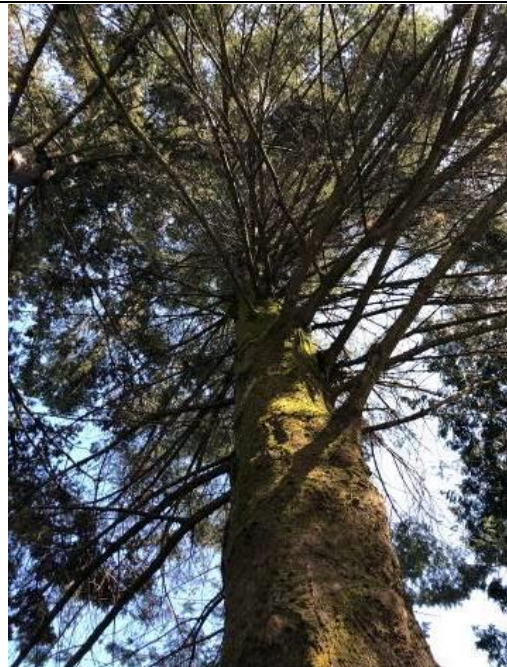
**Photo 6:** Tree #4383

OS4383 (city)	<i>Abies procera</i> , Noble fir	80	y	M	N	NE (Maple St.)	Roots supressed by the road; no sign of insect damage; supressed foliage - primarily east and west, due to proximity to neighbouring trees; LCR=60-70%	Remove - conflicts with civil engineering plans	
OS5	<i>Pseudotsuga menziesii</i> , Douglas-fir	34	Y	M-G	N	Lot 5 (not in scope)	Moderate condition; canopy diameter = 10m; ivy on trunk	Retain	2.1m
OS516	<i>Cedrus Deodora</i> , Deodar cedar	43	Y	M	N	SW (Maple Street)	Trunk deformed at base; bulges; foliage in good condition but supressed by proximity to neighbouring trees (512 and 514); LCR=60%	Remove - conflicts with civil engineering plans	
OS7123 (city)	<i>Pseudotsuga menziesii</i> , Douglas-fir	77	Y	P	N	NE (Maple St.)	Roots supressed by the road; large iclusion on the trunk at 3.5m; canopy formed primarily east and west, due to proximity of the other trees; insect damage on trunk; weeping sap; evidence of long term stress to tree with multiple seasons sap; LCR=55-60%	Remove - conflicts with civil engineering plans

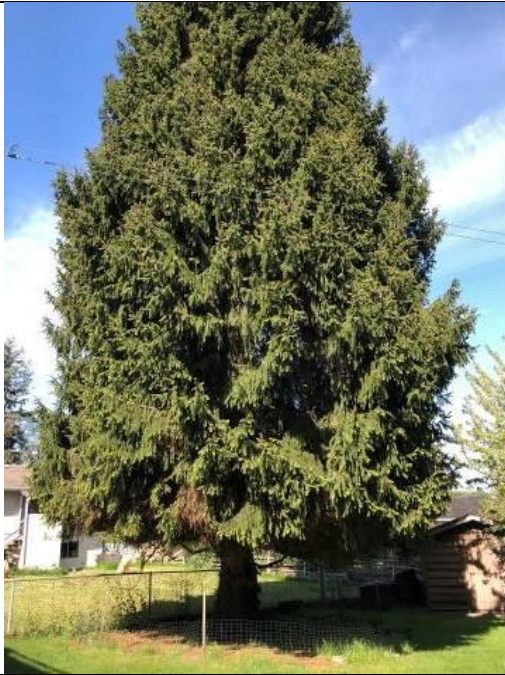
**Photo 7:** Tree #508

Tree Number	Species	DBH (cm)	Protected tree size (Y/N)	Health	ON SITE	Location	Description	Comments	CRZ (m)
508	<i>Picea pugnans</i> , Colorado Spruce	78	Y	M	Y	Lot 6	Open grown, good trunk flare; good branching structure; thinning at top; heavily pruned by resident; no leader; mature tree; weeping sap on trunk; stubs remaining from poor pruning; LCR=80%	Remove-Conflict with proposed development	
509	<i>Prunus</i> sp., Fruiting Cherry	47	Y	P	Y	Lot 6	Open grown; heavily pruned; previously topped at 3.0-4.0m; under stress; in decline; mature tree; weeping sap; codominant at 1.8m, included bark	Remove-Conflict with proposed development	
510	<i>Prunus</i> sp., Fruiting Cherry	42, 39	Y	P	Y	Lot 6	Heavily pruned; under stress; in decline; black rot at the base of the tree, and in crotch; exposed surface root system; located within 2m of concrete slab; previously topped at 4.5m; column of decay suspected; dead limb on south side, with decay at union; included bark; moss on trunk	Remove-Conflict with proposed development

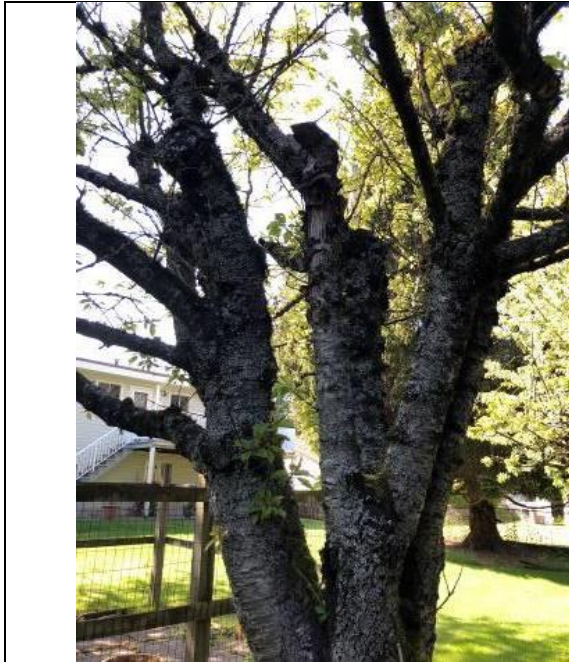
**Photo 11:** Tree #510, Fruiting cherry; previously topped at 4.5m

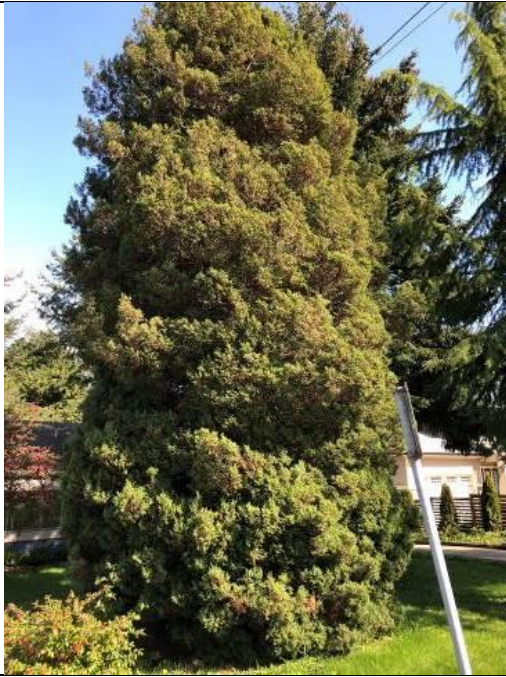
**Photo 15:** Tree #514; in decline

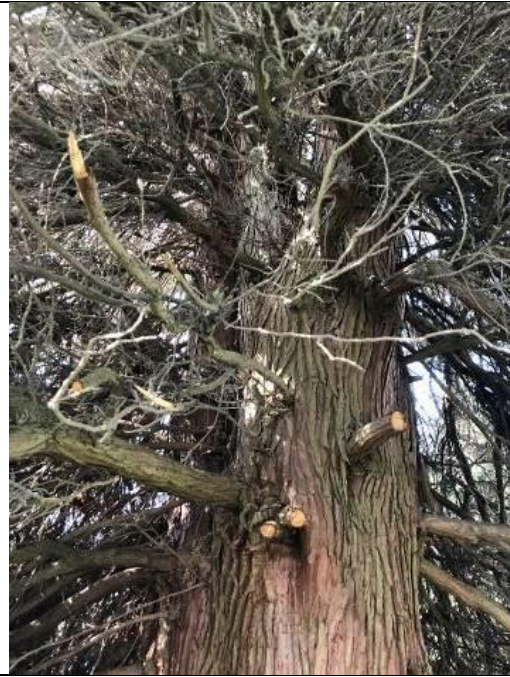
**Photo 16:** Tree #514, middle of canopy; codominant leaders

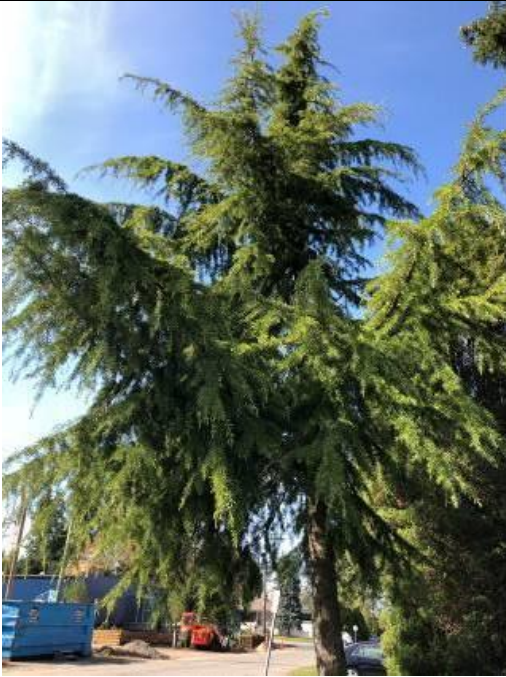
**Photo 17:** Tree #OS516, Deodar cedar; foliage good

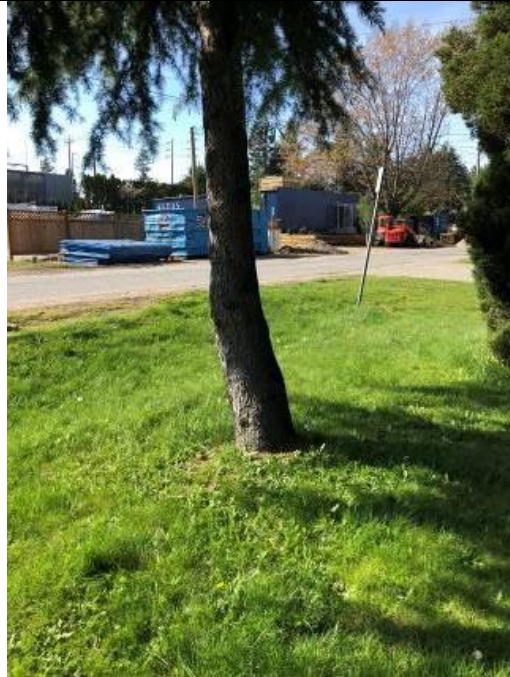
**Photo 18:** Tree #OS516, Deodar cedar; bulge in trunk.

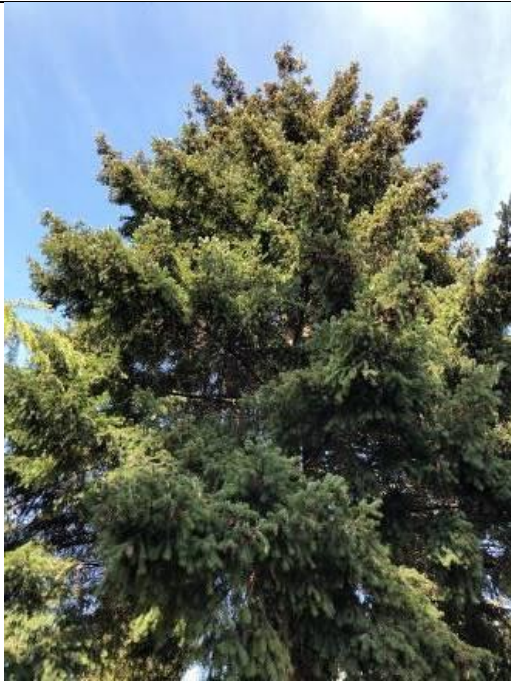
**Photo 19:** Tree #512; canopy in good condition

512	<i>Pseudotsuga menziesii</i> , Douglas-fir	71	Y	G	Y	Lot 7	Base of the tree within 1.5m of concrete driveway; suppressed root system at south (cracked driveway/ roots under driveway) and east (concrete sidewalk); multiple leaders at 2.5m; invasive ivy to 6m; canopy appears healthy; LCR=70-80%	Remove-Conflict with proposed development	
513	<i>Cupressus</i> sp.	38, 36	Y	P	Y	Lot 7	In decline; codominant at 1.2m, included bark; two leaders at 0.80m height; mechanical gouges and damage to trunk; witches' broom; fungus growth (shared with 517 and 518); multiple leaders; suppressed by neighbouring trees (518 and 517); pattern at 3.5m height; LCR=50%	Remove-Conflict with proposed development	
514	<i>Cupressus</i> sp.	56	Y	M	Y	Lot 7	Moderate form; partially suppressed by neighbouring tree to south (516); some minor foliage dieback (weak on south side); LCR=70-80%	Remove-Conflict with proposed development

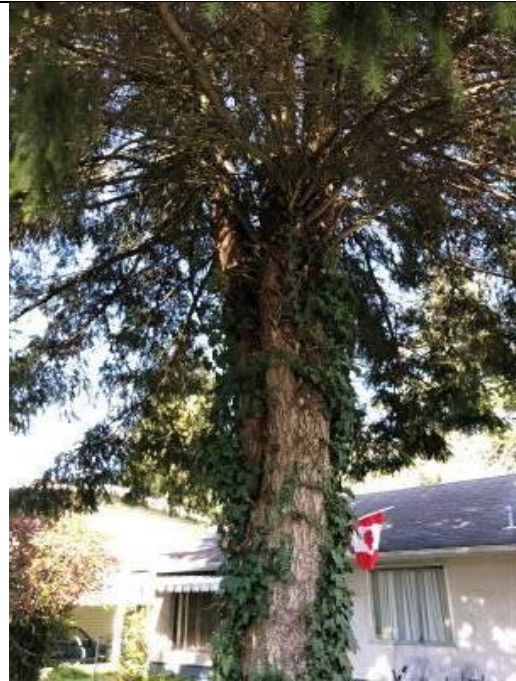
**Photo 20:** Tree #512; trunk with ivy

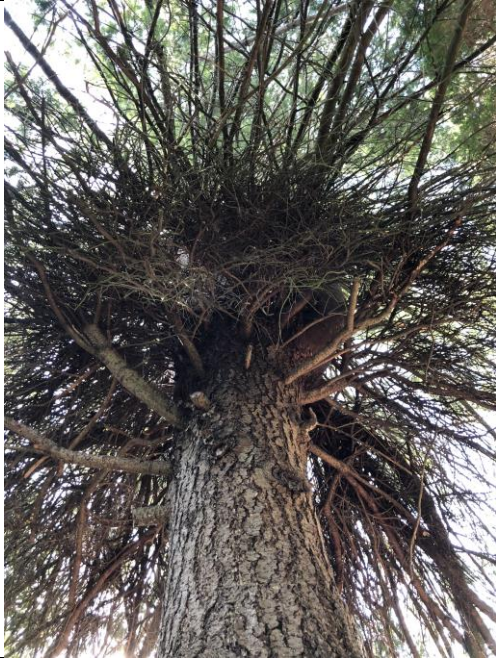
**Photo 23:** Tree #517 witches broom fungus

517	<i>Pseudotsuga menziesii</i> , Douglas-fir	67	Y	P	Y	Lot 7	Trunk flare buried; codominant at 7m; witches' broom branch structure; dead lower canopy (due to lopped branches); compacted soil within critical root zone with some suppression by patio structure; damage on the trunk; bulges; mechanical damage to trunk; fungus (shared with 513 and 518); foliage suppressed by neighbouring tree (513); LCR=50%	Remove-Conflict with proposed development	
518	<i>Pseudotsuga menziesii</i> , Douglas-fir	67	Y	P	Y	Lot 7	Soil at base of tree; compacted with some suppression by patio structure; mechanical damage on trunk; bulges; witches' broom branch structure; fungus (shared with 513 and 517); wood piled at base; foliage suppressed by neighbouring tree (513); LCR=55%	Remove-Conflict with proposed development	
519	<i>Prunus</i> sp., Fruiting Cherry	33	Y	P	Y	Lot 7	Poor condition; significant phototropic lean onto neighbour's property; heavily pruned by resident.	Remove-Conflict with proposed development

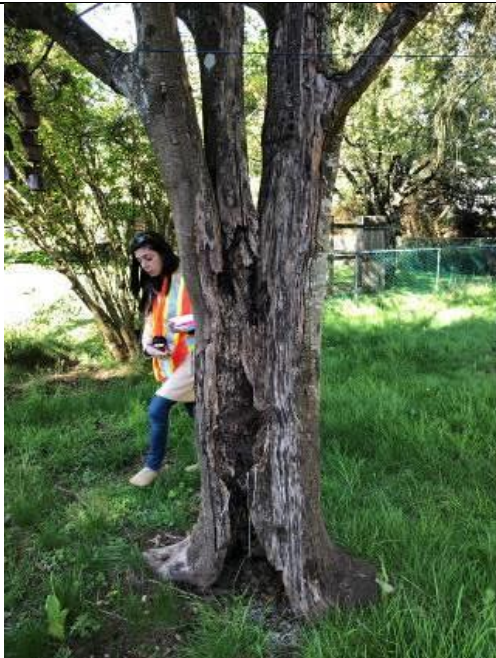
**Photo 25:** Tree #520; dead tree

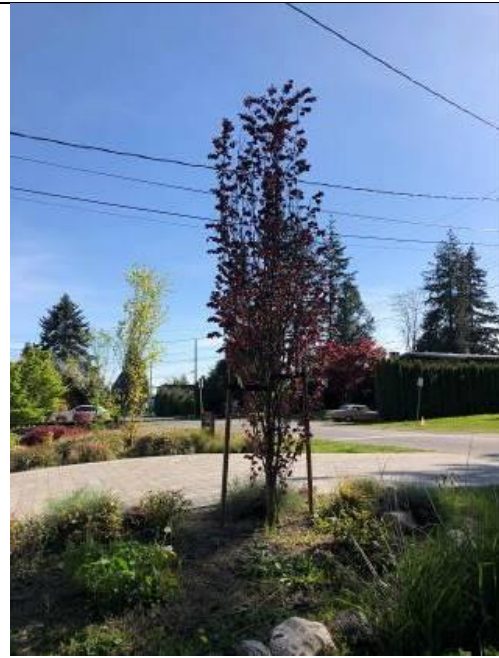
**Photo 26:** Tree #A; undersize newly planted beech

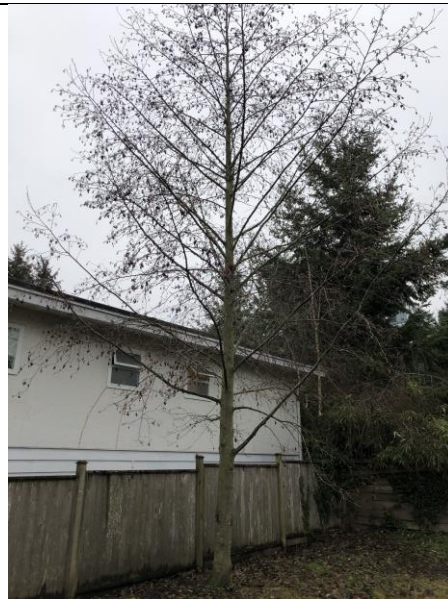
**Photo 28:** Tree #1000 (January 23, 2023)

1000	<i>Alnus rubra</i> , Red alder	21	Y	G	Y	Lot4	Single stem, natural crown form, young, healthy, no major defects found.	Remove-Conflict with proposed development	
587	<i>Chamaecyparis pisifera</i> 'Baby Blue', Sawara Cypress	24, 17, 13, 12	Y	P	Y	Lot 3	Large multiple stem (5-8 stems each); canopy suppressed on south and north side; poor condition; branches partially damaged by snow weight; weak crotch branch connections, included bark; ivy growing throughout	Remove-Conflict with proposed development	
588	<i>Pseudotsuga menziesii</i> , Douglas-fir	81	Y	P	Y	Lot 4	Hedge row on north-east property line of lot 4; planted approximately 2m O.C.; historically heavily pruned by residents and/or Hydro - topped at approximately 1.5m ht; poor condition; bulges on the trunk; multiple leaders overgrown; poor branch connections; history of dropping branches; over head wires above canopy; LCR= 35%	Remove-Conflict with proposed development

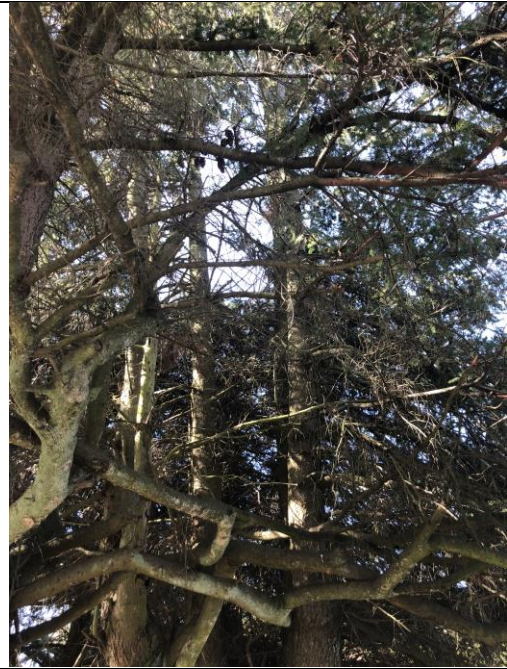
**Photo 32:** Hedgerow; trees #592, 593, 594, 595, 596 with multi-leaders; topped

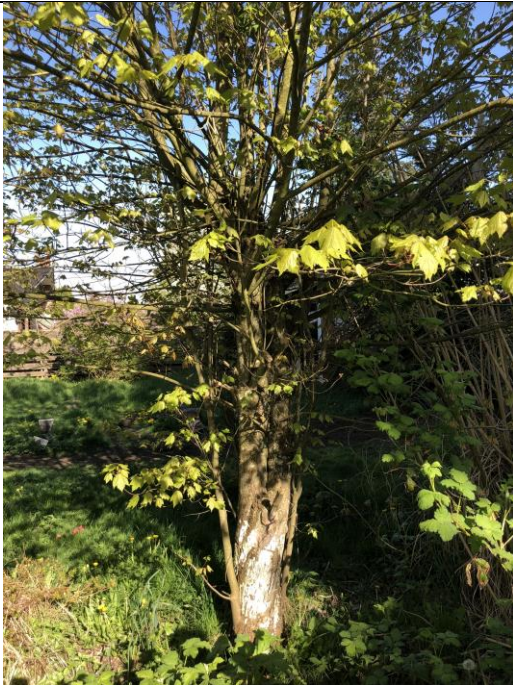
**Photo 35:** Tree #582

582	<i>Acer negundo</i> , Boxelder maple	20	Y	M	Y	Lot 3	Small tree; moderate condition; multiple stump tree; included bark at crotch	Remove-Conflict with proposed development	
583	<i>Prunus</i> sp., Fruiting Cherry	43	Y	P	Y	Lot 3	Open grown; double trunk; mature tree with heavy branch structure; under stress; weak branch structure; open hollow crotch	Remove-Conflict with proposed development
