PROJECT: **VIDAL STREET DEVELOPMENT**

SITE ADDRESS: 14937 Thrift Ave & 1441/1443-45/1465 Vidal Street, White Rock, BC

Original Report November 5, 2018  
Revision 1 May 8, 2019  
Revision 2 September 23, 2020 – A.L.  
Revision 3 July 11, 2022 – D.G.R. - Updated Survey.

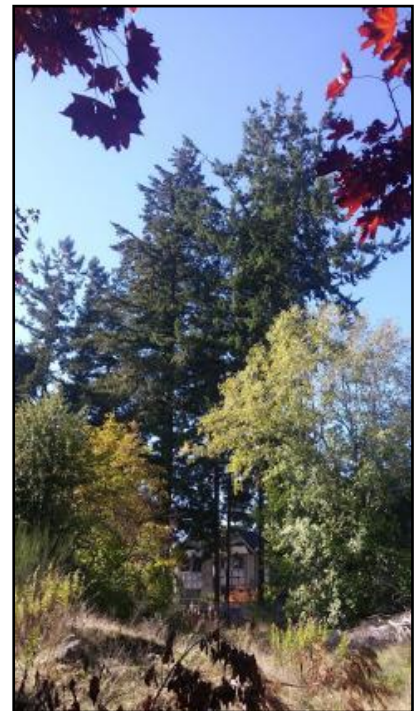
- Tree 06 noticeable decay on single stem of the multi-stemmed tree.
- OS 02-OS 08, dripline extends to/over subject property line. Root radar used to assess root systems. Will need an arborist present to monitor excavation on the property line, and during installation of the proposed retaining wall / landscape features.

**Fig. 5** – View of Trees OS2 – OS8

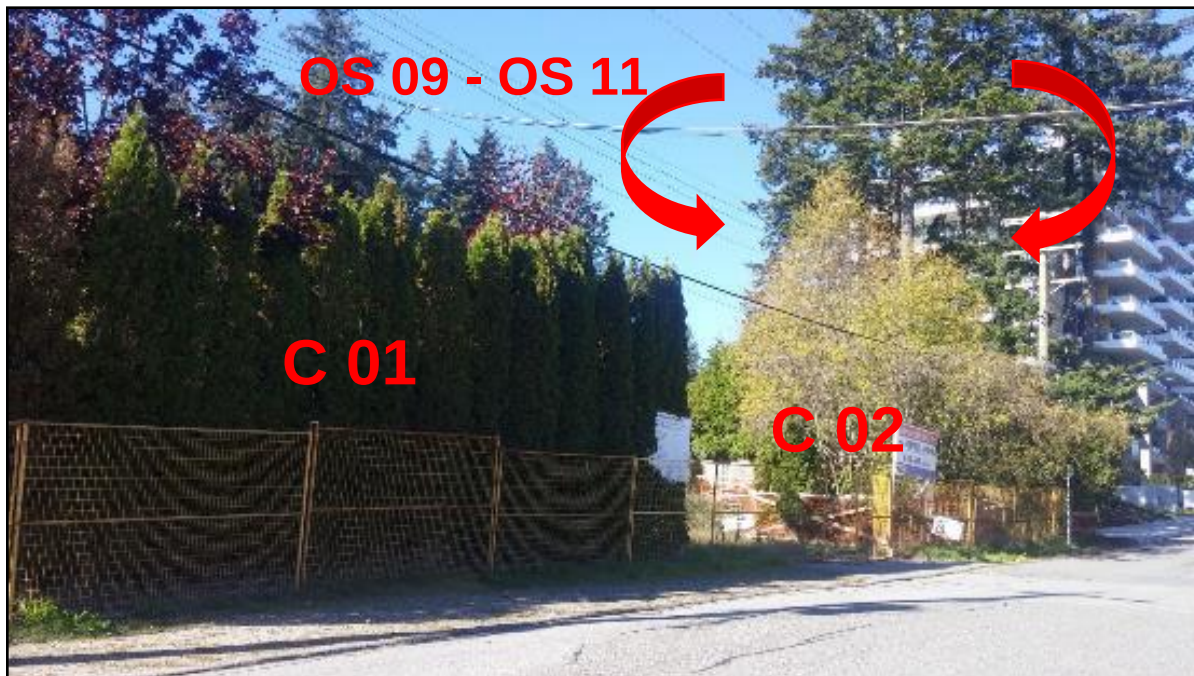
As there are off-site trees with driplines that extend into the subject property, there may be interconnected root systems within the grouping (OS9-OS11) which likely extend onto the property. BC Plant Health Care Root Radar results determined the roots of tree 06 has poor structure and multiple trunks with decay. In addition, OS2-OS6 have feeder or structural roots which grow towards the property. Any work done within the critical root zone will need to be monitored by the arborist. Any retention wall should be maintained to avoid root disruption and destabilization.

**Fig. 7** – View facing north/northwest. OS 9 – OS 11 make up part of the edge of a larger grouping of conifers.

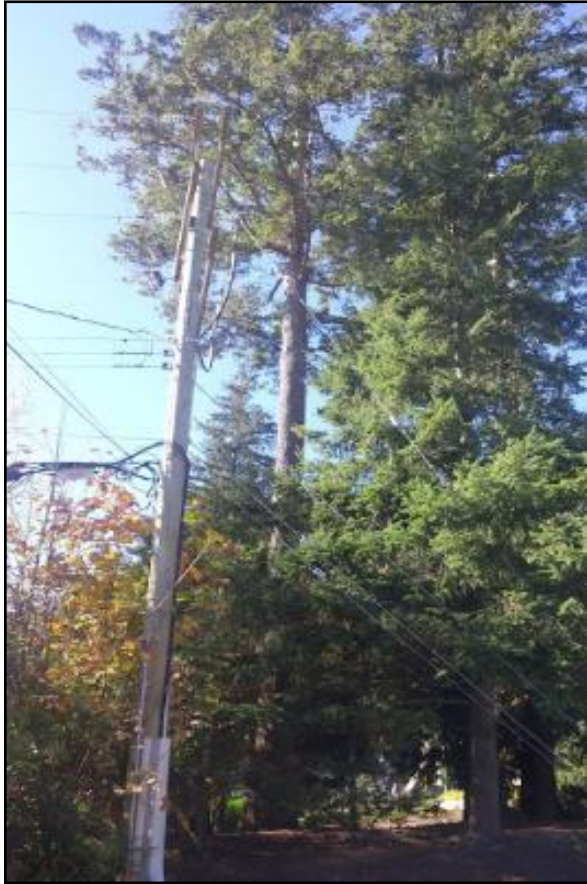
**Fig. 8** – Alternate view of Trees OS 9 – OS 11

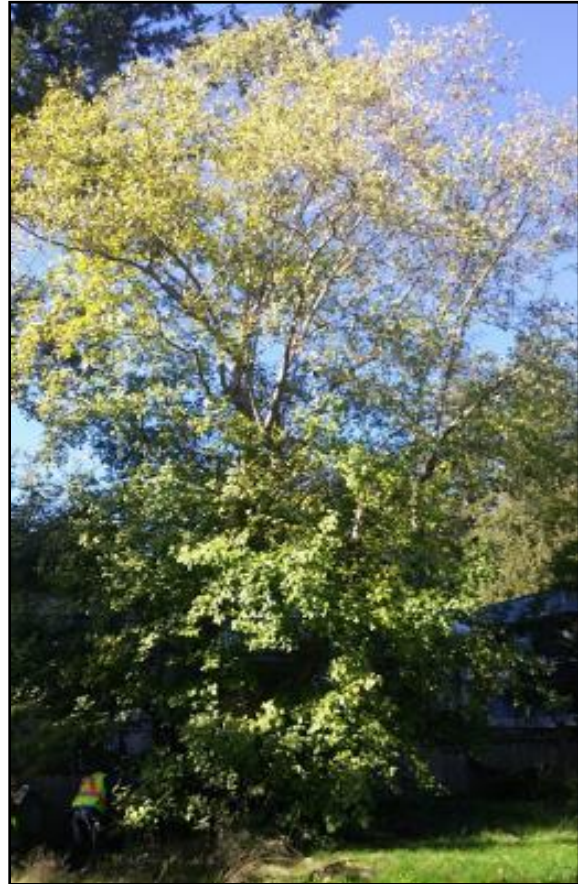
| TREE # | TAG # | COMMON NAME<br>BOTANICAL NAME | LOCATED ON THE SURVEY | DBH (cm) | Crown Radius (m) | LCR (%) | COMMENTS | RETAIN / REMOVE |
|---|---|---|---|---|---|---|---|---|
| 06 | 376 | Red alder<br><i>Alnus rubra</i> | Yes | 114<br>(42, 41, 31) | 9.4 | 80 | Fair form and structure.<br>TRUNK – 3stems from base. Decay present in one stem (0.5 meters in length). Rope girdling eastern trunk, previous tear-out on western trunk. Natural lean east.<br><br><i>BC Plant Health Care root radar results:</i><br><i>Poor structure with multiple trunks and decay. Conflict with proposed development.</i><br><br><b>WITHIN PARKADE FOOTPRINT</b> | Remove |

**Fig. 9** – Red alder (376) located on 1465 Vidal Street.

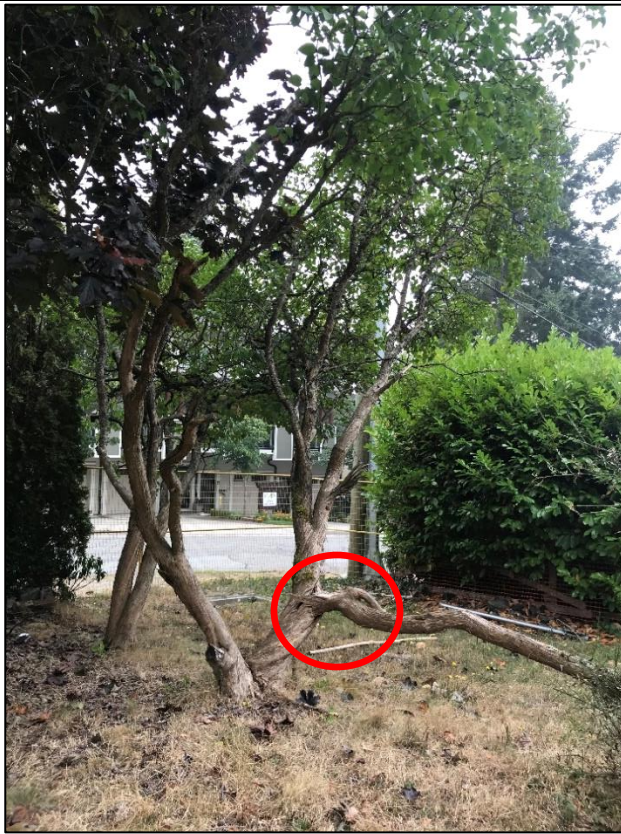
- Tree 05 suffered a failed limb prior to September 15<sup>th</sup>, 2020 visit.
- Tree protection fencing requires repairs and placing for all protected trees prior to any land clearing activities.

| TREE # | TAG # | COMMON NAME<br>BOTANICAL NAME | LOCATED ON THE SURVEY | DBH (cm) | Crown Radius (m) | LCR (%) | COMMENTS | RETAIN / REMOVE |
|---|---|---|---|---|---|---|---|---|
| 05 | 375 | Common lilac<br><i>Syringa vulgaris</i> | No | 31<br>(10,10, 11) | 3.0 | 30 | <b>HANDPLOTTED</b><br>Poor form and structure.<br>TRUNK – Multi-stem from base. Single limb failure since original visit.<br><br><b>WITHIN PARKADE FOOTPRINT</b> | Remove |

**Fig. 13** – Tree #5, failed limb.

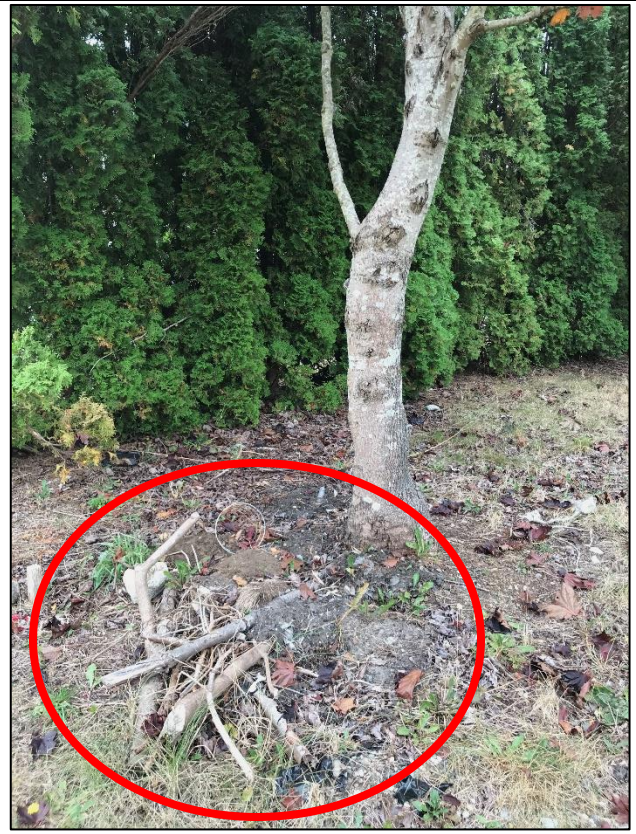
**Fig. 14** – Pruning of tree branches along east property line, 1465, 1443-45.
