PROJECT: VIDAL STREET DEVELOPMENT

SITE ADDRESS: 14937 Thrift Ave & 1441/1443-45/1465 Vidal Street, White Rock, BC

VDZ PROJECT # DP2018-59

Original Report November 5, 2018
Revision 1 May 8, 2019
Revision 2 September 23, 2020 – A.L.
Revision 3 July 11, 2022 – D.G.R. - Updated Survey.

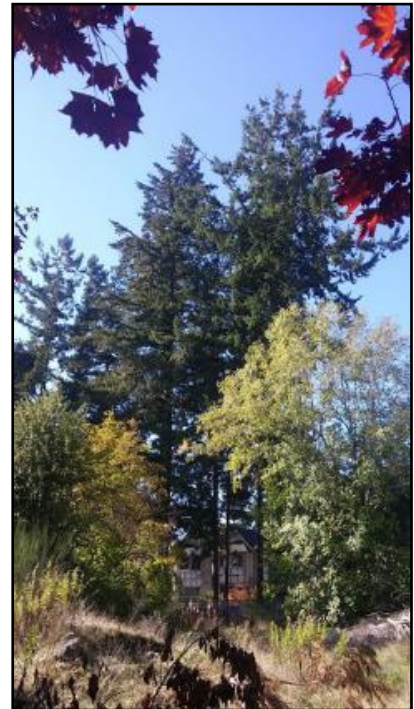
Fig. 5 – View of Trees OS2 – OS8

- Tree 06 noticeable decay on single stem of the multi-stemmed tree.
- OS 02-OS 08, dripline extends to/over subject property line. Root radar used to assess root systems. Will need an arborist present to monitor excavation on the property line, and during installation of the proposed retaining wall / landscape features.

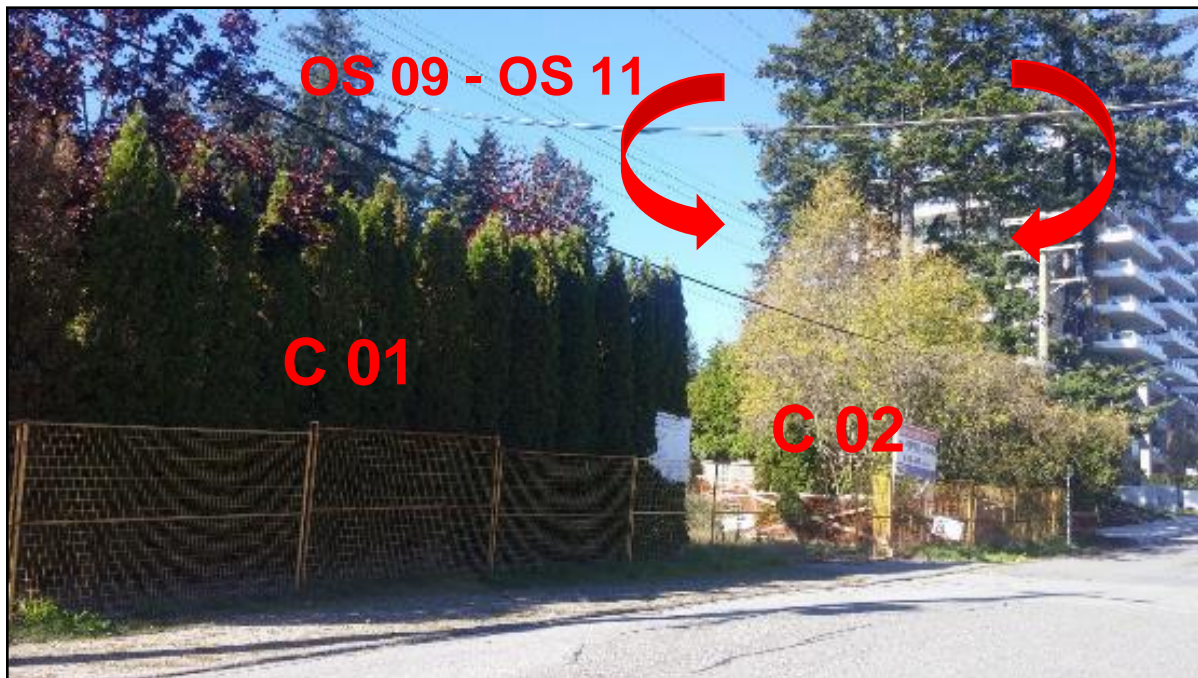
Fig. 7 – View facing north/northwest. OS 9 – OS 11 make up part of the edge of a larger grouping of conifers.

As there are off-site trees with driplines that extend into the subject property, there may be interconnected root systems within the grouping (OS9-OS11) which likely extend onto the property. BC Plant Health Care Root Radar results determined the roots of tree 06 has poor structure and multiple trunks with decay. In addition, OS2-OS6 have feeder or structural roots which grow towards the property. Any work done within the critical root zone will need to be monitored by the arborist. Any retention wall should be maintained to avoid root disruption and destabilization.

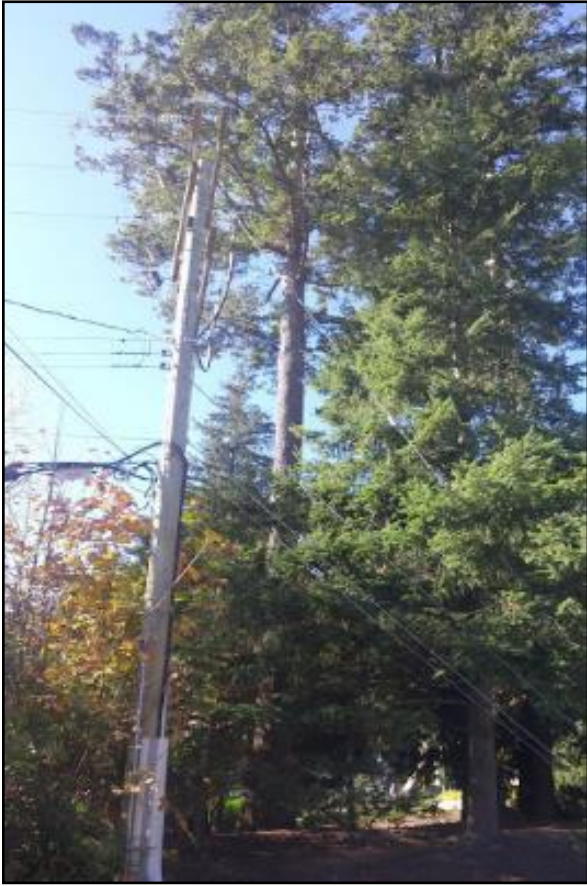
Fig. 8 – Alternate view of Trees OS 9 – OS 11

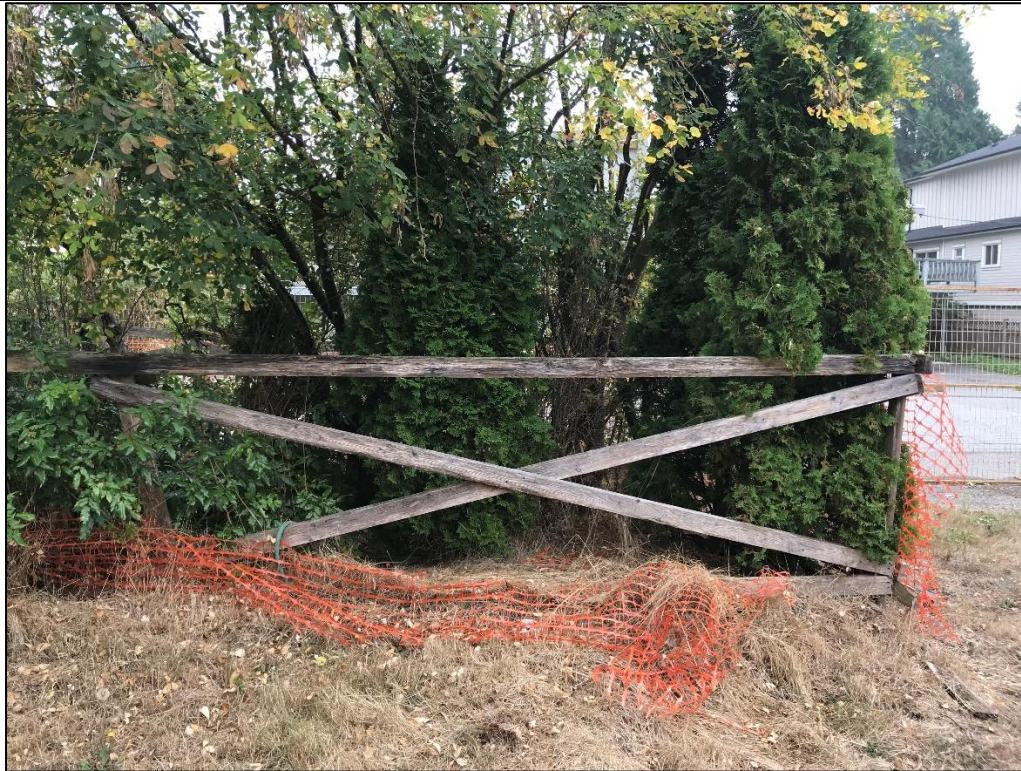
Fig. 9 – View facing east on 1465 Vidal st, tree protection fencing damaged. Needs repair.

- Tree 05 suffered a failed limb prior to September 15th, 2020 visit.
- Tree protection fencing requires repairs and placing for all protected trees prior to any land clearing activities.

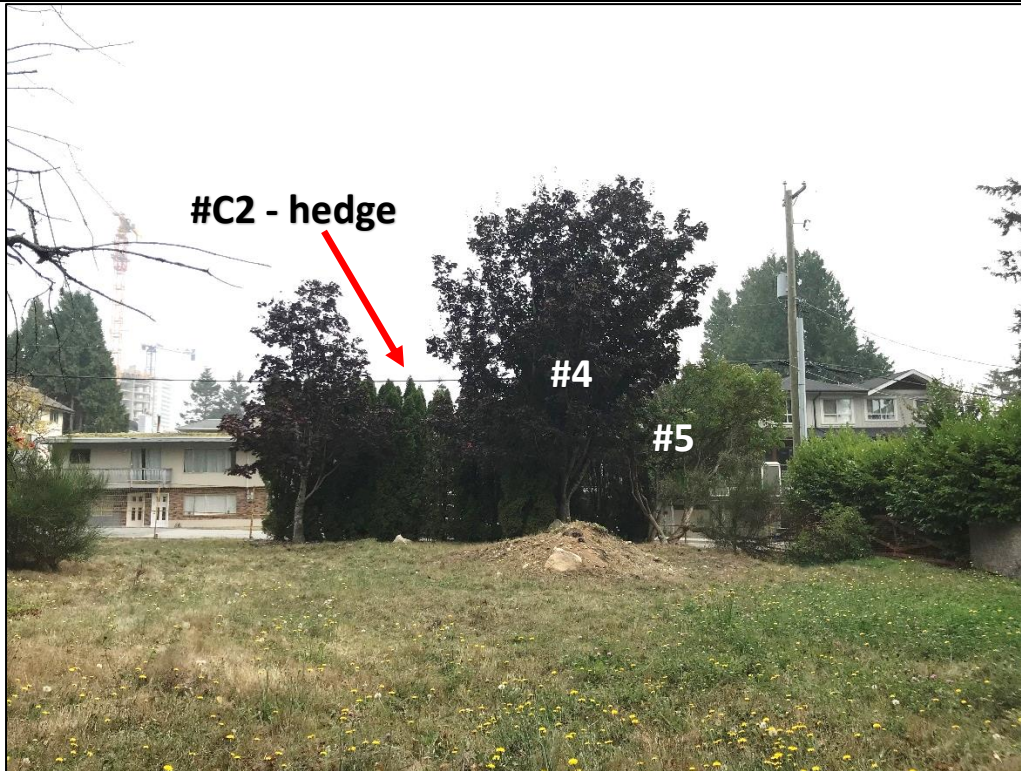
Fig. 10 – View facing east. Southeast corner of 1445 Vidal st. C2 hedge, #4 norway maple, and #5 lilac.

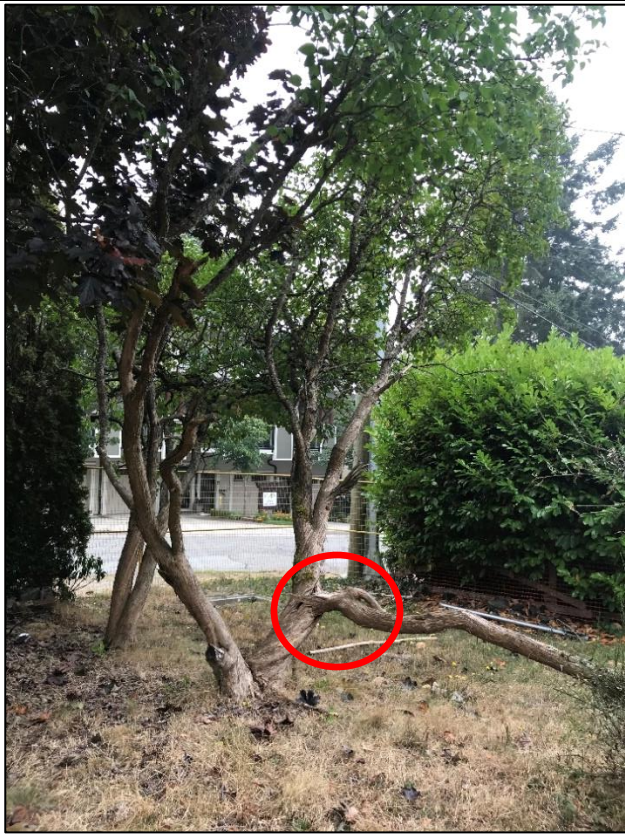
Fig. 13 – Tree #5, failed limb.

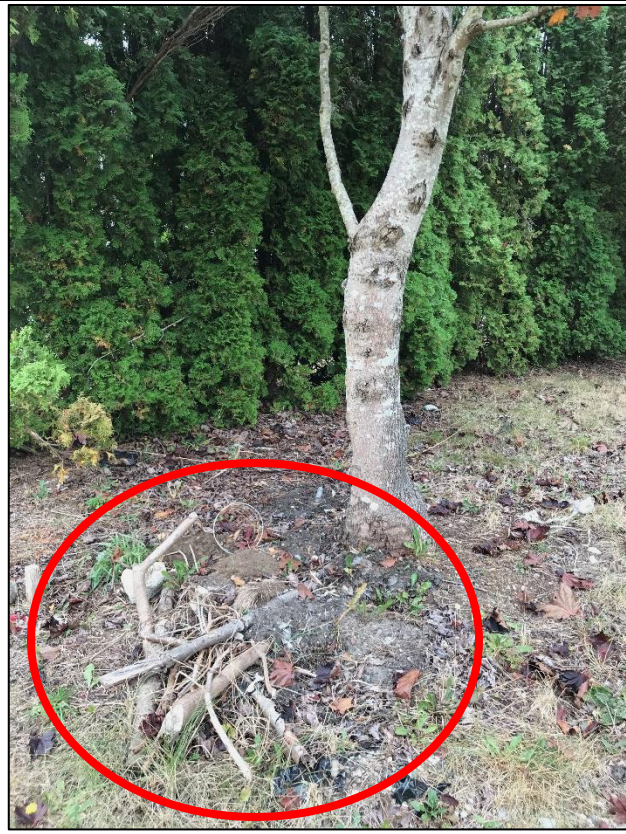
Fig. 14 – Pruning of tree branches along east property line, 1465, 1443-45.
