Preliminary Arborist Report

2 Lot Subdivision
Development Permit Application
15695 Thrift Avenue
White Rock V4B 2M3

Urban Grove Tree Care
and Consulting Ltd

Date: February 14, 2023

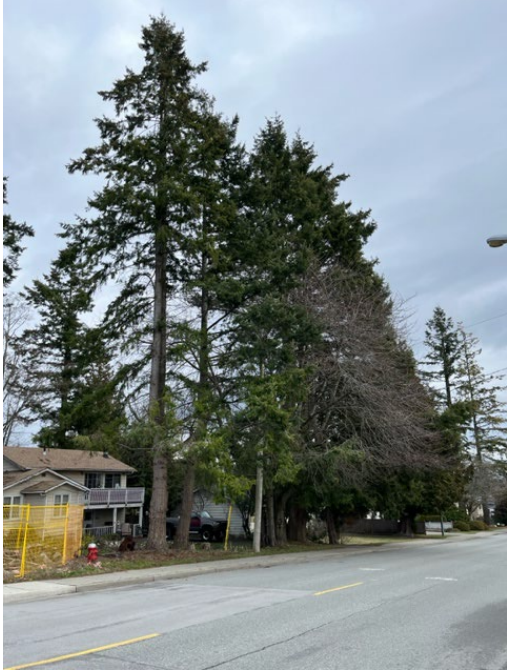
Photo 1. View northeast of row of mixed onsite and city /shared trees (left to right: #519, 520, 523/7642, 525, 524/4327) around the lot's south property boundary.

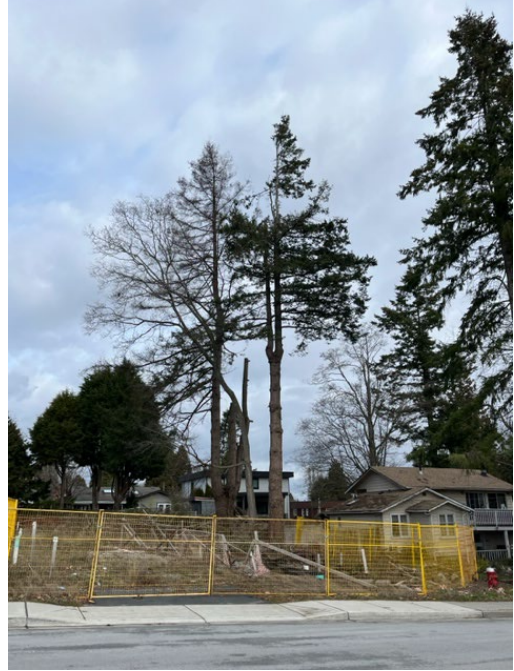
On the west side of Lot A/ 1, Douglas-firs tag #517 and #515, and Red oak tag #901 appear to conflict with building envelopes (foundations) on and off the site. In addition, #517 and #901 pose high risk to development.

Photo 2. View north of the trees around the west property boundary (middle, front to rear: #515, 901, 517, rear, left: offsite 5, rear-right: #518 & offsite 4).

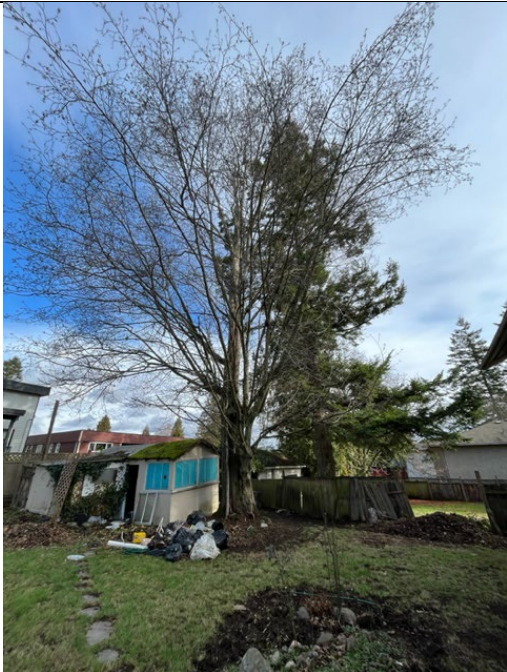
Lot B/ 2, Alder tag #518 poses a risk to site safety with two decay cavities and a crack on the main stem half way up the trunk. All remaining offsite trees along the east side of the lot have minor conflicts with

Photo 3. View east of Alder #518 in rear yard (foreground) with offsite Douglas-fir 4 (background).

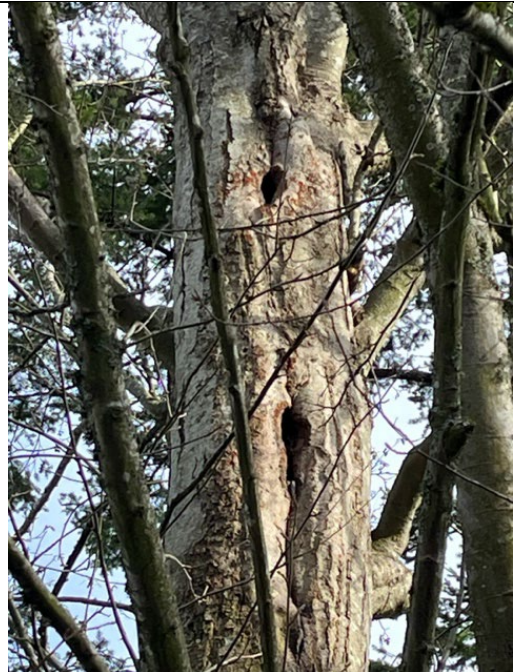
- 2 posing a high risk to the sites (tag #517, 518).
 - Douglas fir # 517 is nearly dead requiring removal.
 - Alder #518 was noted to have two decay cavities and a crack below the lowest cavity. Alders are poor at compartmentalizing decay and due to the size of the crown and trunk and the proximity of future homes this tree poses a high risk to the new development.

Photo 4. Closeup of two decay cavities (Pileated?) at 11m and 13m on the trunk of Alder #518. The lower cavity has a crack below the cavity.

518	Onsite	Red Alder	94	17	90	Fair. High Risk. Single stem, epicormics within 3m of base have become large branches with long reach, deadwood, hanger, decay cavities at 11m (w/crack) and 13m on trunk, likely nests (Pileated?).	Not suitable for retention tree as a high-risk tree. In conflict shed demo & Lot B's subdivision building envelope. 6:1 replacement ratio. \$9000 security. Obtain Type 3 TCP prior to removing. QEP/ RP Bio assessment & permit?	Remove at base outside of nesting season w/ abandoned nest permit? 6 replacement trees required. \$9000 security.	5.6
519	Onsite	Douglas-fir	72	25	80	Fair. Low Risk. Topped in past at 5m, codominant stems (35-45cm each) formed, not included, deadwood, low canopy on south. New exposure on west from City tree removal (Alder).	Tree has potential to be retained with arborist monitored activities in TPZ (pruning, driveway, utilities). Tree requires clearance pruning by ISA cert. arborist prior to demolition.	Retain & protect with TPZ barriers. Arborist monitor works in TPZ (pruning, driveway, utilities).	4.3

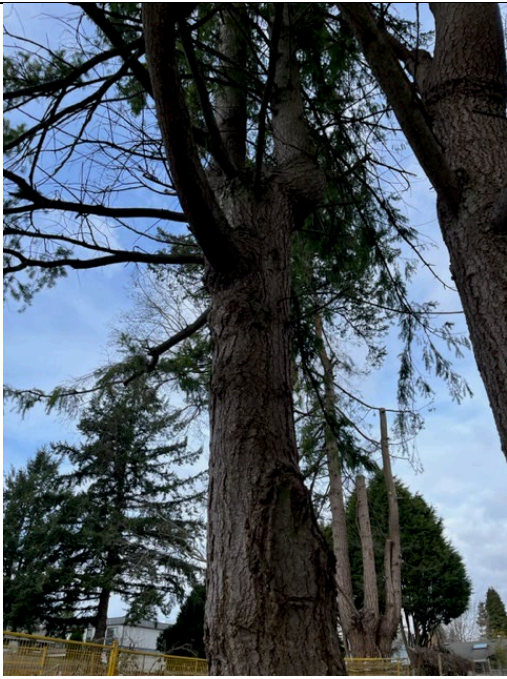
Photo 5. View east of codominant stemmed Douglas fir #519 in southwest corner of site.

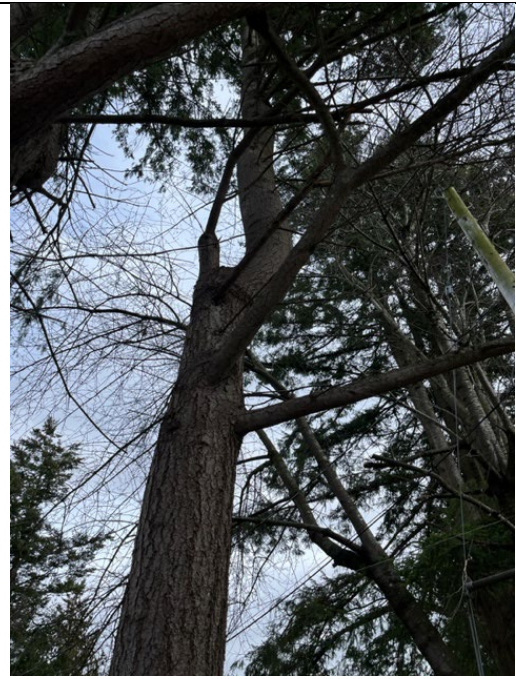
Photo 6. View east of previously topped Douglas fir #520, east of 519, in southwest corner of site.

520	Onsite	Douglas-fir	50	20	80	Fair. Mod. Risk. Topped in past at 5m, codominant stems formed but only 1 stem remains, deadwood, low canopy on south. New exposure on east from 2 conifer tree removals.	Tree has potential to be retained with arborist monitored activities in TPZ (pruning, driveway or utilities). Tree requires clearance pruning by ISA cert. arborist prior to demolition.	Retain & protect with TPZ barriers. Arborist monitor works in TPZ (pruning, driveway, utilities).	3.0

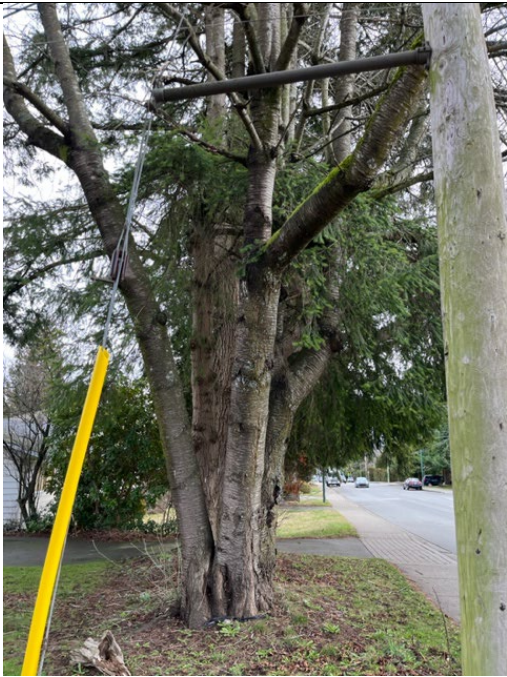
Photo 7. View east of City Cherry 7642/523 shared with property owner. It has 3 included stems from base. The northern stem (523) is leaning to the site.

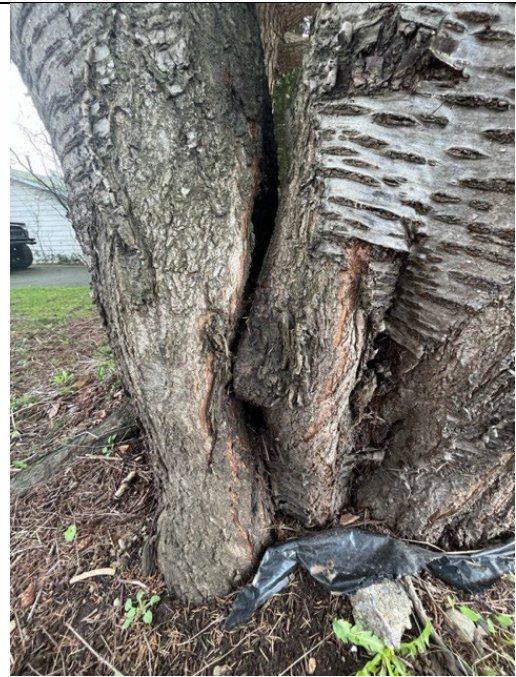
A multi-stemmed (3) Cherry #523/ 4327 requires removal of 1 high risk stem on the north (#523) with retention of the 2 remaining south stems (#4327). Cherry risk abatement is considered pruning and the tree is 'retained' in the tree summary below (Table 1).

Photo 8. Close-up view of base of Cherry #523/7642 with northern stem (left) noted splitting from the southern stems. North stem assessed to be a high risk, only it requires pruning/removal.

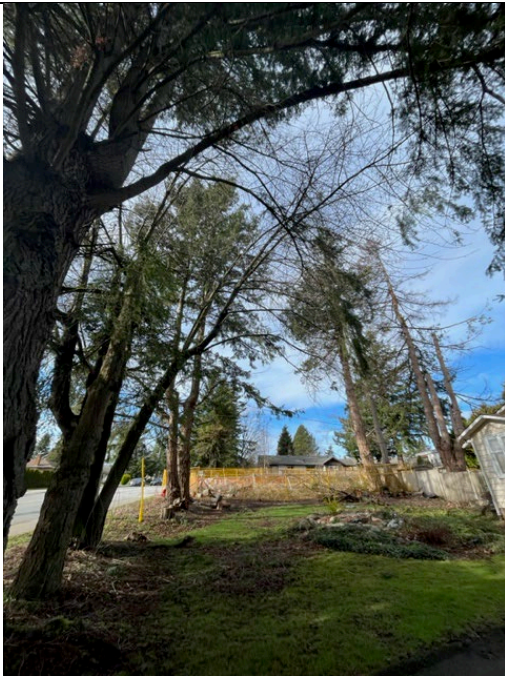
Photo 9. View west of trees along south property line of trees #519, 520 (rear, left), Cherry #523/7642 (leaning stem), Douglas-firs #525 & #524/4327 (foreground, left-rear to front), Douglas - fir # 515, Red oak #901, Douglas-fir #517 (rear, right-left to right).

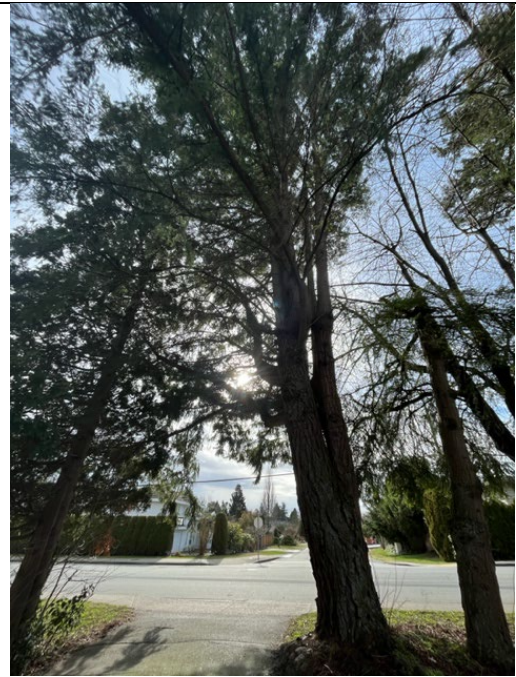
Photo 10. View north from driveway of topped Douglas fir tag #525, Douglas-fir #524/4327, and Offsite Cedar 1 (right to left). Clearance pruning required for demolition / trucks.

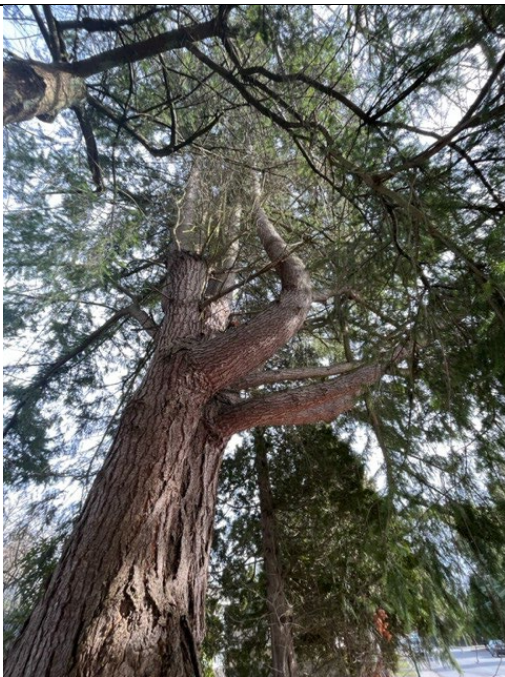
Photo 11. View east into crown of shared tree with city tag #4327 and survey tag #524.

524/ 4327	Onsite/ City (shared)	Douglas-fir	109	29	90	Fair. Mod Risk. Codominant stems at 2m with included bark, multiple tops (5) 2 included, deadwood, low branching, overextended branches, roots heaving driveway. 10m dripline on north.	Ex. Driveway and Pr. utilities at east side of tree conflict with TPZ on Lot B (2). Tree has potential to be retained with arborist monitored activities in TPZ. Tree requires clearance pruning by ISA cert. arborist prior to demolition.	Retain & protect with revised TPZ barriers on site. Arborist monitor works in TPZ (pruning, driveway, utilities).	6.5
525	Onsite	Douglas-fir	53	5	10	Poor. Low Risk. Prev. topped at 5m, 4 live branches remain with low live crown %.	Tree could be retained with arborist monitored activities in TPZ but has <20% live crown and not suitable for long term retention. Removal would open area for utility upgrades. 3:1 replacement ratio. \$4500 security. Obtain Type 3 TCP prior to removing.	Remove at base outside of nesting season. 3 replacement trees required \$4500 security.	3.2

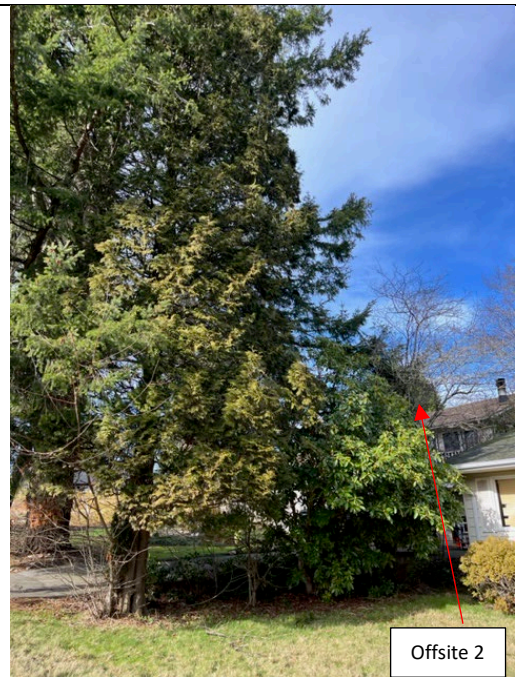
Photo 12. View northwest of offsite Cedar #1 (left) and offsite Plum #2 (far right, right of Rhodo).

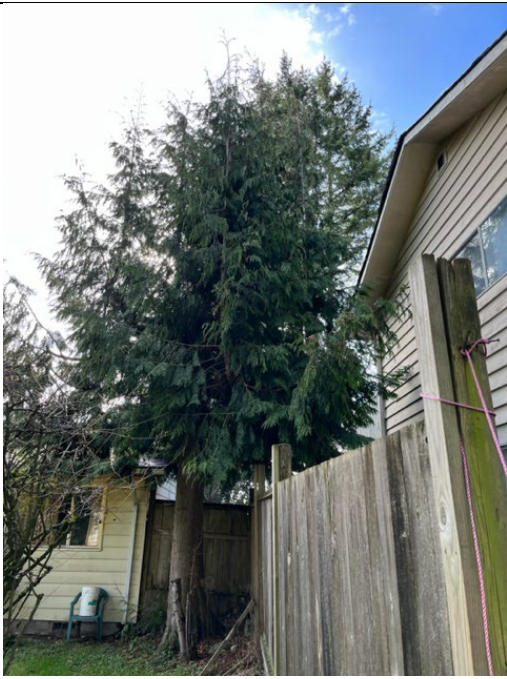
Photo 13. View south from neighbours lot of offsite Cedar #3 with crown extending to subject house. Tree requires clearance pruning on site by ISA certified arborist.

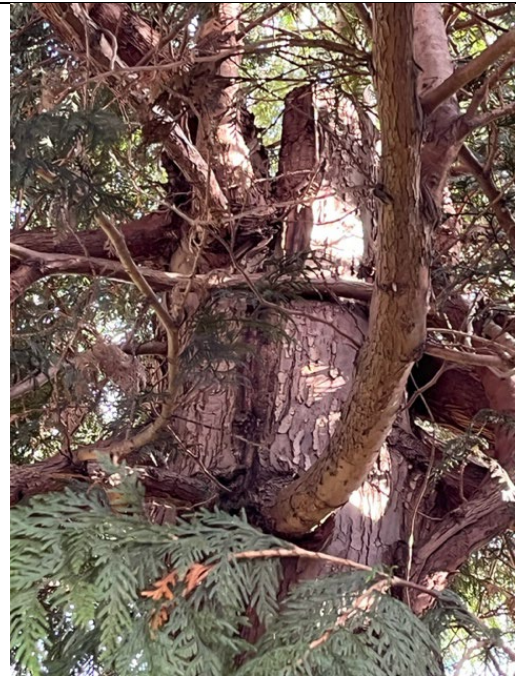
Photo 14. Closeup view of offsite Cedar 3 topped with multiple tops weakly attached to a cracked dead top.

3	Offsite	Western Red Cedar	45	9	50	Poor. Single stem, topped at 5m, multiple tops, weakly attached above cracked trunk. 2.5m dripline onto site.	Slight conflict with building envelope and utilities. Tree has potential to be retained with arborist monitored activities & hydro vacuum exc. w/ in TPZ. Tree requires clearance pruning by ISA cert. arborist prior to demolition.	Retain & protect with revised TPZ barriers on site. ISA cert. arborist to prune for clearance. Arborist monitor works in TPZ (pruning, foundation, hydro vacuum exc. for utilities).	2.7
4	Offsite	Douglas-fir	96	30	90	Good. Single stem, well buttressed, no defects. 7m dripline onto site.	Conflicts with building envelope and utilities. Tree has potential to be retained with arborist monitored activities & hydro vacuum exc. w/ in TPZ.	Retain & protect with revised TPZ barriers on site. Arborist monitor works in TPZ (foundation, hydro vacuum exc. for utilities).	5.8

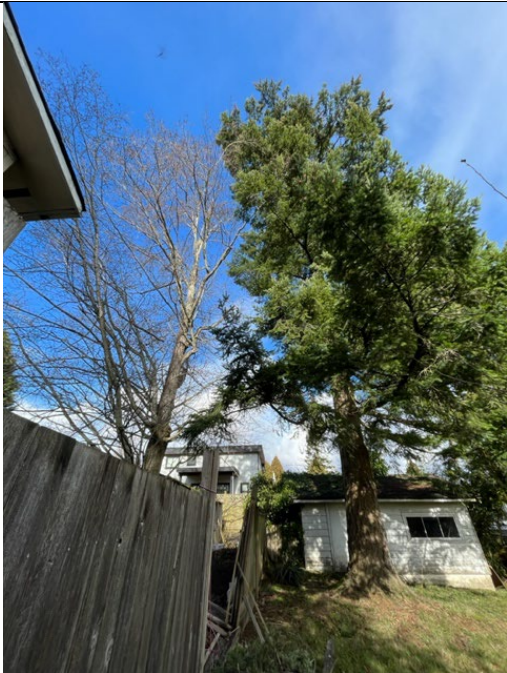
Photo 15. View north from neighbours property of offsite Douglas-fir #4 (right) and Alder Tag #518 (left).

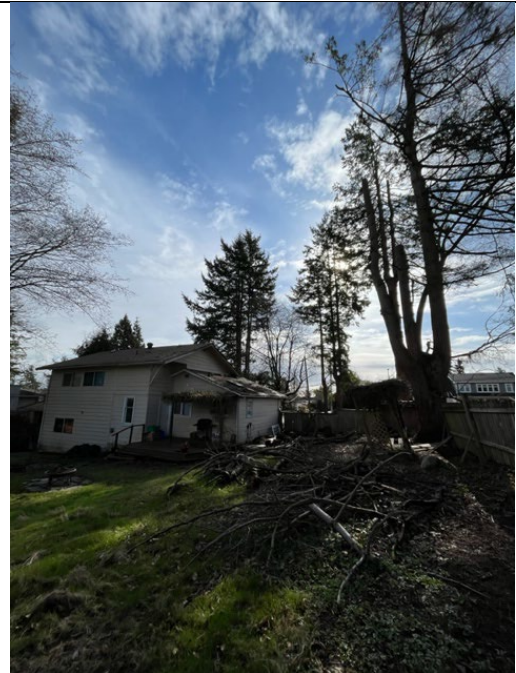
Photo 16. View south from northwest corner of lot of trees along west (right) and south boundaries (rear).
