**Tree Evaluation Report for:  
15643 Buena Vista Avenue  
White Rock, BC**

**Date: February 11, 2021  
Revised: February 8, 2022**

PROJECT TITLE  
TREE PRESERVATION  
AND PROTECTION PLAN

15643 BUENA VISTA  
AVENUE  
WHITE ROCK, B.C.

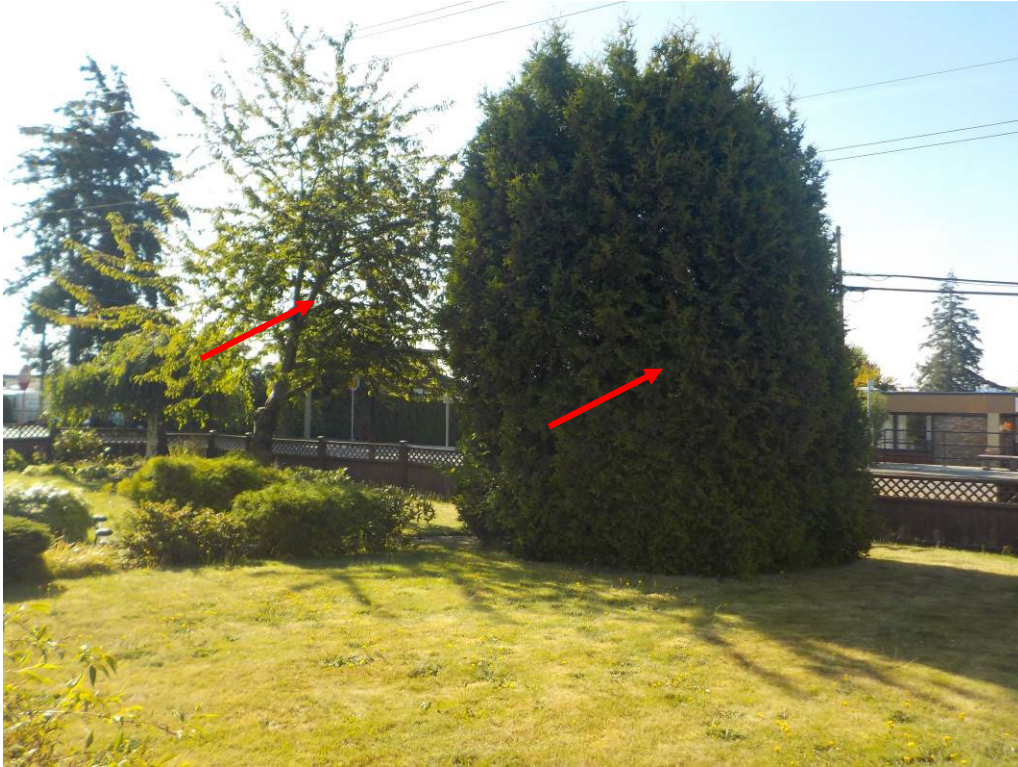
Tree #	Type	DBH (cm)	Dripline (m)	LCR (%)	Condition (Structure, Health)	Comments	TPZ (m)	Recommendation
100	Excelsa Redcedar ( <i>Thuja plicata</i> 'Excelsa')	~20/ 15/15	2.5	100	M, MG	Multiple other stems. High foliage density. Expected to suffer significant root loss from excavation and require significant canopy loss for clearance.	2.5	Remove.
4409	Cherry ( <i>Prunus sp.</i> )	32	4.0 (south)	NA	MP, M	Asymmetrical crown to the south. Some gummosis. Low foliage density in the upper canopy.	2.5	Retain. Construct pathway above grade within TPZ.
4410	Falsecypress ( <i>Chamaecyparis sp.</i> )	15/14/ 10	1.0	100	M, MG	Hedging cultivar. High foliage density.	2.0	Retain.
4411	Deodar Cedar ( <i>Cedrus deodara</i> )	56	5.3	90	G, G	Healthy foliage.	4.0	Retain. Construct planters above grade with no excavation within TPZ.
4412	Japanese Maple ( <i>Acer palmatum</i> )	12/11/ 10	3.8	NA	M, MG	Irregular crown due to past shading. Healthy foliage. Tree conflicts with construction.	1.5	Remove

**Figure 1.** Tree 4409 and 100 from left to right.

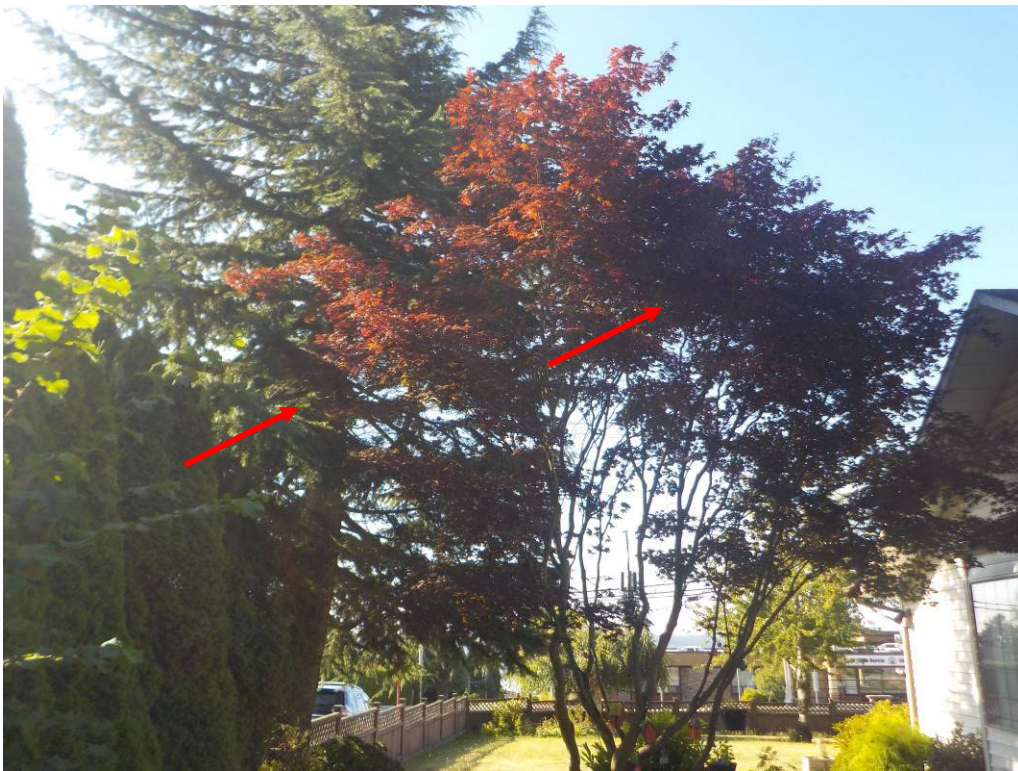
**Figure 2.** 4411 and 4412 from left to right.

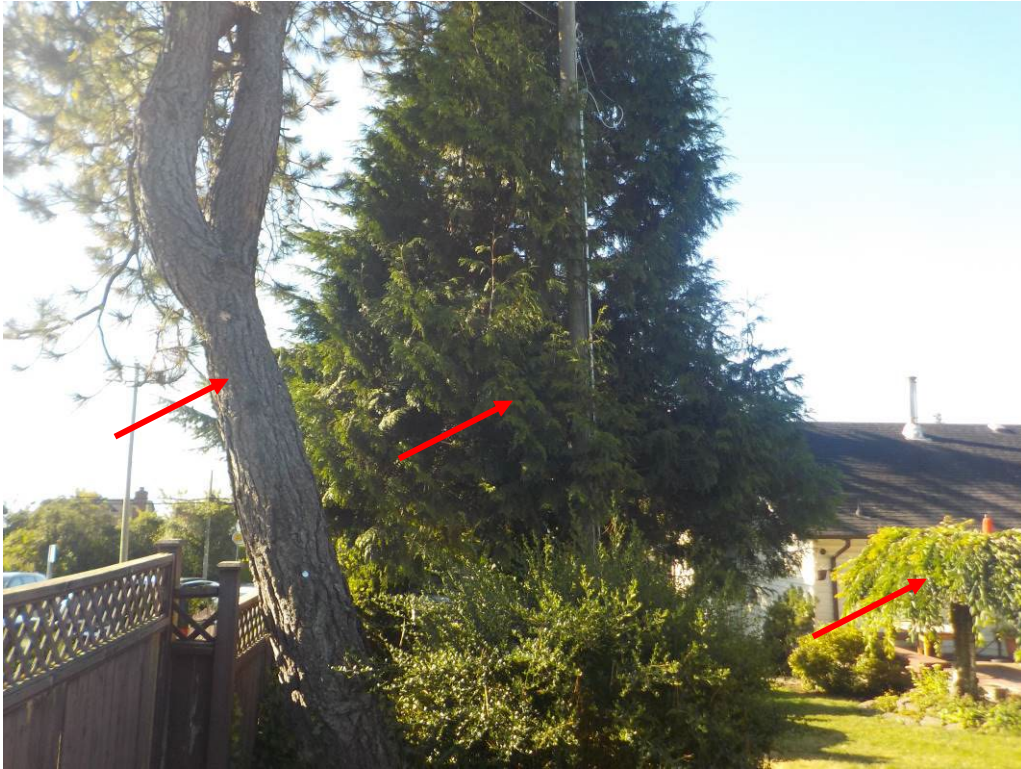
4413	Weeping Cherry ( <i>Prunus sp.</i> )	32	1.6	NA	MG, MG	Minor skeletonization of leaves. Typical of species. Tree conflicts with construction.	2.5	Remove.
4414	Western Redcedar ( <i>Thuja plicata</i> )	23/15	3.3	90	M, M	Ivy infestation. Asymmetrical crown due to power pole clearance pruning. Multiple tops. Tree conflicts with construction – driveway.	2.5	Remove.
4415	Austrian Pine ( <i>Pinus nigra</i> )	57	3.6	65	MP, M	Co-dominant stems form at ~3.0. Asymmetrical crown due to powerline clearance pruning. Moderate flagging. Large pistol-butt base. Poorly weighted.	4.0	Retain.

**Figure 3.** Tree 4415 ,4414 and 4413 from left to right.,

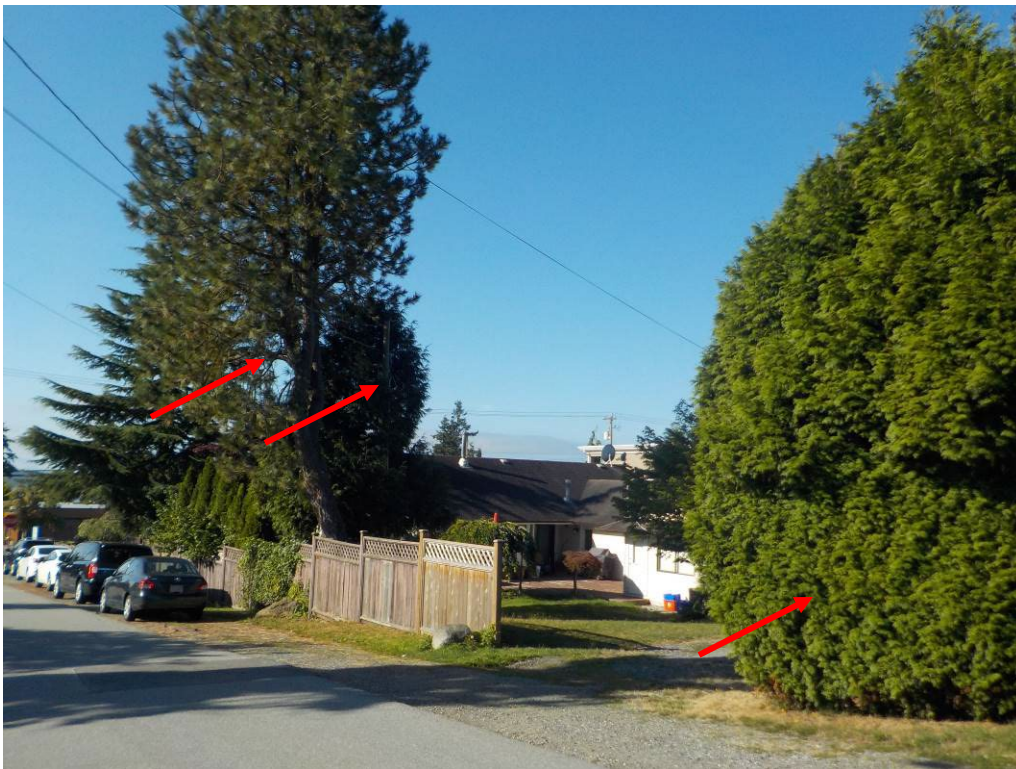
**Figure 4.** Tree 4415, 4414 and H1, from left to right.

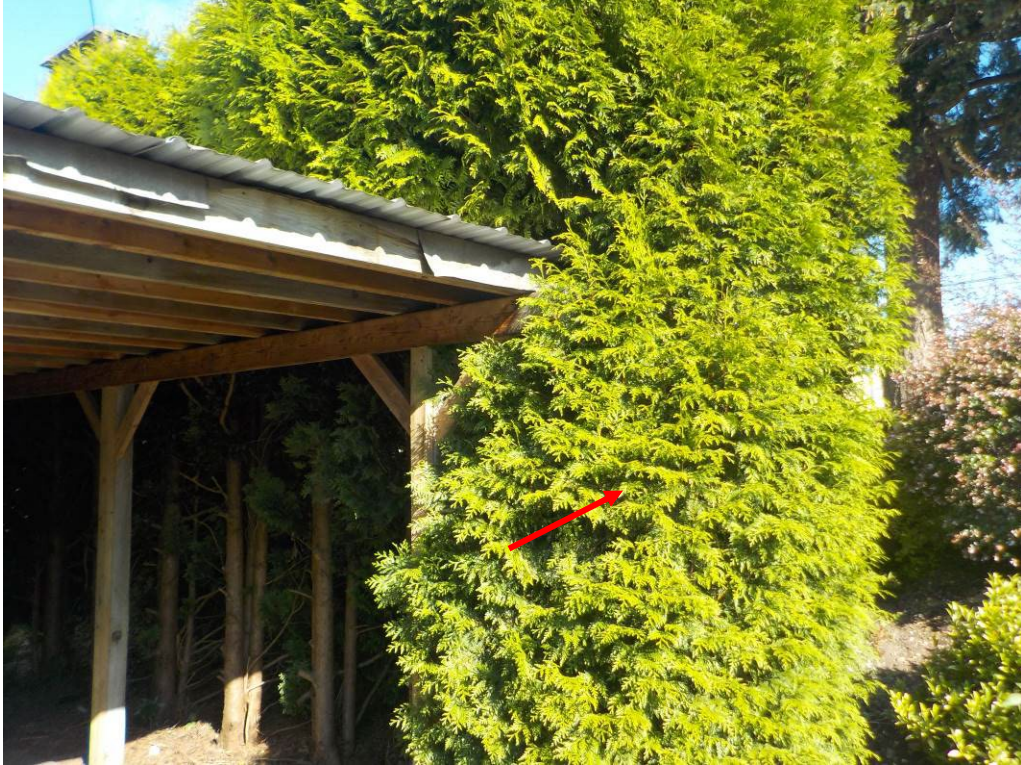
Tree #	Type	DBH (cm)	Dripline (m)	LCR (%)	Condition (Structure, Health)	Comments	TPZ (m)	Recommendation
4416	Excelsa Redcedar ( <i>Thuja plicata</i> 'Excelsa')	12/10/ 9	~2.0 (east)	100	M, MG	Bare spot to the south due to shading/clearance pruning. Planted in a hedgerow – remainder of stems <30. Healthy foliage.	1.5	Retain.
H1	Excelsa Redcedar ( <i>Thuja plicata</i> 'Excelsa') X2	~35	~3.5	100	M, MG	High foliage density. Thick branching, limited access to stem.	2.5	Retain.
<b>ADDITIONAL RECOMMENDATIONS</b>								
<ul style="list-style-type: none"> <li>• <b>In order to prevent root damage, which may adversely affect the health and or stability of the retained trees, any ground disturbance or grade alteration within the recommended Tree Protection Zone provided in the table above shall be under the direction of the project arborist.</b></li> <li>• <b>Location is approximate for all non-surveyed trees.</b></li> <li>• <b>Permission from the registered owner(s)/city is required prior to the removal of all city, offsite, and shared trees regardless of their size.</b></li> </ul>

**Figure 5.** Tree 4416

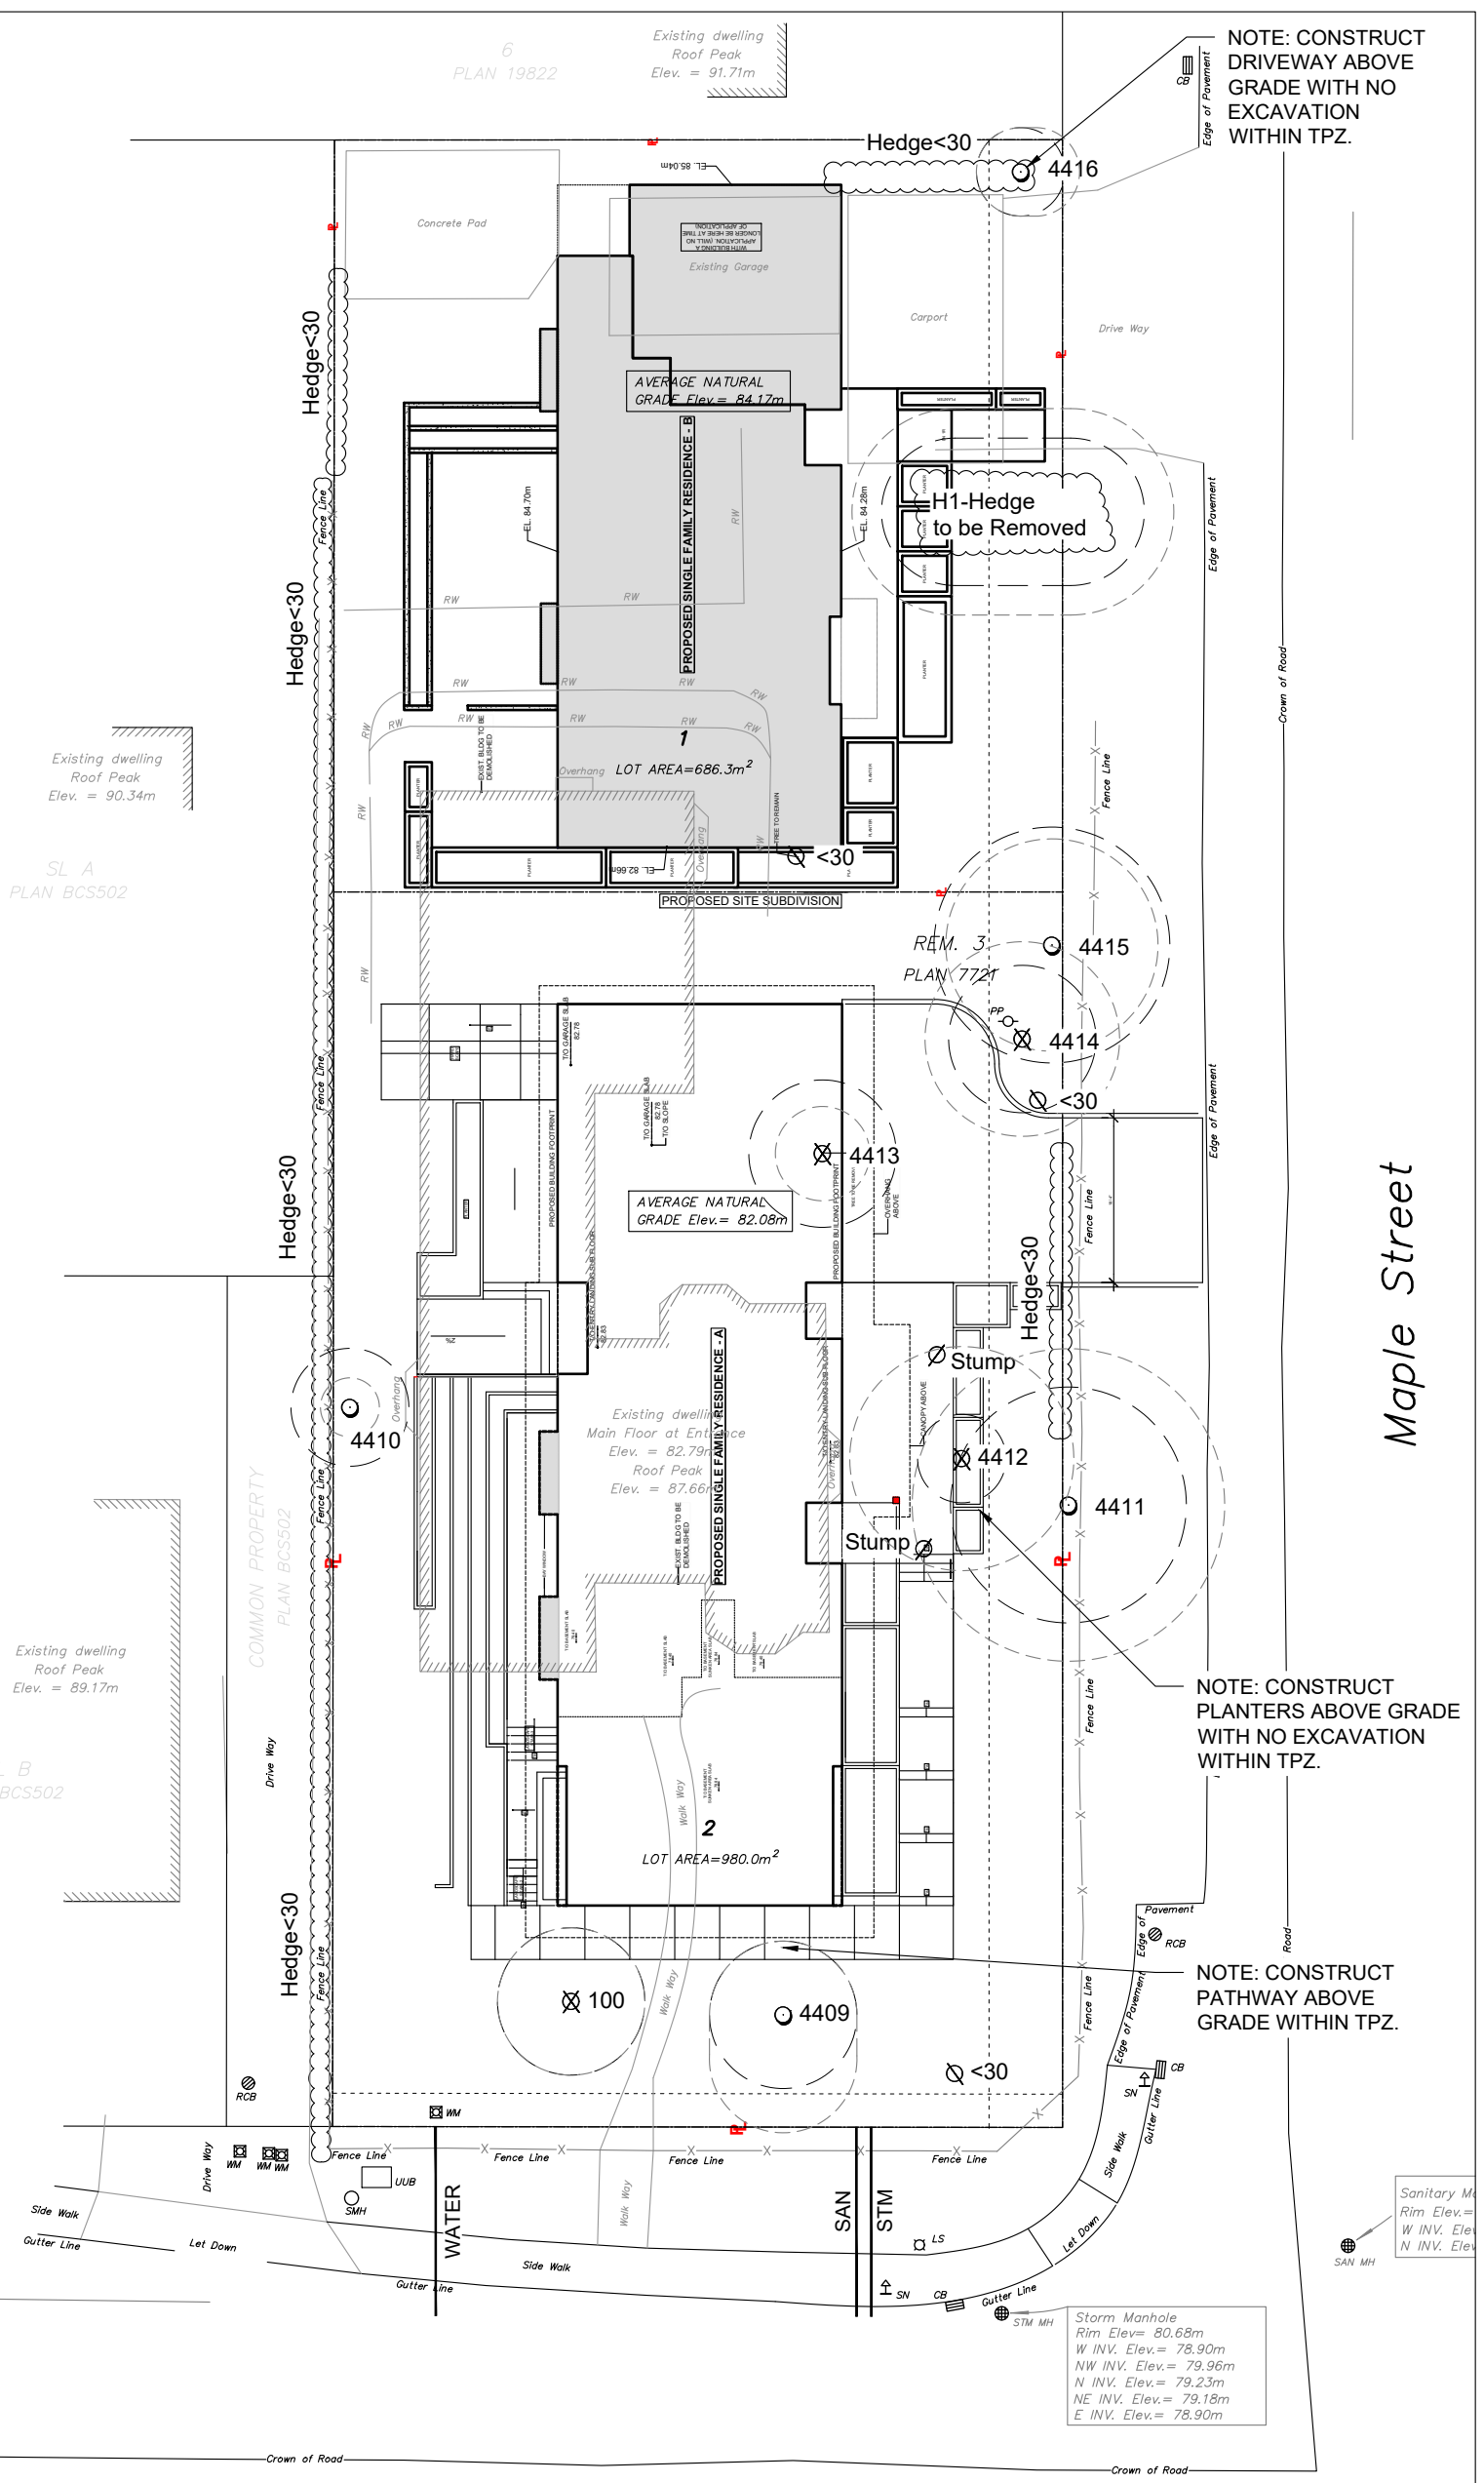
T1 - TREE REMOVAL AND  
PRESERVATION PLAN

NOTE: CONSTRUCT  
DRIVEWAY ABOVE  
GRADE WITH NO  
EXCAVATION  
WITHIN TPZ.
