ATTACHMENT A

1590 Lancaster Street

(City File: 22-038)

**Arborist Report for Development
1590 Lancaster Street
White Rock, BC V4B 3H4**

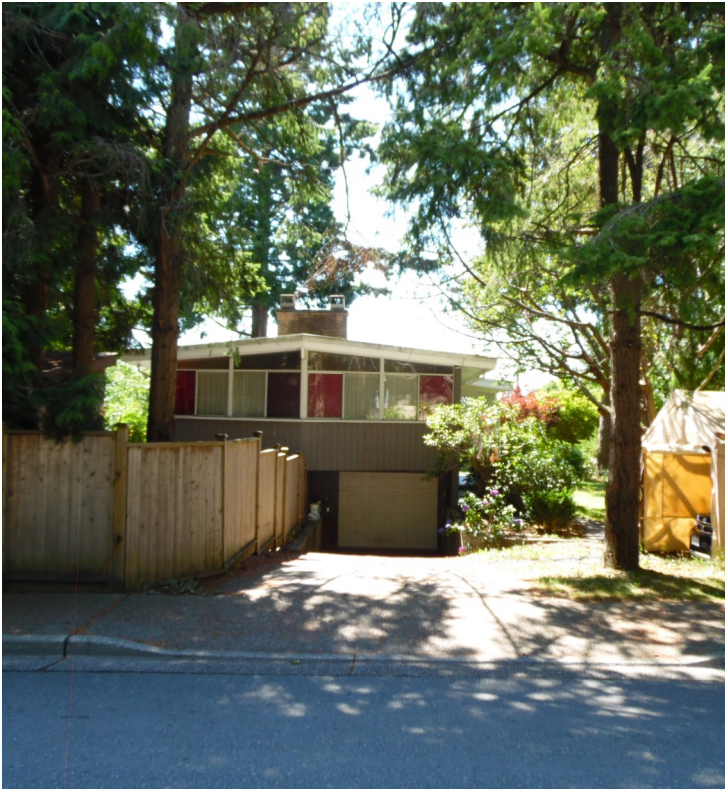
Photo 1
View of property from North Bluff Road.

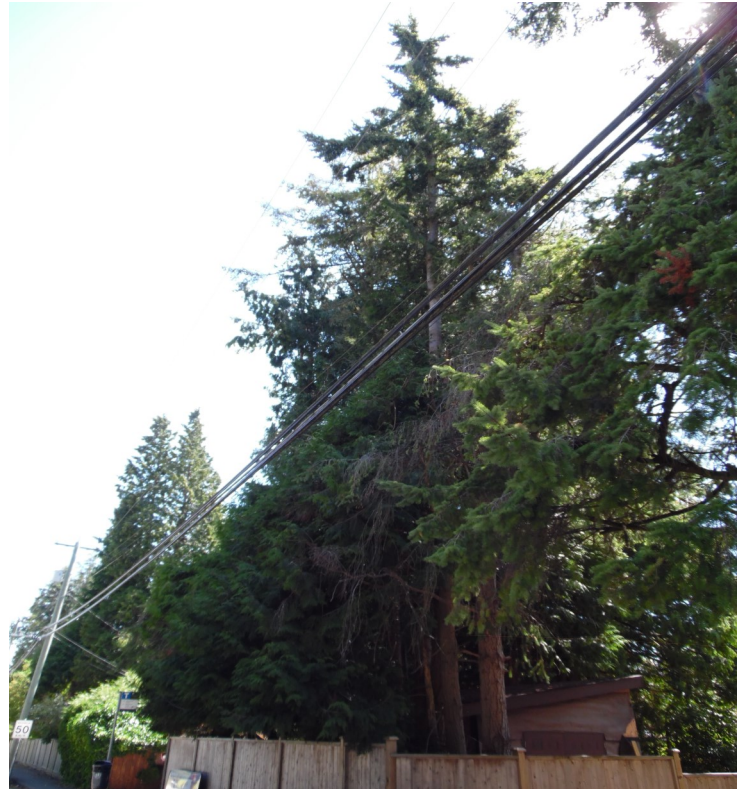
Photo 2
Trees along North Bluff Road are Hydro-pruned.

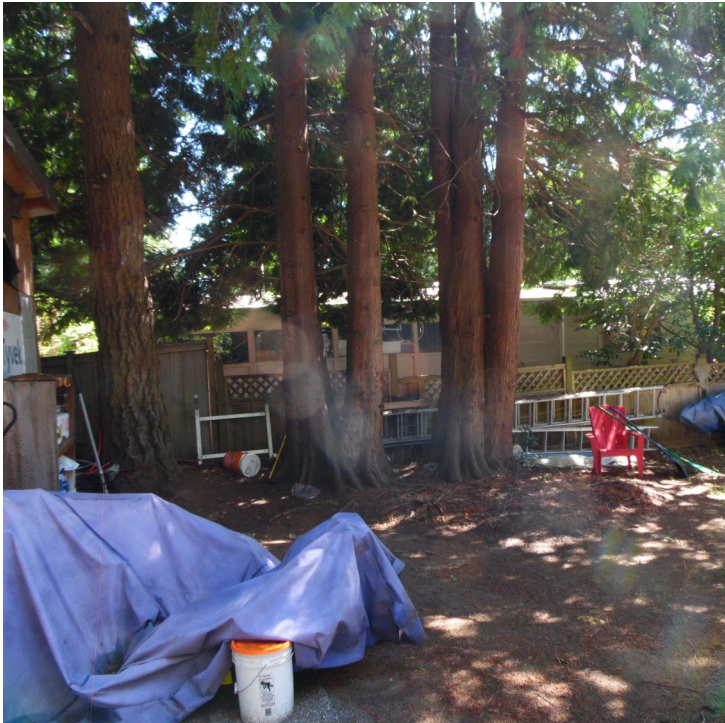
Tree #1807 is dead/dying or in a state of decline beyond repair and is recommended for removal. All other trees are viable for long term retention.

Tree #1809 and OS1 will have 45% and 40% encroachment into their critical root zones from the new house excavation zone. Tree #OS1 is recommended for removal due to conflicts with construction. Tree #1809 is recommended for retention with Arborist supervision and supplemental watering during excavation. Tree #1809 is an anchor to the surrounding grove therefore extra measures should be taken to retain it.

Photo 3
Trees #1807, 1808 and 1809 from left to right.

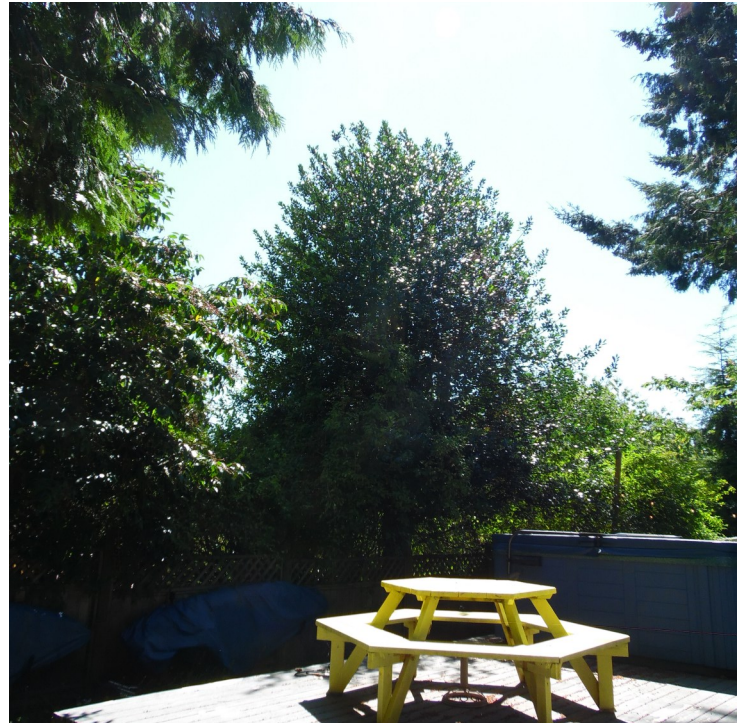
Photo 4
Tree #OS1.

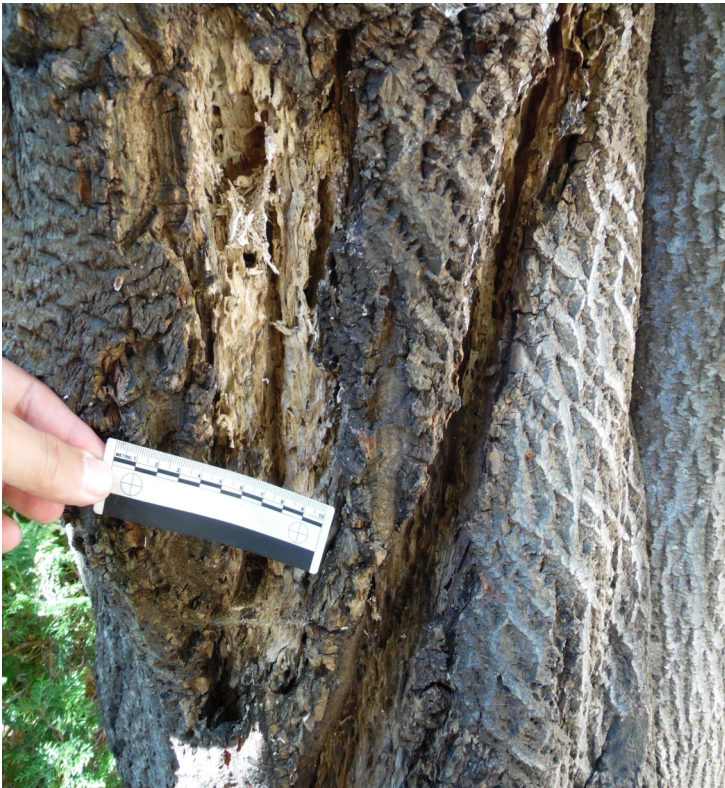
Photo 5

1805	Cascara buckthorn <i>Rhamnus purshiana</i>	59	8	30	70	Poor	Poor	Multi stemmed at 1m with included bark Significant heartwood and sapwood decay on main stem Retain and Monitor	6.0	3.6

Trees #1805, 1813, 1814, 1815, and 1816 will have 100% encroachment into their critical root zones and are therefore recommended for removal due to conflicts with construction.

Tree #1805 has extensive decay found in the main trunk.

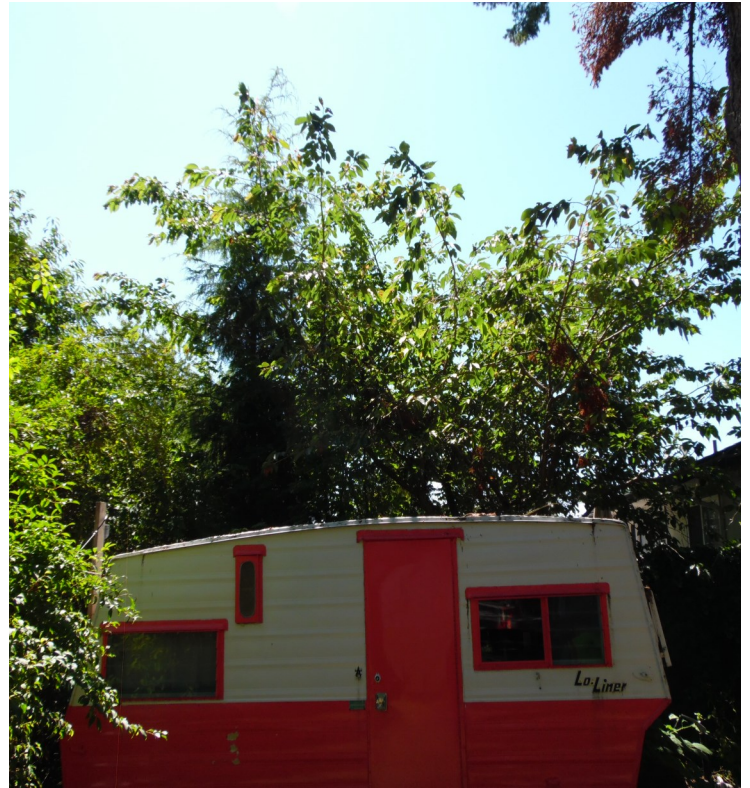
Tree #OS2 behind trailer.

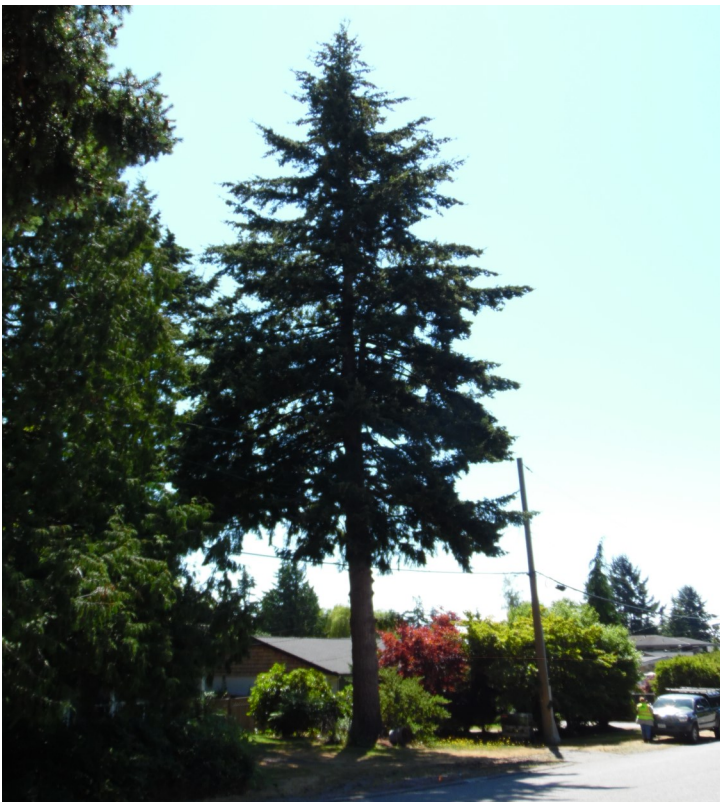
Photo 7

All services come from Lancaster Street into the critical root zones of trees #1819 and #C1 and are therefore recommended for removal due to conflicts with services.

Tree #1819.
