OCP Amendment 15409 Buena Vista Avenue White Rock

Proposed 15-unit Apartment Building

Inventory and Assessment of Trees Associated to Construction at 15409 Buena Vista Avenue, White Rock

March 22, 2022

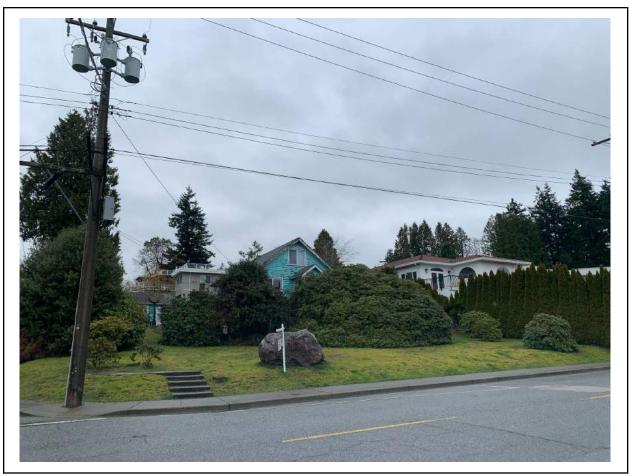
image of property from street at time of field data collection

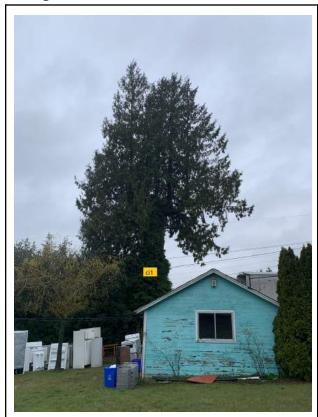
IMAGE 1- Tree ci1

- Tree barriers shown on the "Tree Plan for Construction" are to be installed and kept in place during the entire duration of construction.
 - Arborist supervision recommended for building/parkade excavation within TPZ of tree ci1.
