**Tree Evaluation Report for:
14205 – Malabar Avenue
White Rock, BC**

Date: January 5, 2023

Table 1- Tree Evaluation: 14205 – Malabar Avenue, White Rock, BC

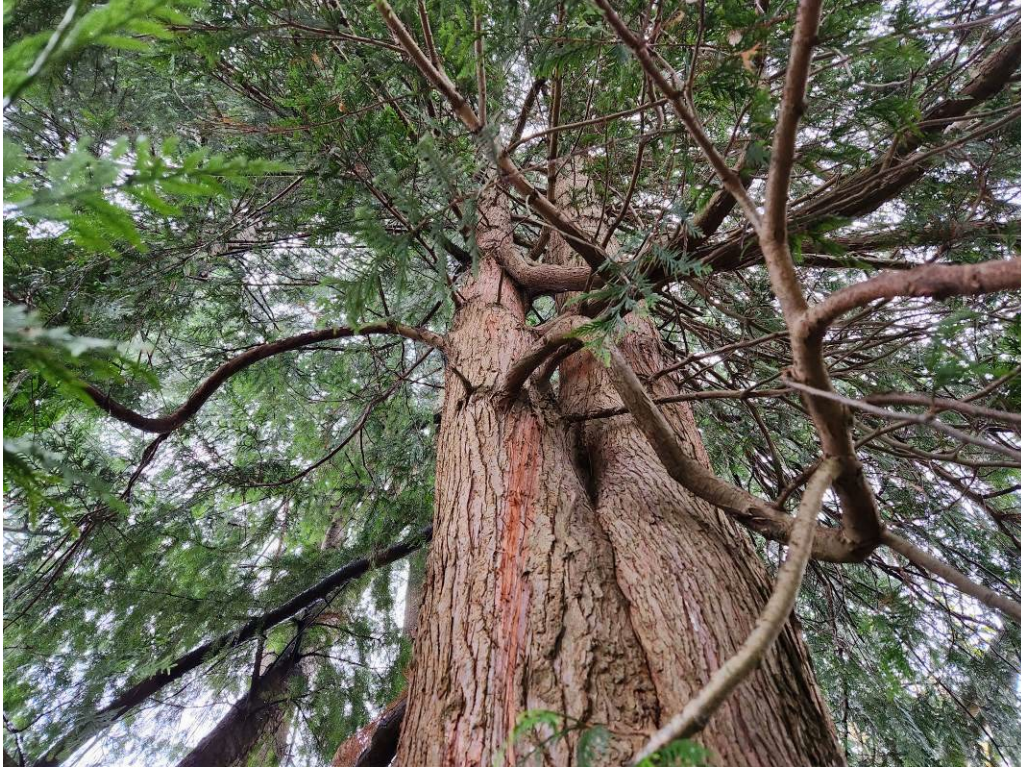
Figure 5. Canopy of tree 35

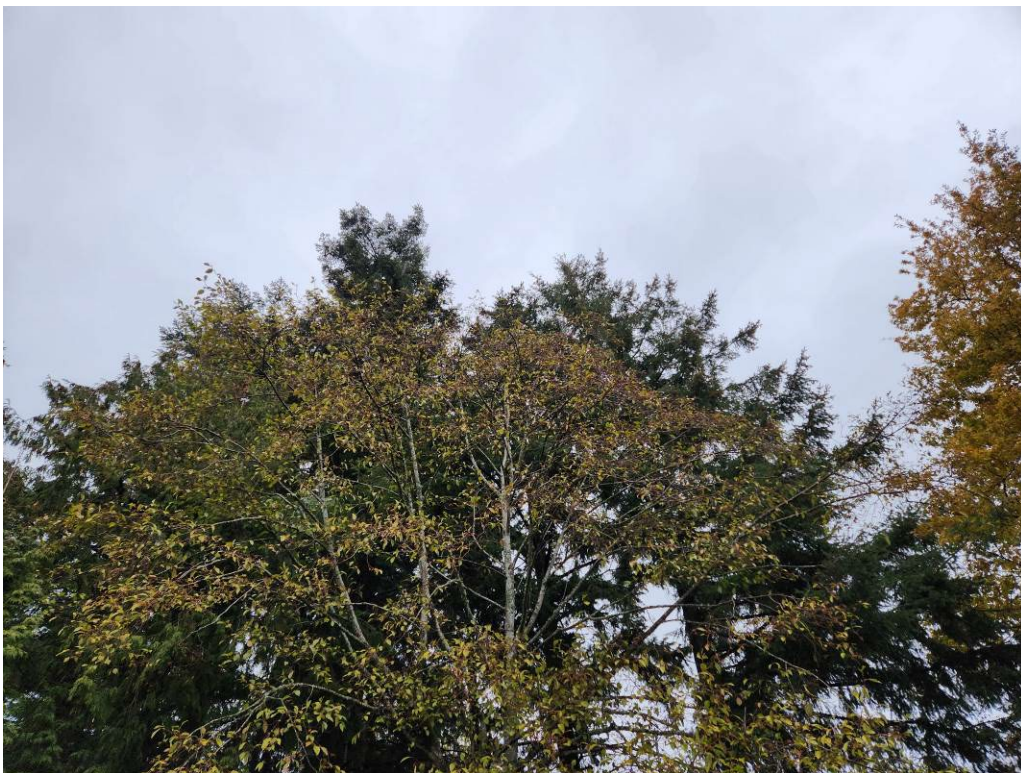
Figure 6. Canopies of trees to the north appear relatively healthy.
