**ESC & ENVIRONMENTAL LETTER FOR
14205 Malabar Avenue, White Rock, B.C.**

ESC & Environmental Letter for
14205 Malabar Avenue, White Rock, B.C.

ATC File #18-435

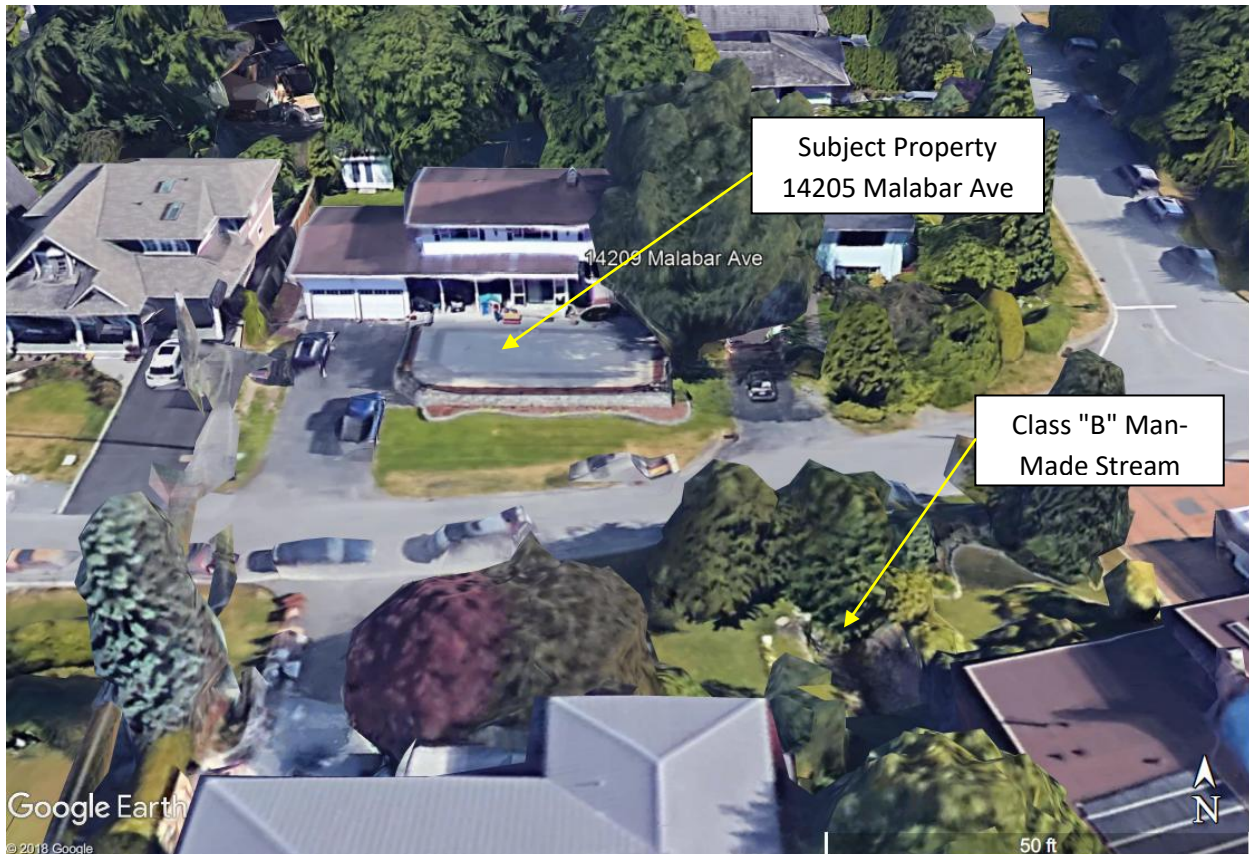
Figure 1: Aerial photo with Environmental Feature across the street from late May to the subject property.

Streamside protection bylaws and building setbacks in the City of White Rock follow the Province of BC's Riparian Area Regulation (RAR) guidelines. When analyzing the stream on the south side of Malabar Avenue by using the detailed RAR guidelines, the streamside protection and enhancement area (SPEA) would result in a 10 metre setback from the stream's high water mark (HWM).

Measurements were taken by ATC at the time of our site visit on May 1st, 2018. The 10 metre setback taken at the location where the stream daylight on the South side of Malabar, fell on the asphalt of

Malabar Avenue and did not reach the subject property line. The subject property therefore falls outside of the RAR-determined SPEA.

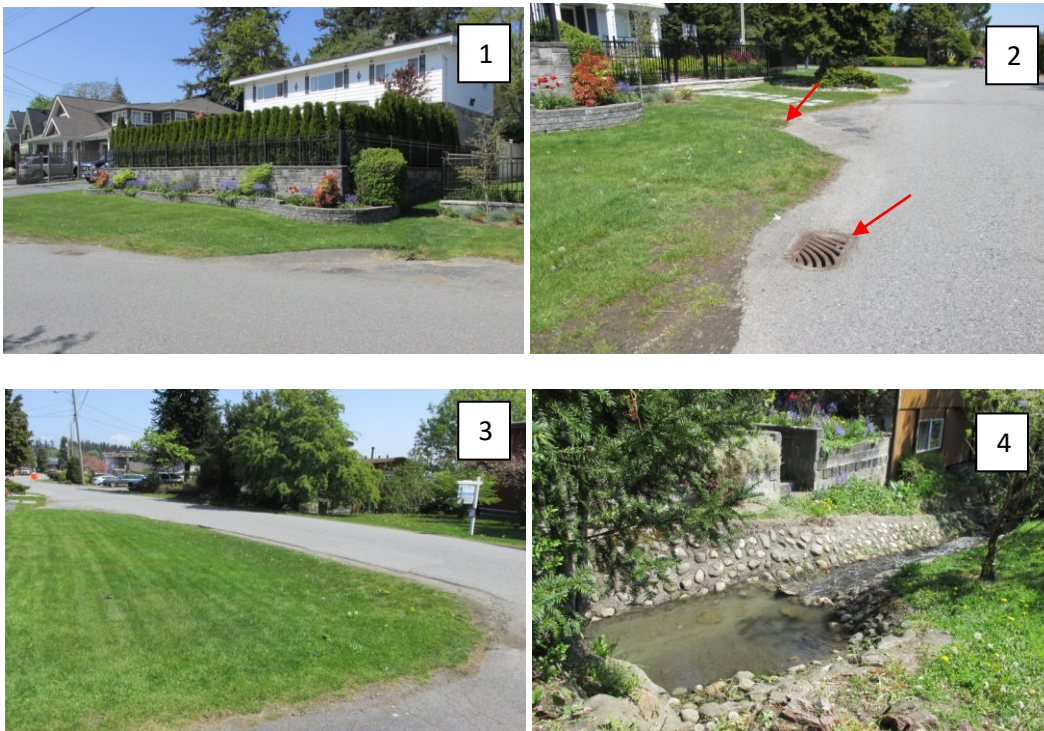
Site Photos:

ATC observed that the property slopes slightly to the South, and that two catch basins are located in front of the subject property on Malabar Avenue. It appears that both catch basins drain into a culverted stream which daylight immediately south of Malabar Avenue. This man-made stream then flows directly South and eventually into Semiahmoo Bay.

No fish presence in this stream would be foreseen given the steep slope down to Semiahmoo Bay; however, ATC would classify the stream as being a Yellow-coded, Class "B" stream, which are defined as *"Providing food/nutrient to downstream fishes."*

1. General view of the residence currently found on the subject property.
2. General view of the two catch basins located adjacent to site.
3. Easterly view of the entrance driveway off Malabar Avenue.
4. Southerly view of the man-made stream found South of Malabar Avenue across from the subject property.

1. To maintain the paved driveway during house demolition and at times of truck traffic to prevent any soil from site making its way out onto Malabar Avenue via the truck tires;
2. Install inserts in all catch basins adjacent to site;
3. install silt fencing along the southern and eastern property lines to prevent any materials from leaving site;
4. Cover all soil piles with poly sheeting when not in use; and
5. If any additional areas require truck access, then a gravel access pad in those areas is recommended.
