MEMORANDUM

Attention:	Jim Gordon, P.Eng., City of White Rock	Date:	April 20,2022		
cc:		From:	Calum Buchan, P.Eng.		
Project:	Marine Drive Hump Vegetation Management	File:	GA22-1085-00		
		Sent Via:	email		
Subject:	Geotechnical Review of Vegetation Management Strategy

White Rock Hump April 20, 2022 GA22-1085-00 Memorandum

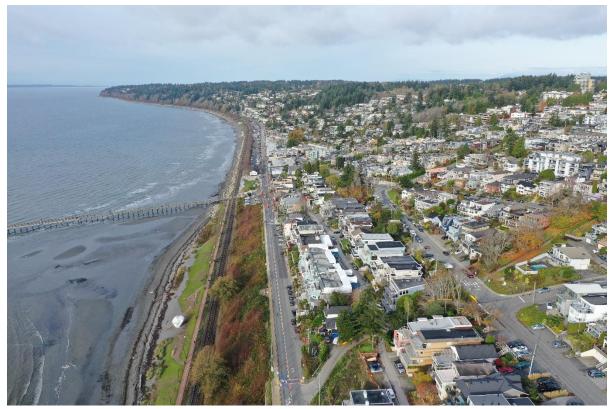
Photo 1: Looking west across Hump to the White Rock Pier

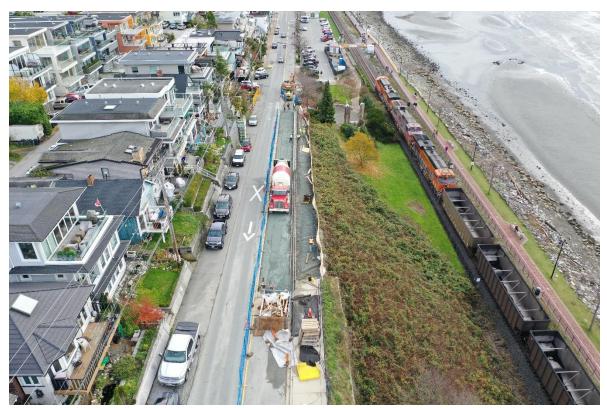
Photo 2: Looking eastward from above top of Hump

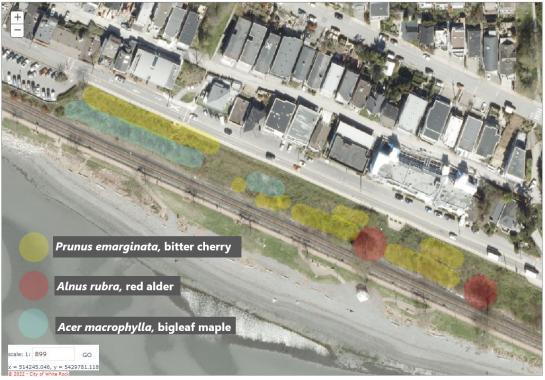
General Composition of Plant Community – West Side of Hump

*Areas not indicated with a colour code are Himalyan blackberry.

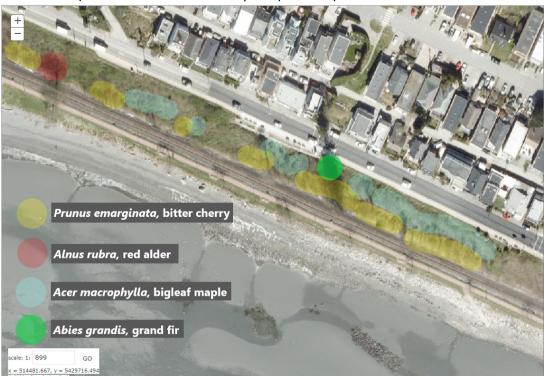
General Composition of Plant Community - Top of Hump
