THE CORPORATION OF THE
CITY OF WHITE ROCK
CORPORATE REPORT

DATE: August 14, 2023

SUBJECT: Hump Maintenance Update

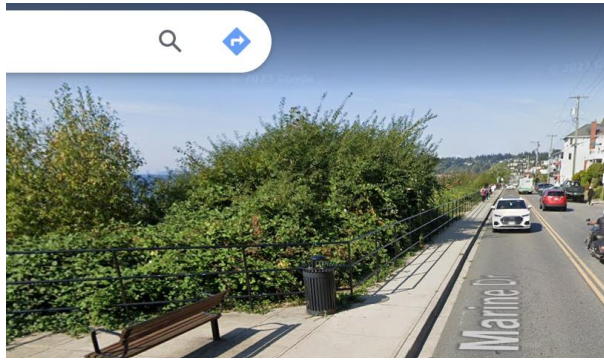
September 2022

The following sequence of photos show a thicket of bitter cherry to the west of the viewpoint. In 2011, the thicket rose above the sidewalk and was subsequently removed to ground level sometime around 2015. Then in 2018, the regrowth is evident at railing level and then much higher in September 2022. This pattern of regrowth is consistent with arborists opinions of the viability of the bitter cherry when cut leaving the supporting root structures intact.

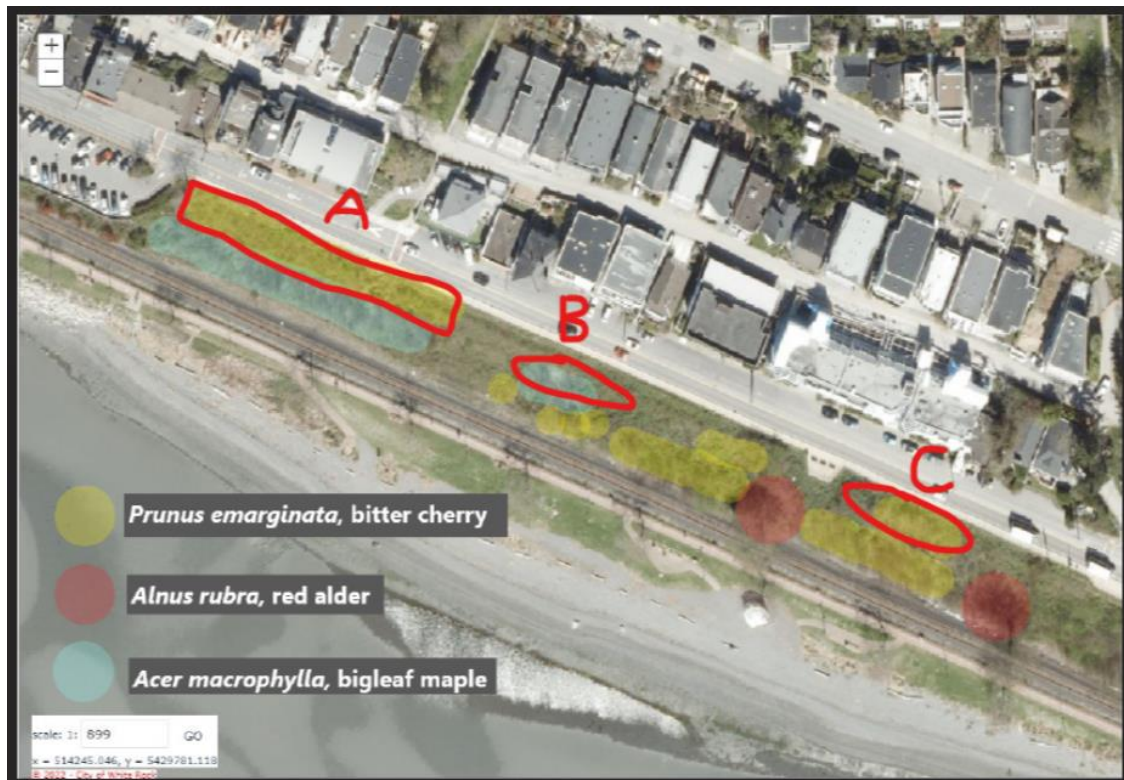
The easterly sections of the Hump do not need remedial works prior to plan implementation as they are either steeper or have had recent reconstruction. Details for the three areas of potential remediation are described below.

Area A, immediately east of the parking area is comprised of a thicket of bitter cherry adjacent to the sidewalk and bigleaf maple near the lower reaches of the slope. The bitter cherry can be removed and some of the smaller shoots of big leaf maple near the top of the slope; however, the big leaf maple in the lower reaches is either too established or too far downslope to be trimmed. These will grow and eventually take from the view, but the upper areas near the sidewalk can be opened up and regularly maintained.

Shoots of big leaf maple near the top of the slope can be removed and maintained; however, the big leaf maple in the lower reaches is either too established or too far downslope to be trimmed and will grow larger over time.

The bitter cherry thicket to the east of the viewpoint can be removed in the upper reaches of the slope.

The estimated costs for the work in areas A plus B is \$25K. The estimated cost for the work in area C, east of the viewpoint is \$10K. Operating funding of \$75K is included in the 2023 Financial Plan – this was originally intended for a comprehensive study of the entire Hump leading to a replanting and maintenance plan.

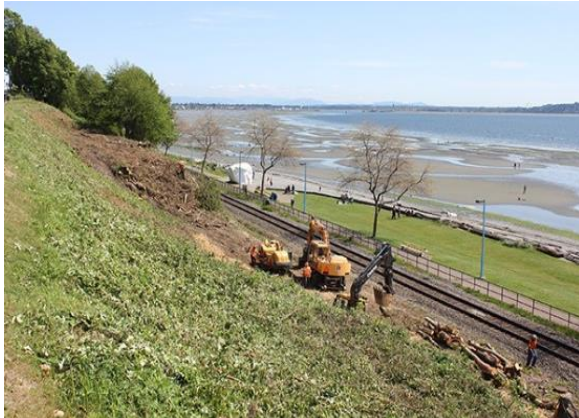
White Rock residents are passionate about the growth and trees on the Hump, including views, the natural environment and slope stability. Current staff are advised that the Hump was “clearcut” on or around 2015. Pictures from that time show an area that was completely cut down using heavy machinery.

The two pictures shown above show the difference in scope between the 2015 and 2023 works; however, increased community engagement with the city generated from the vegetation and tree removal in 2015 remains, with some residents expressing strong concerns about the recent maintenance works.
