THE CORPORATION OF THE
CITY OF WHITE ROCK
CORPORATE REPORT

SUBJECT: City Hall – Seismic Report - 2020

White Rock City Hall

Seismic Assessment and Retrofit Report

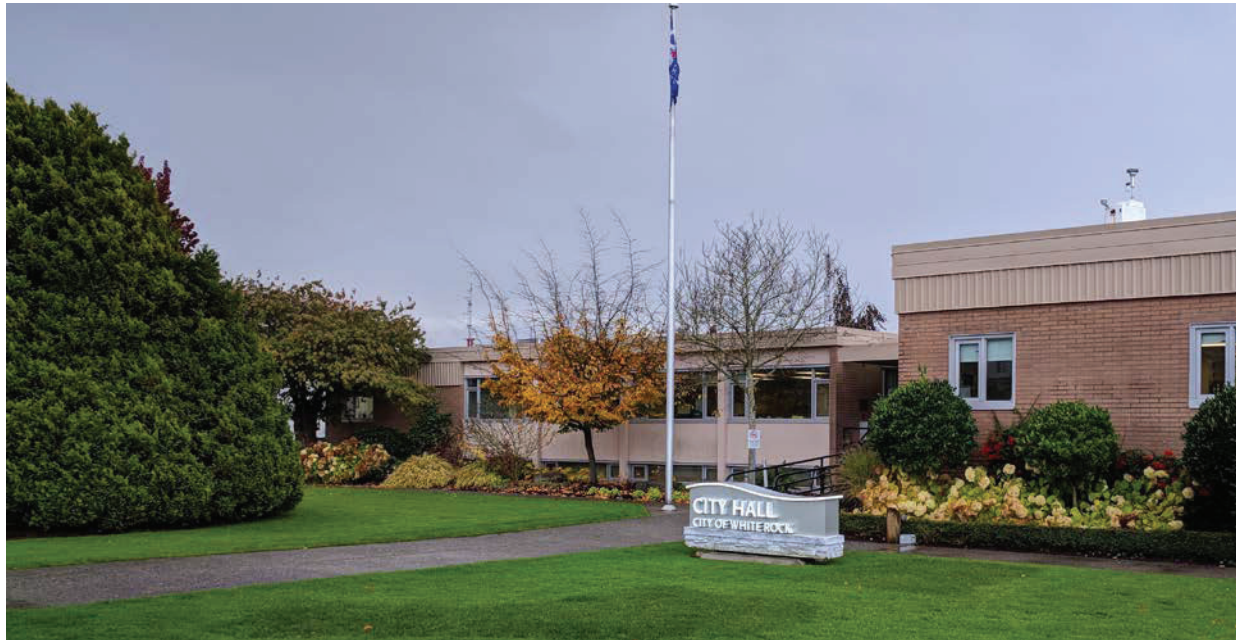
Figure 1: North Elevation of White Rock City Hall

White Rock City Hall was originally constructed in 1962. It is a two-storey structure with flat roofs. The lower level has a basement wall on the north side but exits at grade on the south elevation. Figure 1 below includes a photograph of the main entry area on the north side of the building.

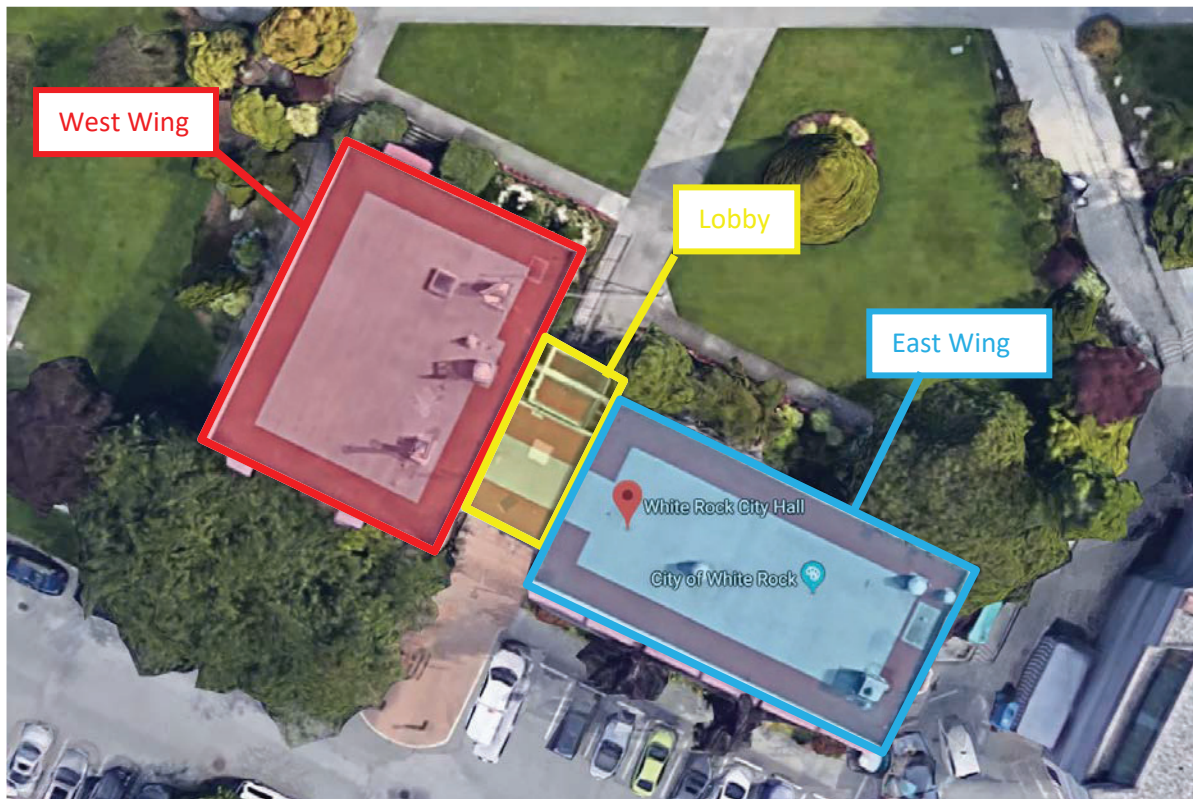
Figure 2: Key Plan of White Rock City Hall

The building can be separated into three distinct portions or “blocks”. Figure 2 provides a key plan of the blocks. These are the West Wing which houses the Council Chambers on the upper level, the East Wing, and the lobby. All three blocks have the same floor elevations at both the lower and upper levels. The West Wing has a higher roof elevation than the East Wing, and the lobby has a lower roof elevation than both East and West Wings.
