## Arboricultural Assessment Report

Project File No.: 18-028

Project Name: Mixed Use / Residential  
1570/1580 Maple Street, 15654/15664/15674  
North Bluff Road and 1593 Lee Street  
White Rock, BC.

**Re: Arboricultural Services at 1570/1580 Maple St., 15654/15664/15674 North Bluff Rd. & 1593 Lee St., White Rock, BC.**

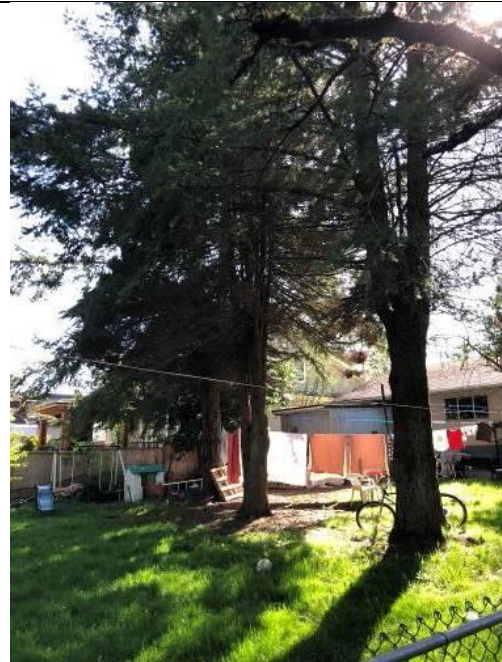
**Photo 12:** Tree #518, 513, 517

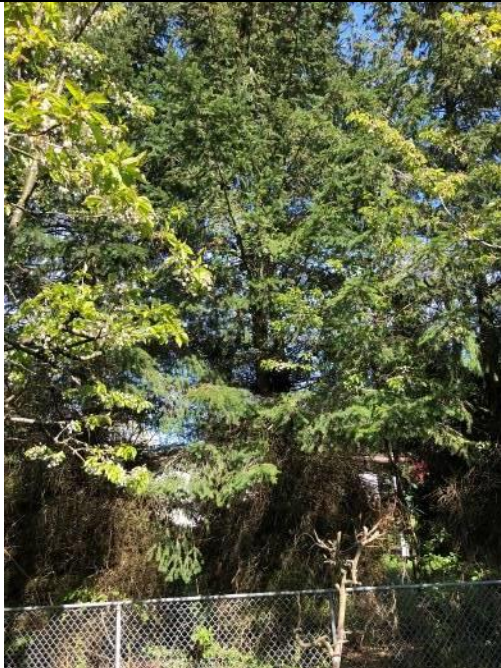
**Photo 13:** Tree #OS1, OS2, OS3; neighbouring property small hedgerow

Tree Number	Species	DBH (cm)	Protected tree size (Y/N)	Health	ON SITE	Location	Description	Comments	CRZ (m)
OS2	<i>Pseudotsuga menziesii</i> , Douglas-fir	37	Y	M	N	Lot 5 (neighbours)	Neighbours Douglas-fir trees (OS1-OS3); has leader; canopy diameter = 3.9m; LCR=70-75%	Retain	2.2m
OS3	<i>Pseudotsuga menziesii</i> , Douglas-fir	35	Y	M	N	Lot 5 (neighbours)	Neighbours Douglas-fir trees (OS1-OS3); has leader; canopy diameter = 3.5m; LCR=70-75%	Retain	2.1m
OS4	<i>Prunus</i> sp., Fruiting Cherry	n/a	n/a	P	N	Lot 8 (neighbours)	Dead; nvasive ivy on the trunk.; neighbouring tree	Retain	
OS4382 (city)	<i>Thuja plicata</i> , Western redcedar	79	Y	P	N	NE (Maple St.)	Roots supressed by the road and driveway; one trunk and multiple leaders; clearance pruned; reaction wood noted on branch connections, particularly in crotch of leaders; metal hook installed in tree; included bark in a branch at 3m height; suckering on trunk; full canopy; LCR=60-70%	Remove - conflicts with civil engineering plans

Based on the existing health and condition of existing trees, as noted in the inventory our recommendation is to retain tree OS1-OS5 and #A.

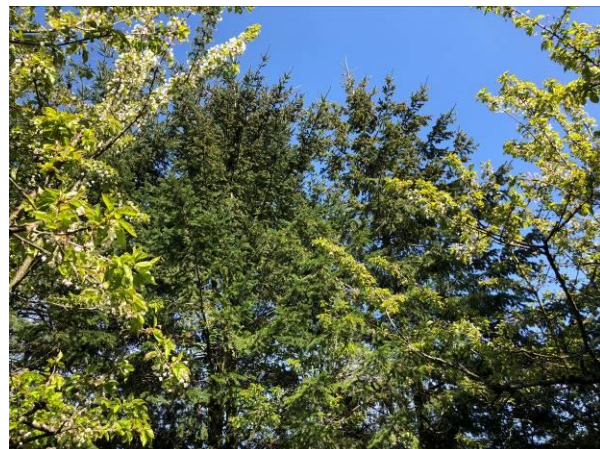
**Photo 14:** Tree #OS1, OS2, OS3; neighbouring property small hedgerow

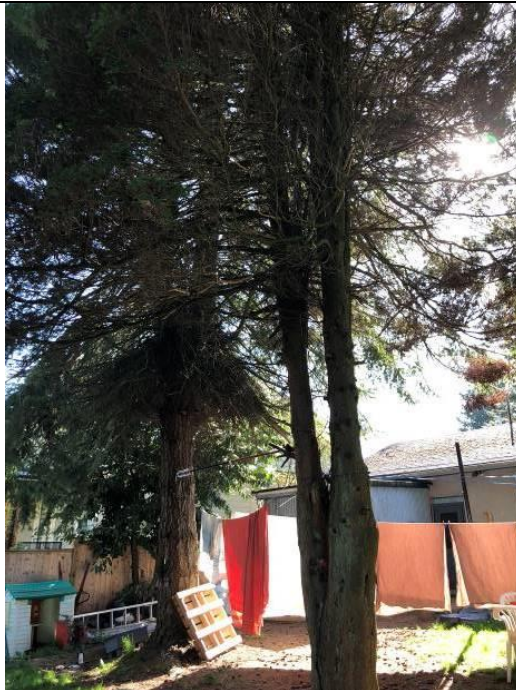
**Photo 23:** Tree #517 witches broom fungus

517	<i>Pseudotsuga menziesii</i> , Douglas-fir	67	Y	P	Y	Lot 7	Trunk flare buried; codominant at 7m; witches' broom branch structure; dead lower canopy (due to lopped branches); compacted soil within critical root zone with some suppression by patio structure; damage on the trunk; bulges; mechanical damage to trunk; fungus (shared with 513 and 518); foliage suppressed by neighbouring tree (513); LCR=50%	Remove-Conflict with proposed development	
518	<i>Pseudotsuga menziesii</i> , Douglas-fir	67	Y	P	Y	Lot 7	Soil at base of tree; compacted with some suppression by patio structure; mechanical damage on trunk; bulges; witches' broom branch structure; fungus (shared with 513 and 517); wood piled at base; foliage suppressed by neighbouring tree (513); LCR=55%	Remove-Conflict with proposed development	
519	<i>Prunus</i> sp., Fruiting Cherry	33	Y	P	Y	Lot 7	Poor condition; significant phototropic lean onto neighbour's property; heavily pruned by resident.	Remove-Conflict with proposed development

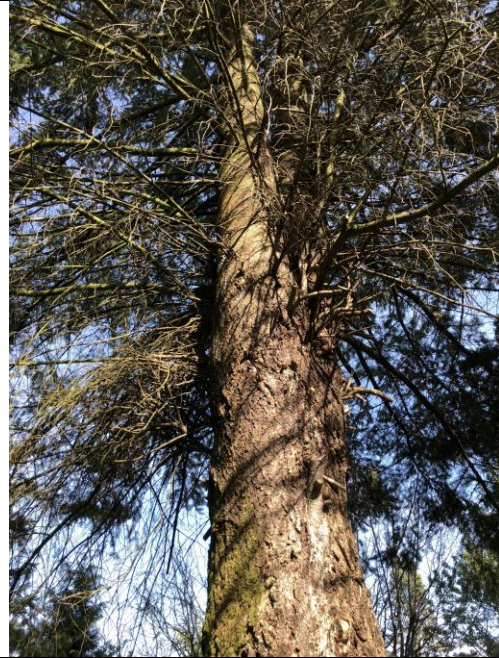
**Photo 27:** Trees #587, 585

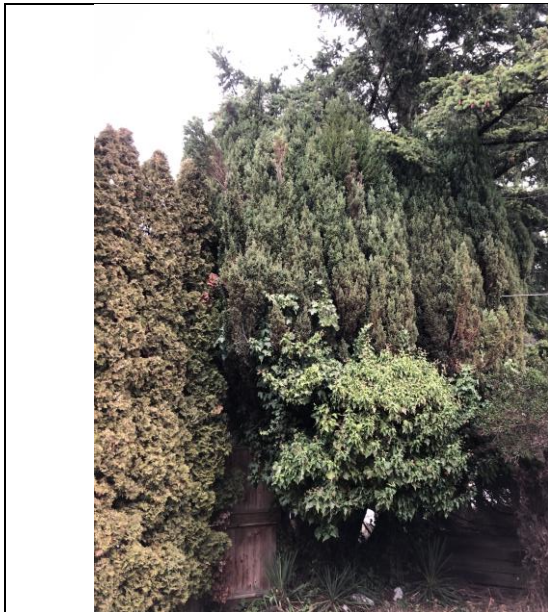
**Photo 28:** Tree #1000 (January 23, 2023)

1000	<i>Alnus rubra</i> , Red alder	21	Y	G	Y	Lot4	Single stem, natural crown form, young, healthy, no major defects found.	Remove-Conflict with proposed development	
587	<i>Chamaecyparis pisifera</i> 'Baby Blue', Sawara Cypress	24, 17, 13, 12	Y	P	Y	Lot 3	Large multiple stem (5-8 stems each); canopy suppressed on south and north side; poor condition; branches partially damaged by snow weight; weak crotch branch connections, included bark; ivy growing throughout	Remove-Conflict with proposed development	
588	<i>Pseudotsuga menziesii</i> , Douglas-fir	81	Y	P	Y	Lot 4	Hedge row on north-east property line of lot 4; planted approximately 2m O.C.; historically heavily pruned by residents and/or Hydro - topped at approximately 1.5m ht; poor condition; bulges on the trunk; multiple leaders overgrown; poor branch connections; history of dropping branches; over head wires above canopy; LCR= 35%	Remove-Conflict with proposed development

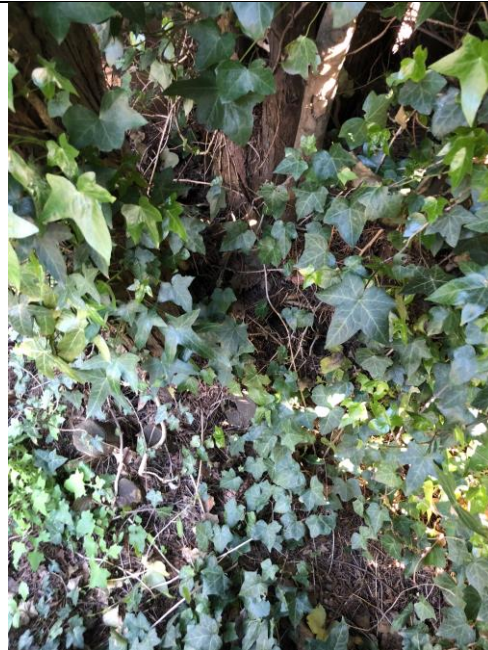
**Photo 31:** Hedgerow; trees #592, 593, 594, 595, 596

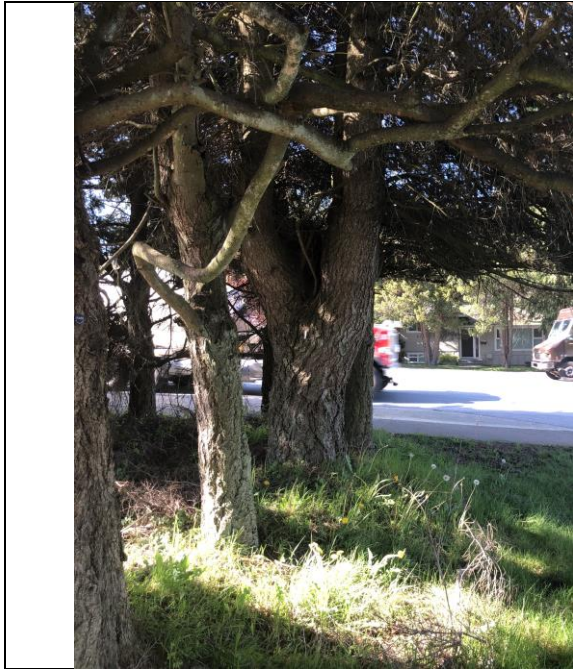
**Photo 32:** Hedgerow; trees #592, 593, 594, 595, 596 with multi-leaders; topped

Tree Number	Species	DBH (cm)	Protected tree size (Y/N)	Health	ON SITE	Location	Description	Comments	CRZ (m)
592	<i>Pseudotsuga menziesii</i> , Douglas-fir	64	Y	P	Y	Lot 4	Hedge row on north-east property line of lot 4; planted approximately 2m O.C.; historically heavily pruned by residents and/or Hydro - topped at approximately 1.5m ht; poor condition; bulges on the trunk; multiple leaders overgrown; poor branch connections; history of dropping branches; over head wires above canopy; LCR= 35%	Remove-Conflict with proposed development	
593	<i>Pseudotsuga menziesii</i> , Douglas-fir	46	Y	P	Y	Lot 4	Hedge row on north-east property line of lot 4; planted approximately 2m O.C.; historically heavily pruned by residents and/or Hydro - topped at approximately 1.5m ht; poor condition; bulges on the trunk; multiple leaders overgrown; poor branch connections; history of dropping branches; over head wires above canopy; LCR= 35%	Remove-Conflict with proposed development

594	<i>Pseudotsuga menziesii</i> , Douglas-fir	42	Y	P	Y	Lot 4	Hedge row on north-east property line of lot 4; planted approximately 2m O.C.; historically heavily pruned by residents and/or Hydro - topped at approximately 1.5m ht; poor condition; bulges on the trunk; multiple leaders overgrown; poor branch connections; history of dropping branches; over head wires above canopy; LCR= 35%	Remove-Conflict with proposed development	
595 (surveyor) 4109 (City)	<i>Pseudotsuga menziesii</i> , Douglas-fir	43	Y	P	shared	Lot 4 and Lee St.	Hedge row on north-east property line of lot 4; planted approximately 2m O.C.; historically heavily pruned by residents and/or Hydro - topped at approximately 1.5m ht; poor condition; bulges on the trunk; multiple leaders overgrown; poor branch connections; history of dropping branches; over head wires above canopy; LCR= 35%	Remove-Conflict with proposed development

596 (surveyor) 4110 (City)	<i>Pseudotsuga menziesii</i> , Douglas-fir	86	Y	P	Y	Lot 4	Hedge row on north-east property line of lot 4; planted approximately 2m O.C.; historically heavily pruned by residents and/or Hydro - topped at approximately 1.5m ht; poor condition; bulges on the trunk; multiple leaders overgrown; poor branch connections; history of dropping branches; over head wires above canopy; LCR= 35%	Remove-Conflict with proposed development	
597 (surveyor) 4381 (City)	<i>Pseudotsuga menziesii</i> , Douglas-fir	42	Y	P	Y	Lot 4	Hedge row on north-east property line of lot 4; planted approximately 2m O.C.; historically heavily pruned by residents and/or Hydro - topped at approximately 1.5m ht; poor condition; bulges on the trunk; multiple leaders overgrown; poor branch connections; history of dropping branches; over head wires above canopy; LCR= 35%	Remove-Conflict with proposed development

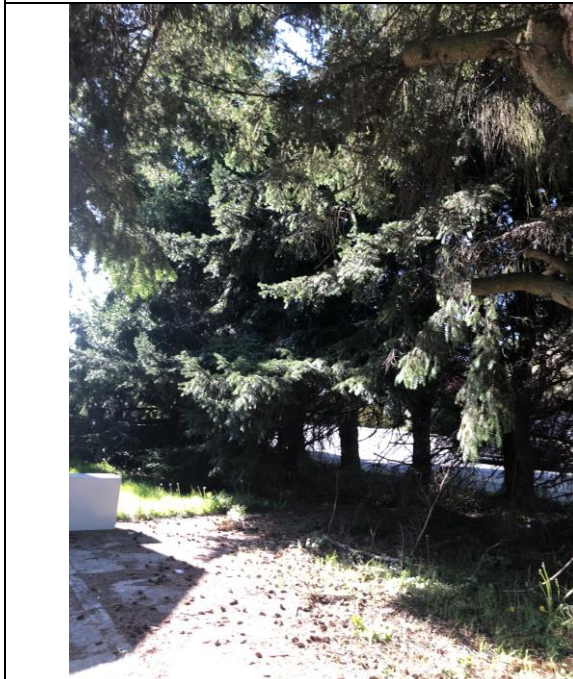
**Photo 34:** Tree #586

- ❖ January 24, 2023, report is updated with new site plan and site assessment, two more trees (#582 and #1000) were found reaching bylaw size. Tree #586 is revised to be removed due to its confliction with proposed PMT.
- ❖ July 30, 2019 update to address City comments from April 23, 2019 and make recommendations for the removal of City tree #OS4382, OS4383 and OS7123, to meet Engineering requirements.

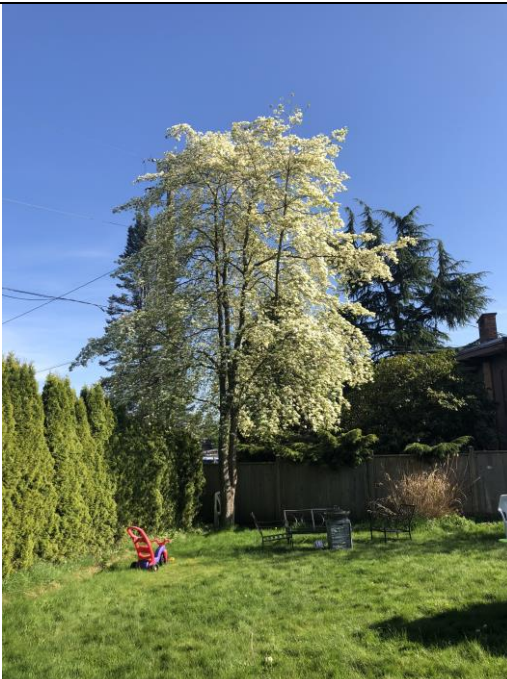
**Photo 35:** Tree #582

582	<i>Acer negundo</i> , Boxelder maple	20	Y	M	Y	Lot 3	Small tree; moderate condition; multiple stump tree; included bark at crotch	Remove-Conflict with proposed development	
583	<i>Prunus</i> sp., Fruiting Cherry	43	Y	P	Y	Lot 3	Open grown; double trunk; mature tree with heavy branch structure; under stress; weak branch structure; open hollow crotch	Remove-Conflict with proposed development
