PROJECT: **VIDAL STREET DEVELOPMENT**

SITE ADDRESS: 14937 Thrift Ave & 1441/1443-45/1465 Vidal Street, White Rock, BC

Original Report November 5, 2018  
Revision 1 May 8, 2019  
Revision 2 September 23, 2020 – A.L.  
Revision 3 July 11, 2022 – D.G.R. - Updated Survey.

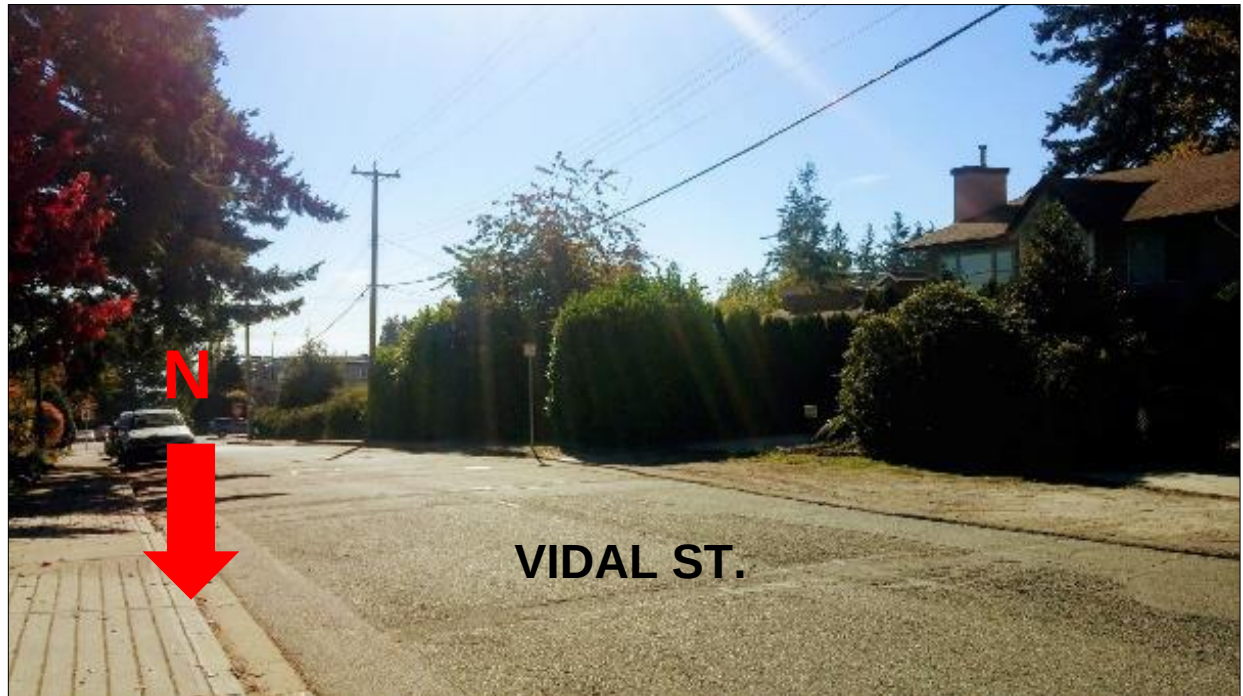
**Fig. 2** - View facing south along Vidal Street to Thrift Avenue.

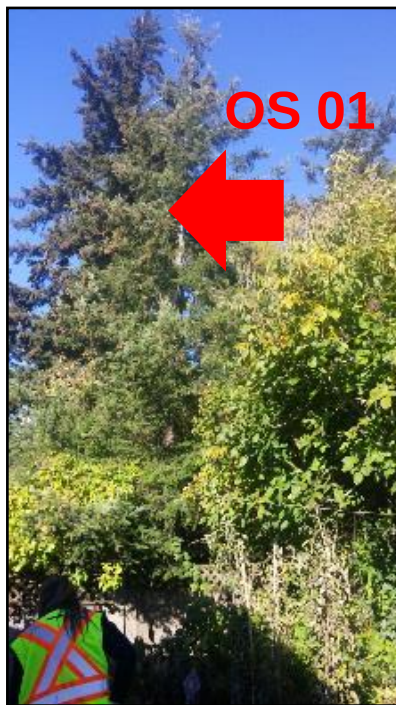
**Fig. 3** – Off-site Douglas-fir tree

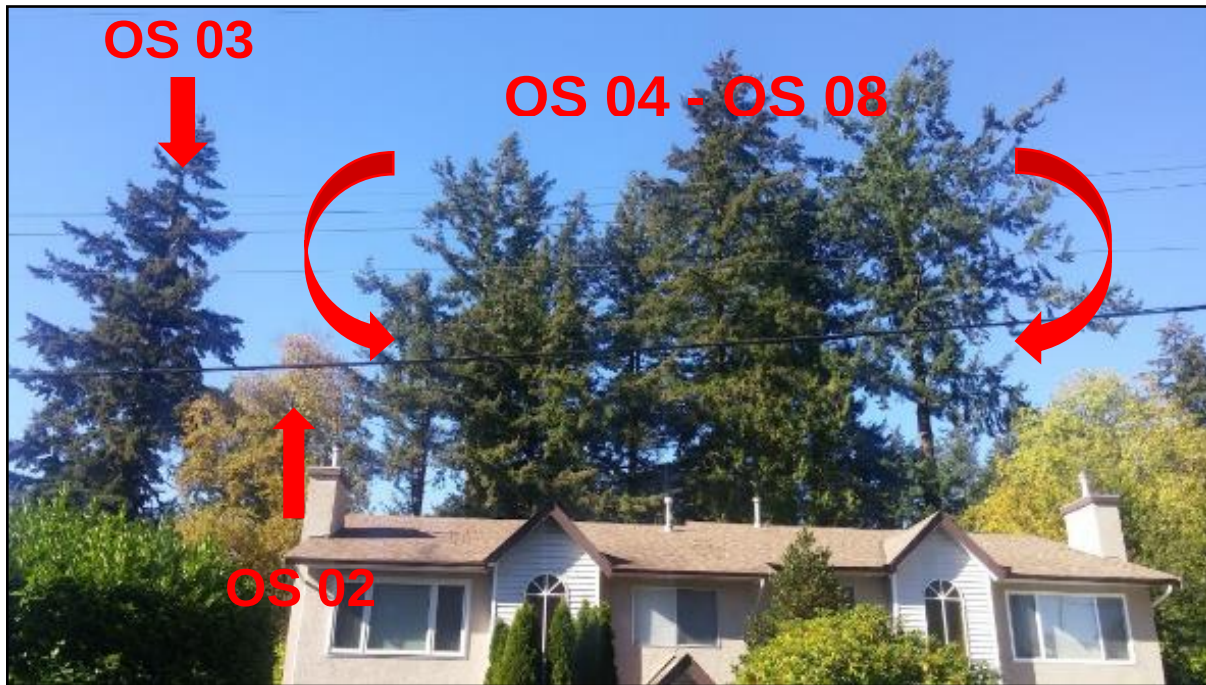
As there are off-site trees with driplines that extend into the subject property, there may be interconnected root systems within the grouping (OS9-OS11) which likely extend onto the property. BC Plant Health Care Root Radar results determined the roots of tree 06 has poor structure and multiple trunks with decay. In addition, OS2-OS6 have feeder or structural roots which grow towards the property. Any work done within the critical root zone will need to be monitored by the arborist. Any retention wall should be maintained to avoid root disruption and destabilization.

**Fig. 6** – Stand of off-site conifers located directly west of 1441/1443-45/1465 Vidal Street.

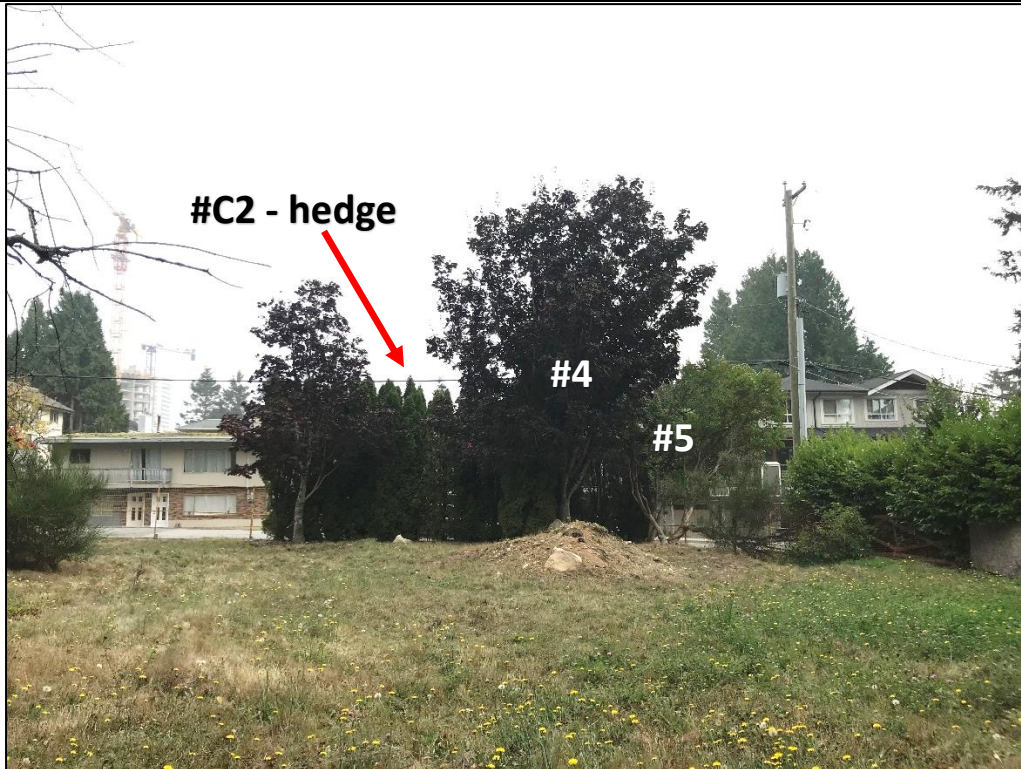
- Tree 05 suffered a failed limb prior to September 15<sup>th</sup>, 2020 visit.
- Tree protection fencing requires repairs and placing for all protected trees prior to any land clearing activities.

| TREE # | TAG # | COMMON NAME<br>BOTANICAL NAME | LOCATED ON THE SURVEY | DBH (cm) | Crown Radius (m) | LCR (%) | COMMENTS | RETAIN / REMOVE |
|---|---|---|---|---|---|---|---|---|
| 05 | 375 | Common lilac<br><i>Syringa vulgaris</i> | No | 31<br>(10,10, 11) | 3.0 | 30 | <b>HANDPLOTTED</b><br>Poor form and structure.<br>TRUNK – Multi-stem from base. Single limb failure since original visit.<br><br><b>WITHIN PARKADE FOOTPRINT</b> | Remove |

**Fig. 10** – View facing east. Southeast corner of 1445 Vidal st. C2 hedge, #4 norway maple, and #5 lilac.
