# WHITE ROCK

## Facilities Master Plan Update

August 29, 2023

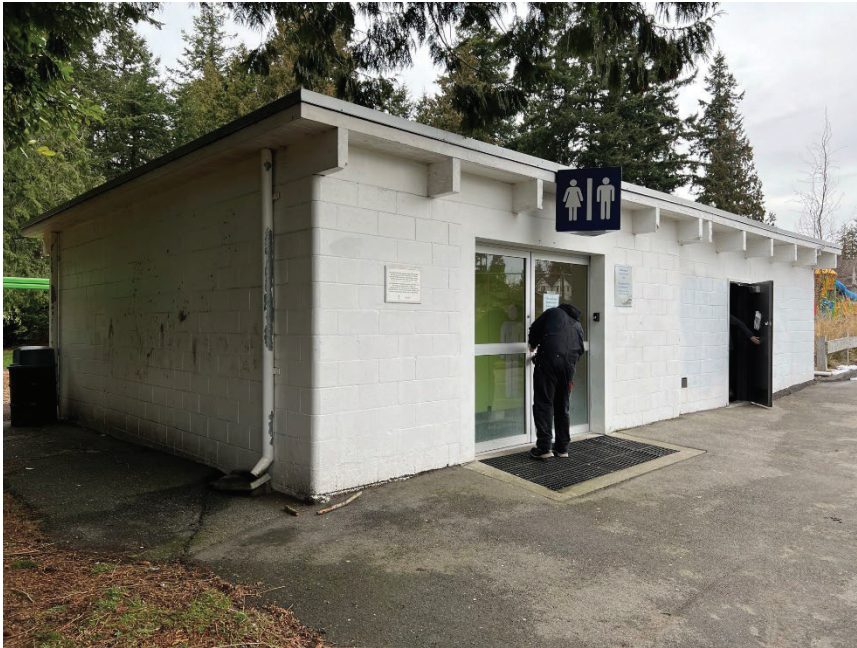
The Ruth Johnson Park Comfort Station is a public washroom facility located in Centennial Park. It contains male and female washrooms; a dedicated universal washroom; a service corridor; and a storage space. The building was upgraded roughly around 2011 to serve the growing need for public washrooms for the surrounding Ruth Johnson Trails, White Rock Generations Playground, and Centennial Park Soccer and Running Oval.

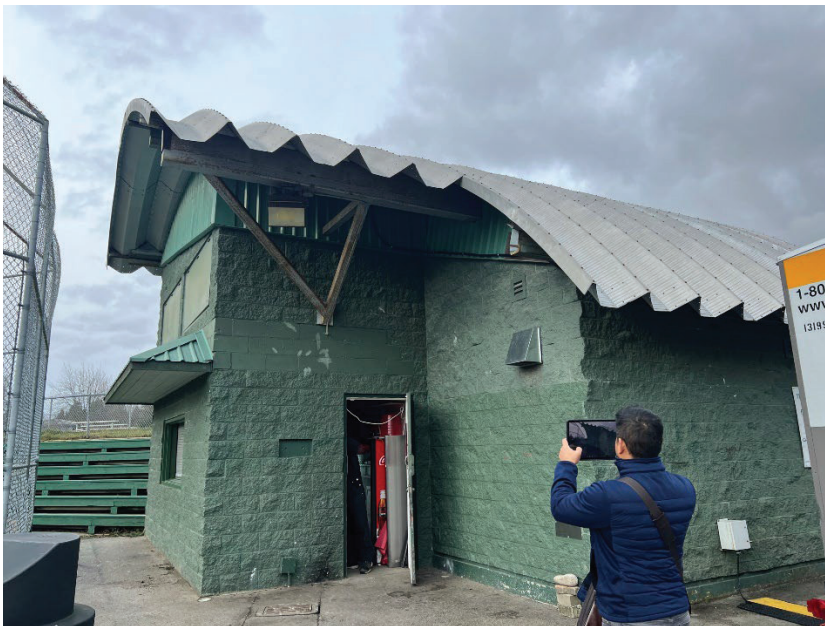
The Centennial Baseball Diamond Comfort Station is a public washroom facility and concession space located in Centennial Park. It contains male and female washrooms, a dedicated universal washroom, second level storage, and a concession space that is part of the initial building. The building was upgraded roughly around 1999 to serve the growing demand of the Centennial Baseball Diamond.

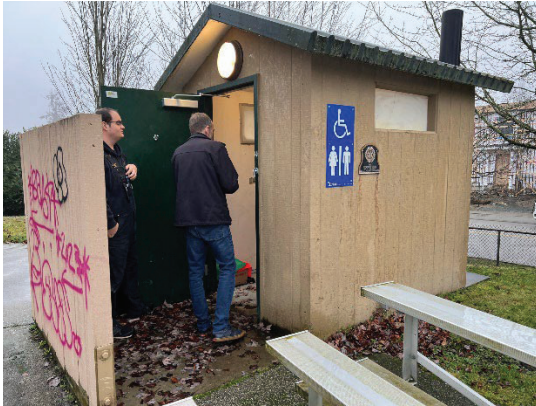
The Peace Arch Elementary Comfort Station is a public washroom facility located at the Peace Arch Elementary field. It is a single washroom building. It was built in 2011 to serve as a public washroom for recreational activities on the field.

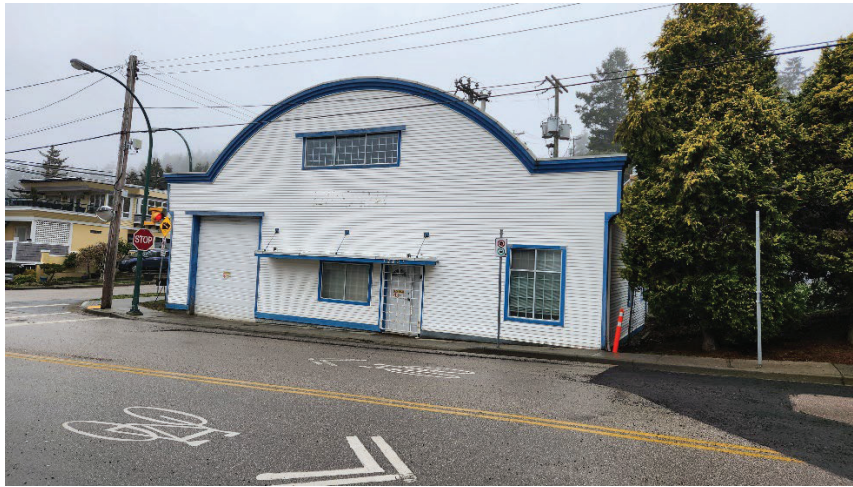
The Waterworks Yard and Shop Building, originally built in the late 1940s, is located on northeast corner of Oxford Street and Buena Vista Yard. It contains a workshop, staff lounge, offices, and a storage attic. Outside, there is a covered garage and storage shed. A few personnel of the Public Works Department work from here.

The building is showing signs of foundation settlement on the south side creating cracking in the finishes and sloping floors. If the City plans to continue to occupy the building these issues will need to be repaired. A geotechnical assessment will be the first step to determine the cause, followed by structural repairs and upgrade.

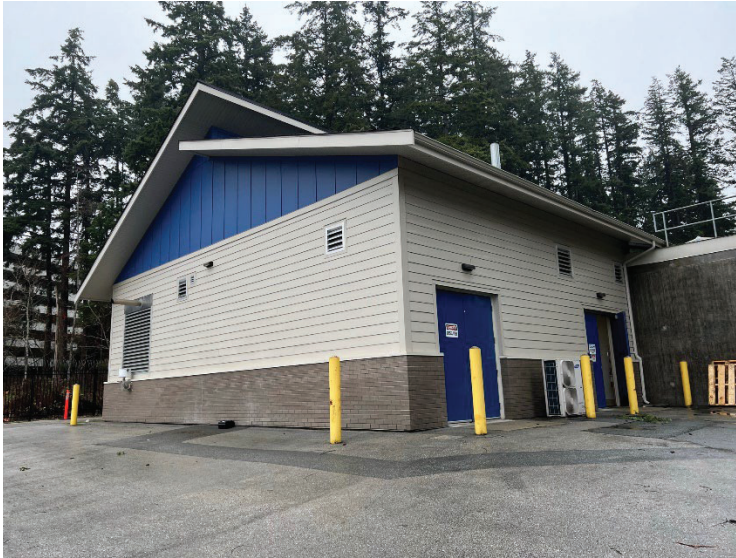
The Oxford Pump House and a separate small building housing a generator, built in 2015, is located beside the Water Treatment Plant which was later added in 2018. It also houses a few staff from the Public Works Department.

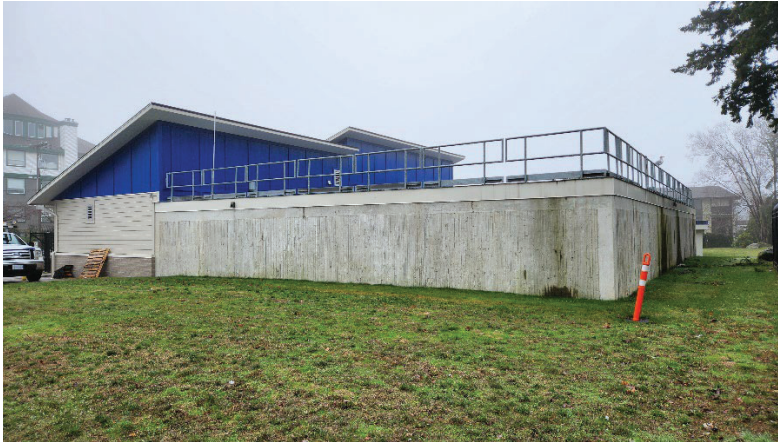
The Merklin Pump House, built in 2018, is located at North Bluff Road and Merklin Street serving as pumping station facility for the City of White Rock. It contains a pump station room, generator room, and reservoir. A few personnel from the Public Works Department work from here.

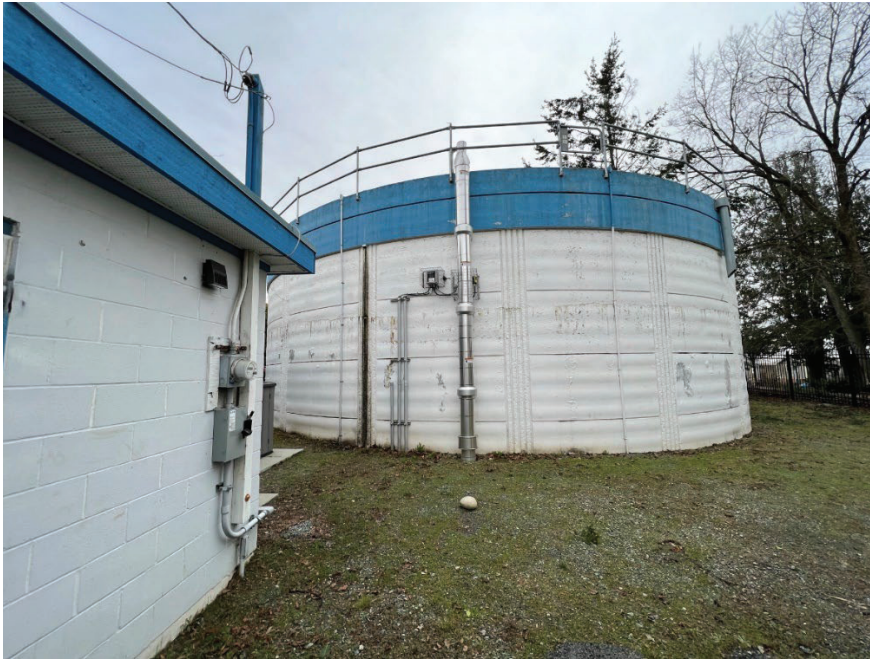
The Roper Pump House and Reservoir, built roughly around 1970, is located at Johnston Lane and Roper Avenue serving as pumping station facility and reservoir for the City of White Rock. The site contains a small single pump station building and reservoir tank. There are a few staff from the Public Works Department who service the facility weekly. It has a portable back-up generator with external transfer switch for quick connect to the building.

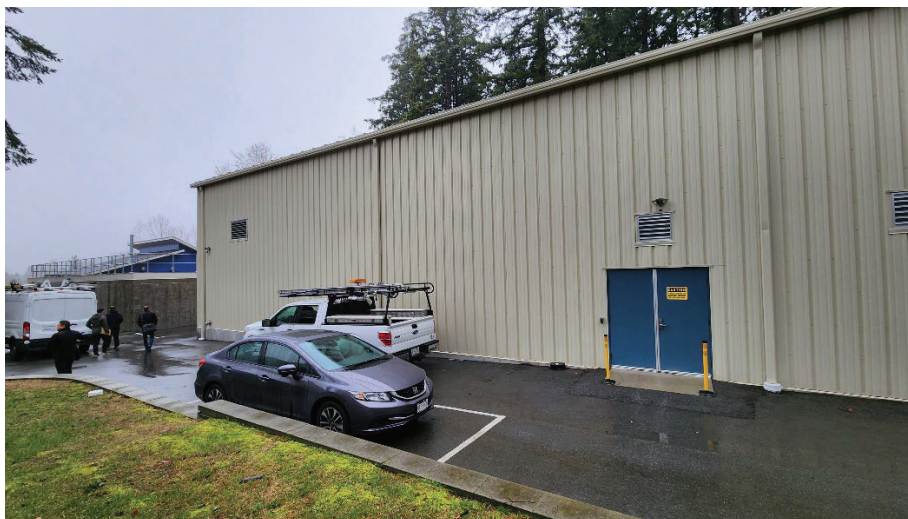
The Water Treatment Plant, built in 2019, is located at Goggs Avenue and Overall Street serving as water treatment facility for the City of White Rock. It is adjacent to the previously built Oxford Pump station and reservoir. A few personnel of the Public Works Department work from here.

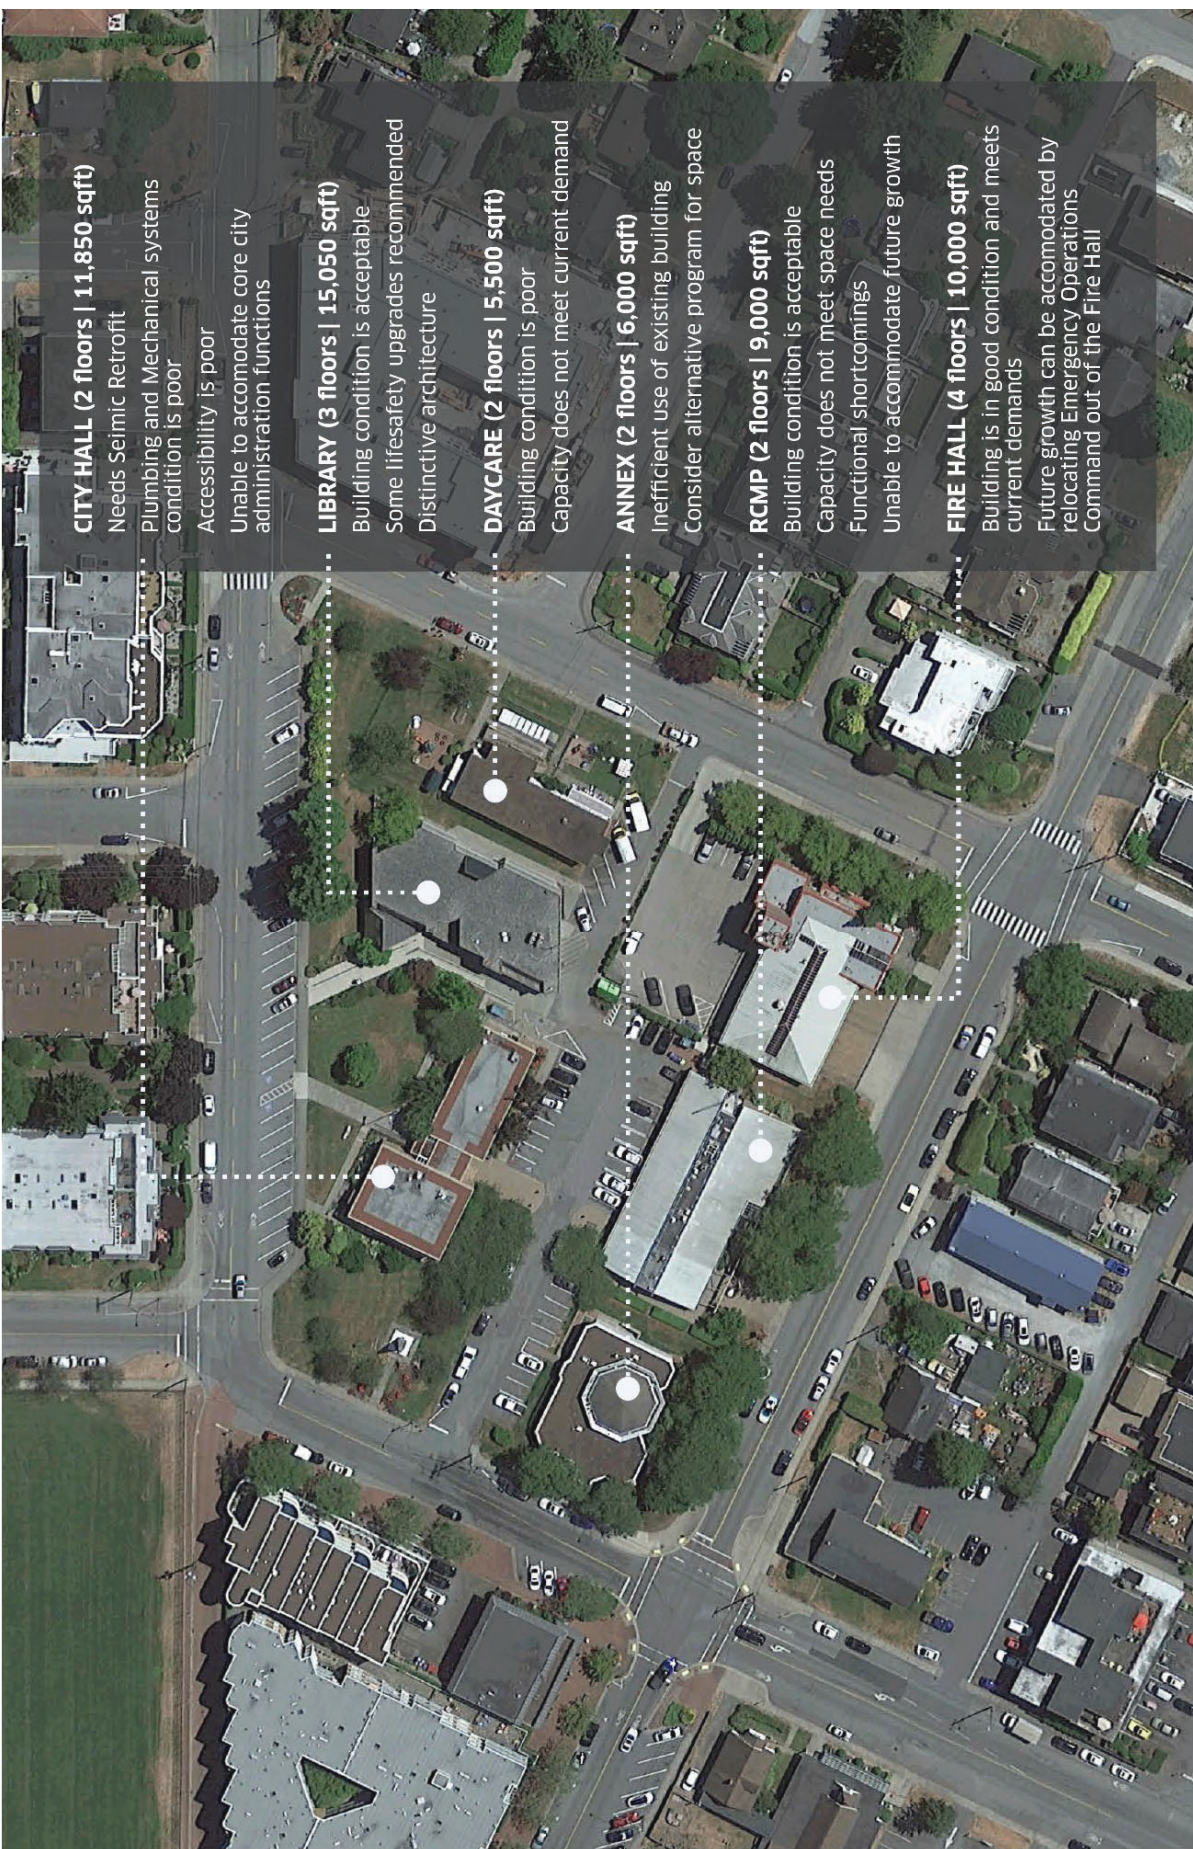
4.4.1 City Hall Block – Visual Summary of Existing Conditions

The map on the following page outlining salient points from facility assessments of the six buildings attempts to begin looking at these individual buildings as components of a larger whole. It is the first step to begin understanding relationships and synergies, and forms the premise for exploring approaches for potential redevelopment of this entire city block.

4.4.1 - City Hall Block – Visual Summary of Existing Conditions recaps salient points from building assessments of the six buildings in an attempt to begin looking at these individual buildings as components of a larger whole and begin understanding relationships, synergies, and challenges.
